MEPCO S396/3001

End of Life Strategy PAC Presentation

06/15/24

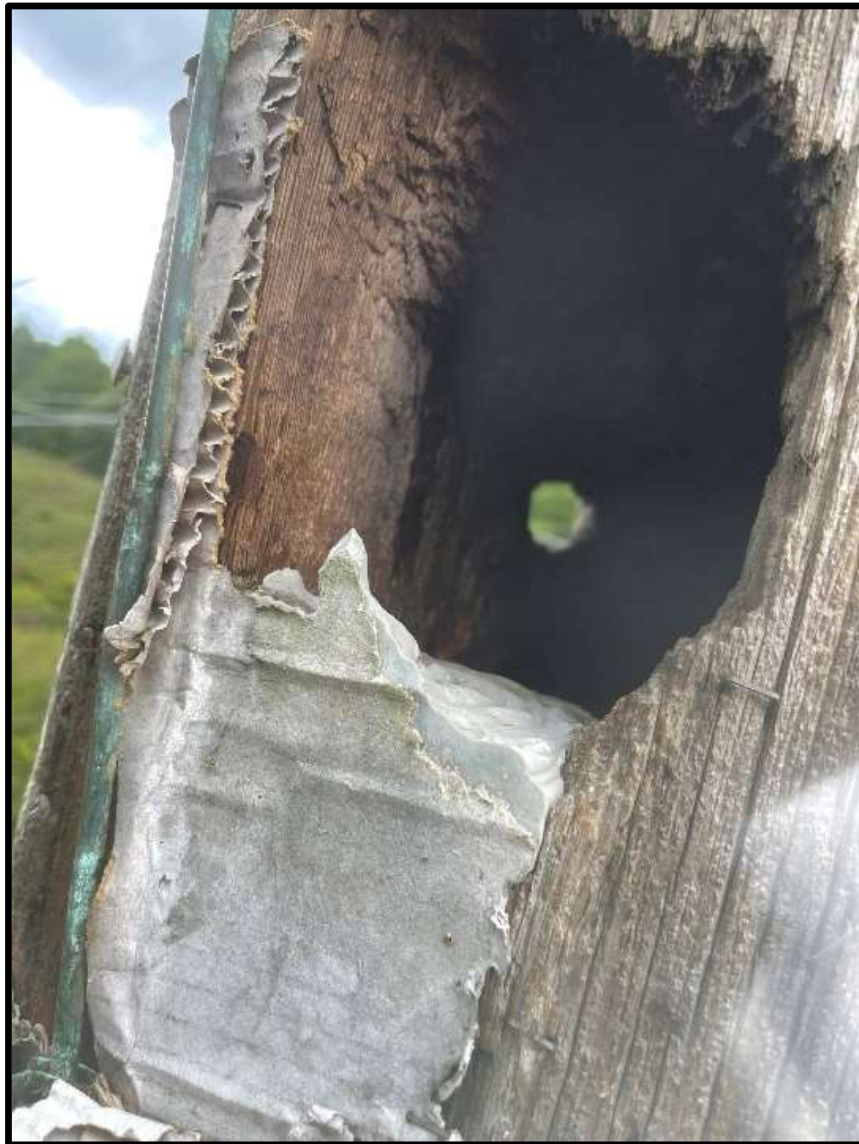
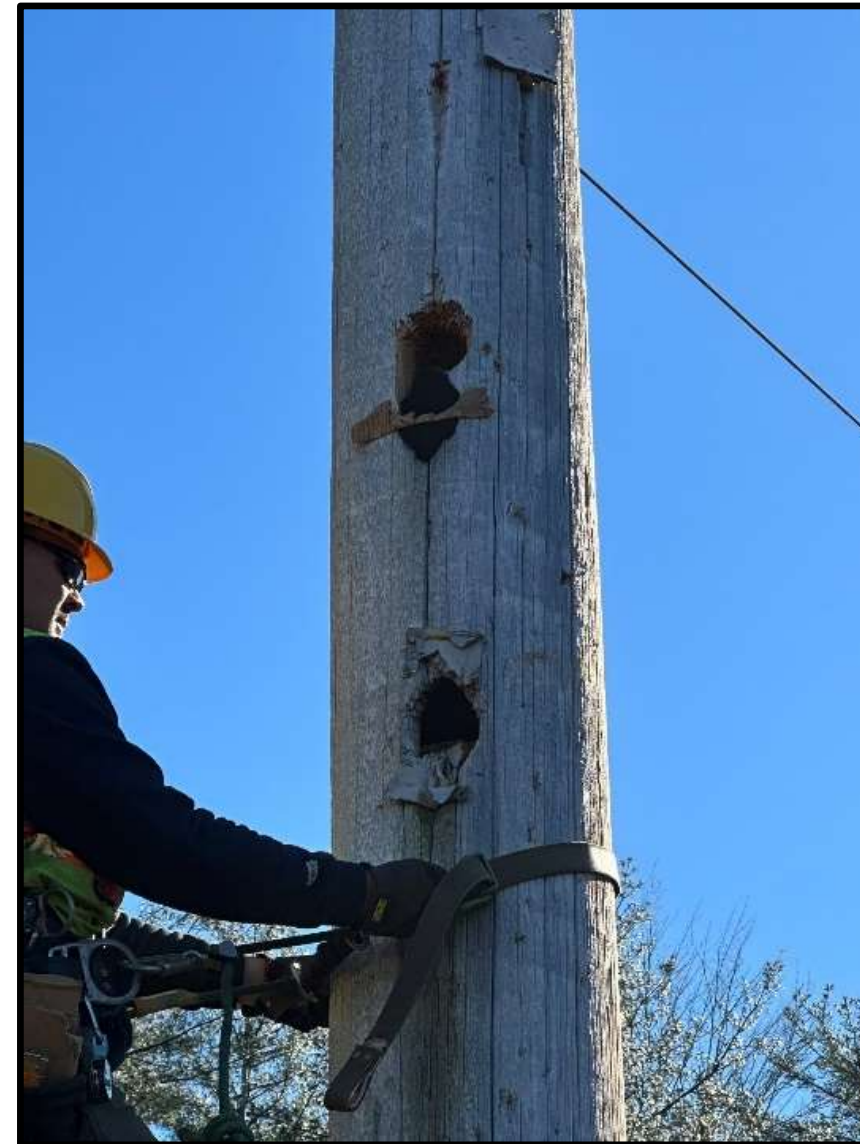
Asset Condition Photos

- These photos represent why patching woodpecker holes are not a long-term solutions.

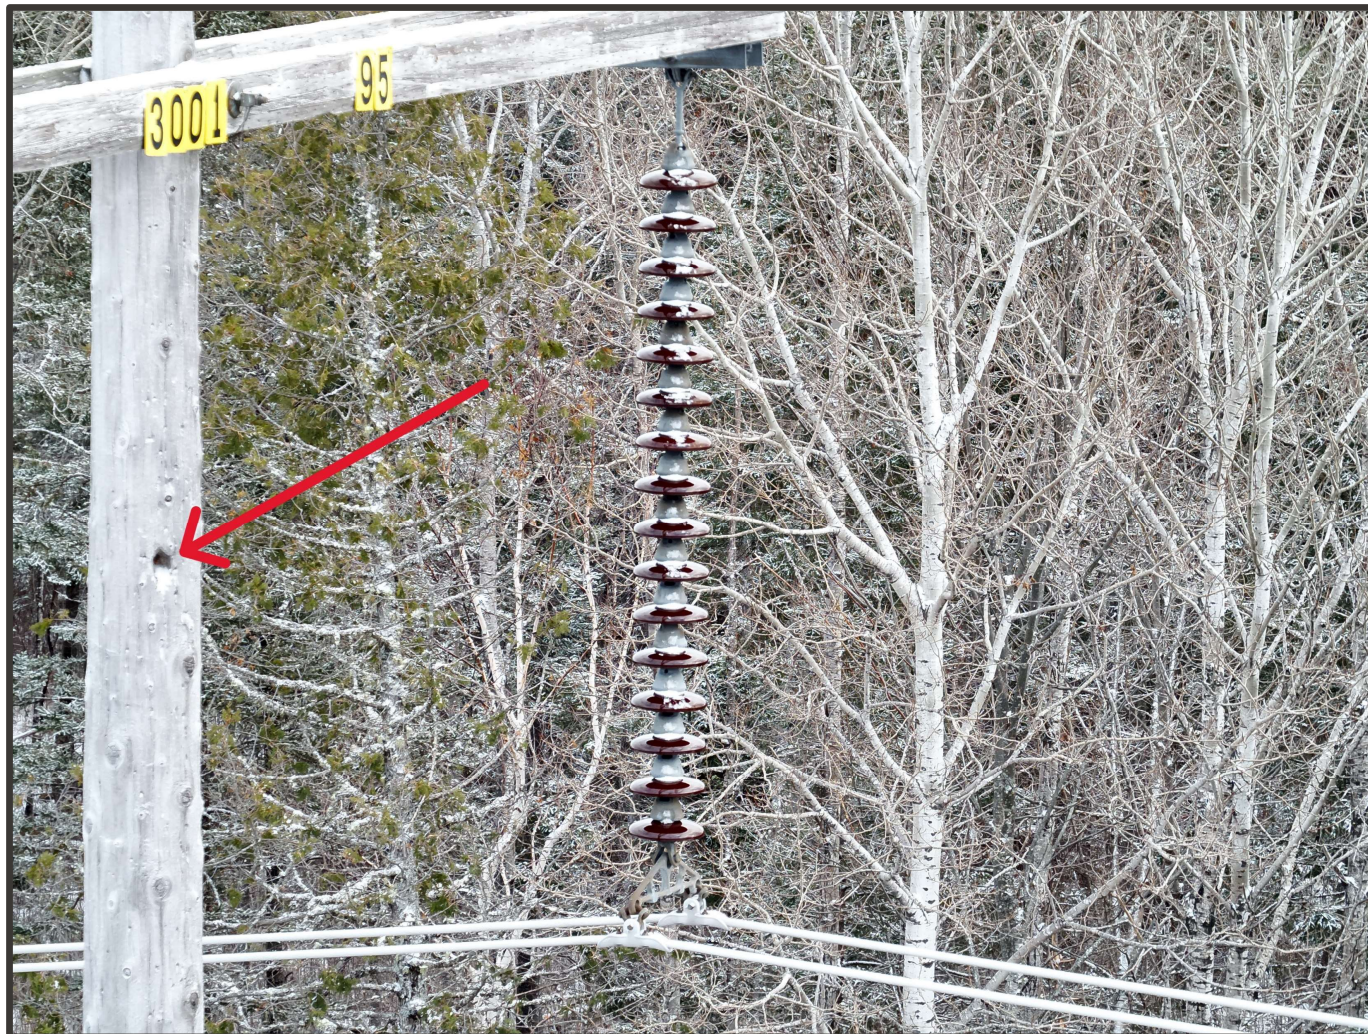
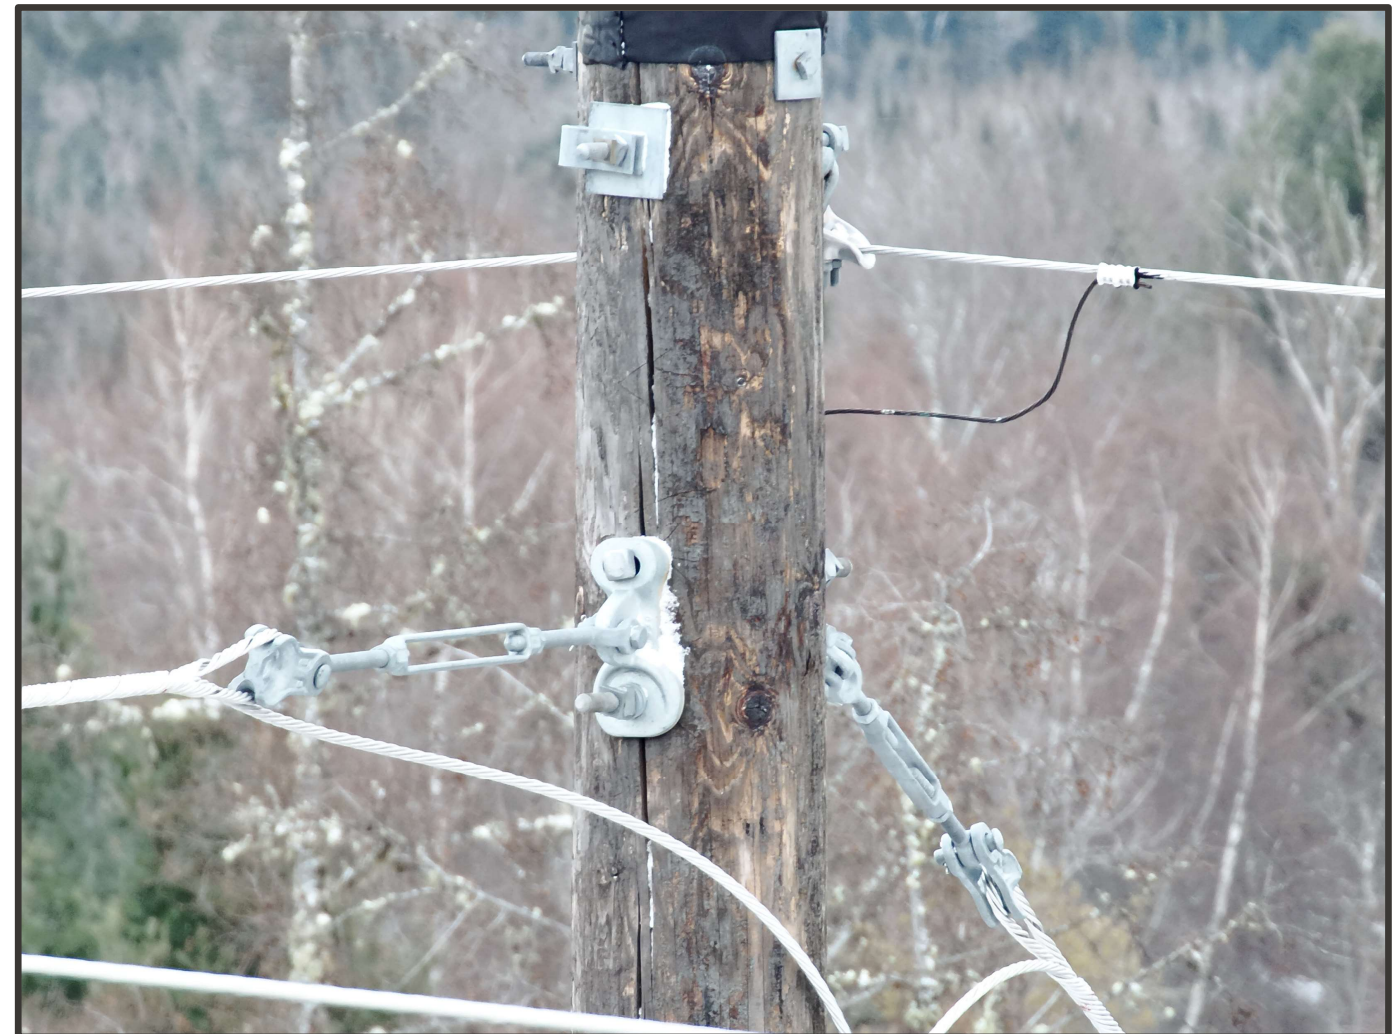
Drone Inspection Photos

- Drone inspection was used on inaccessible structures and non-climbable structures.
- The following photos are representative of damage caused by woodpeckers, rotting, and splitting.
