Line 3041 and Line 3754 Structure Replacements – Project Update

Planning Advisory Committee Meeting
July 17, 2024

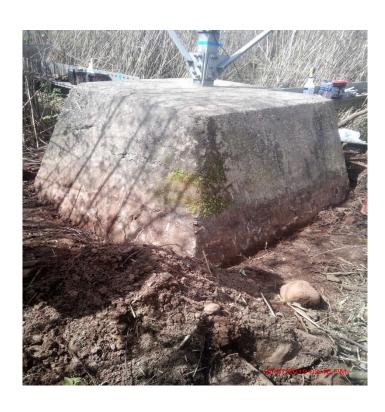
Line 3041 - Structure 9500 Foundation Deterioration

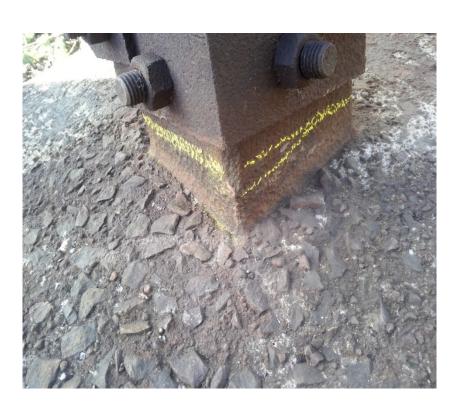
Line 3041 - Structure 9551 Section Loss

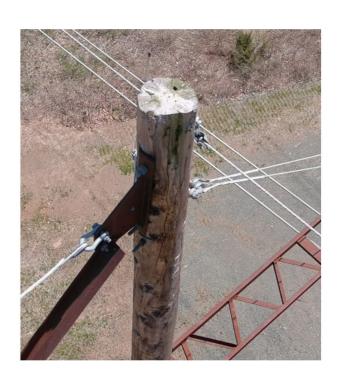
Line 3041 - Structure 30020 Splitting Pole Top

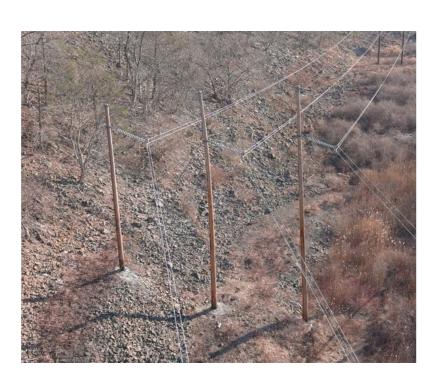
Line 3041 - Structure 9564 Leaning Poles & Washout Concerns

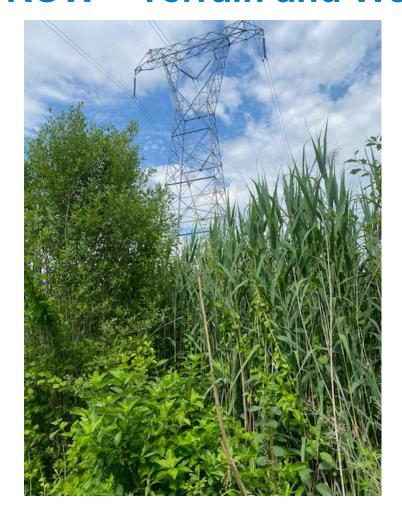
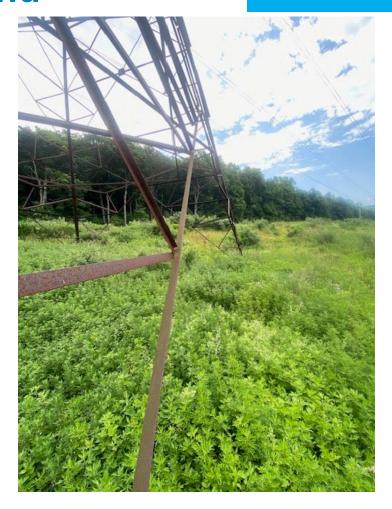
Left - Examples of seasonal growth within wetland Right – Seasonal growth and terrain within ROW

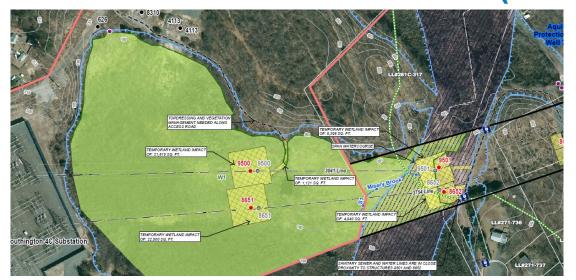
Above – Wetland locations east of the Southington SS

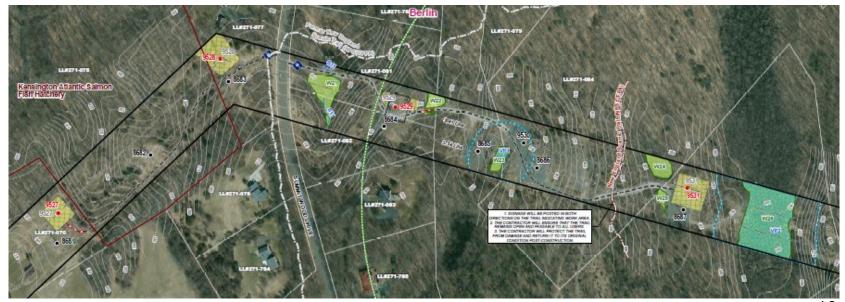
Below – Topographical contour lines demonstrating elevation complications located within the ROW

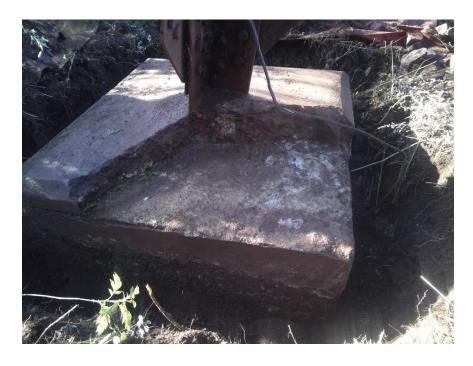
Line 3754 - Structure 8717

Deteriorated concrete, steel foot of structure leg exposed with rust and corrosion

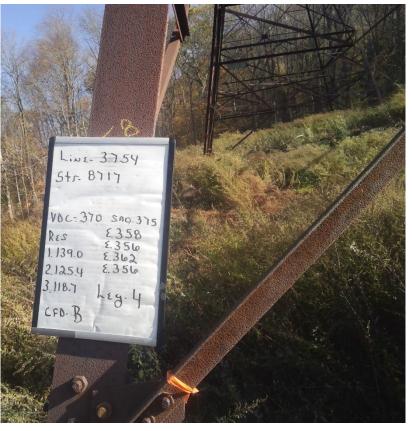
Line 3754 – Structure 8717 Rust and pitting of galvanized steel structures
