# ISO-NE PAC MEETING

09/18/2024

## 302 345 kV Line Asset Condition Refurbishment

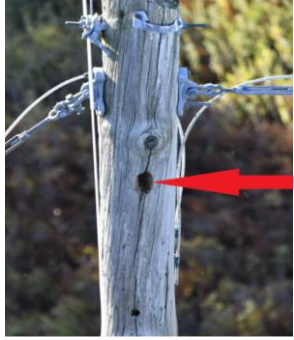
**Str 375**

# Project Needs – Points of Concern: Woodpecker

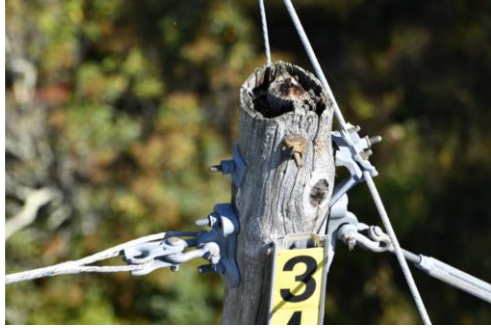
**Str 316**

# Project Needs – Points of Concern: Pole Top Deterioration

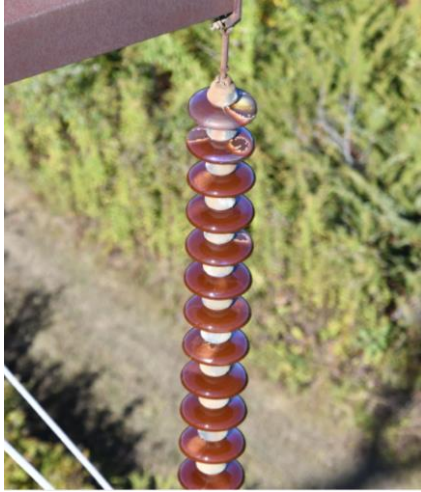
**Str 206**

# Project Needs– Points of Concern: Insulators

- Replace 19 wooden pole structures with engineered H-frame steel pole structures
- Replace damaged/flashed insulators at three (3) structures
- Perform minor maintenance activities (e.g. tightening loose bolts/nuts/cotter pins) at ten (10) structures
