# K19 Line Structure Replacement

VELCO

Planning Advisory Committee Meeting

10/23/24

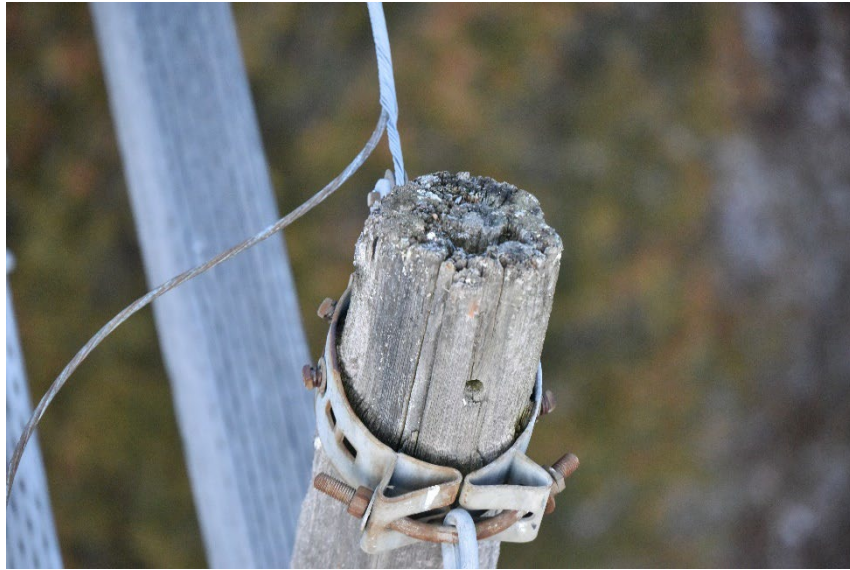
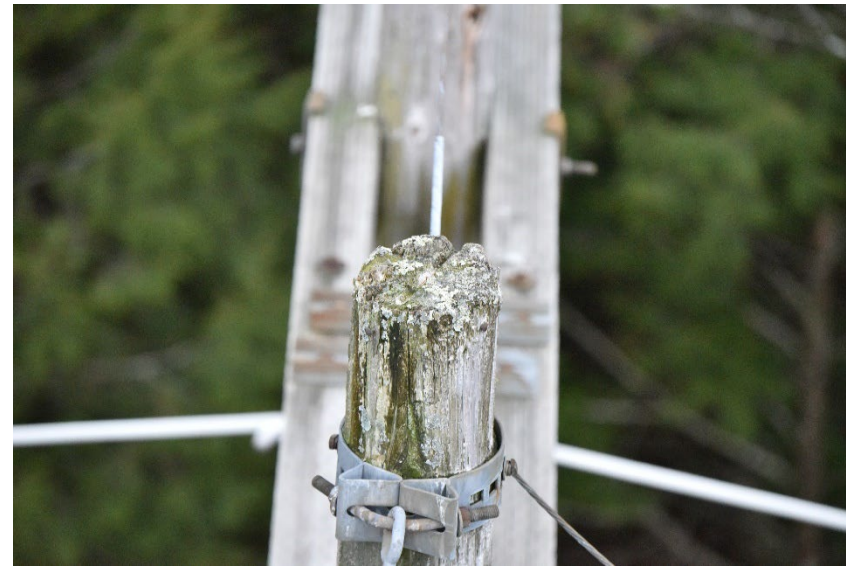
## Pole Rot

- Located in variable lowland terrain with large wetlands and challenging side slopes
- Major issues being addressed include significant woodpecker damage, internal pole voids, and rotten pole tops

Structure Concerns	
Primary Concerns	
<b>Wood structure rot and decay</b>	<ul style="list-style-type: none"> <li>Recent inspections performed in 2020 and 2021 have identified 41 of 93 wood structures with woodpecker damage, pole top rot, cracked crossarms, splitting poles, and other forms of decay</li> <li>These structures must be replaced to maintain reliability and ensure ongoing integrity of the line</li> <li>Affected structures average 49 years old and are reaching the end of the typical 60 year useful life for 115kV natural wood structures.</li> </ul>
<b>Steel lattice structure deterioration</b>	<ul style="list-style-type: none"> <li>No steel structures identified</li> </ul>
Secondary concerns	
None

- Additional assessment findings include severely weathered and cracked poles
- Replace 41 out of 93 wood H-frame structures. Majority of replacements will be with steel H-frames, including the southern section of the line where the woodpecker damage is located. Minimal wood H-frames will be installed to reduce wood pole inventory.
