B-154N / C-155N – King Street Tap Asset Condition Refurbishment

National Grid

October 23, 2024

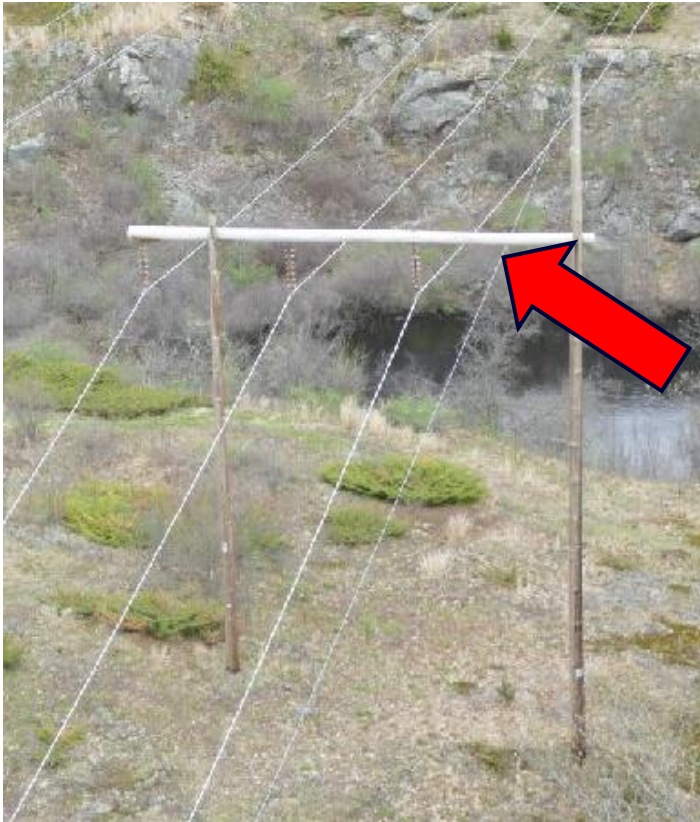
B-154N Structure 44

These structures use a wood pole as a crossarm which is prone to failure. Water collects in the side grain on the upper side of the arm and rots the wood prematurely.

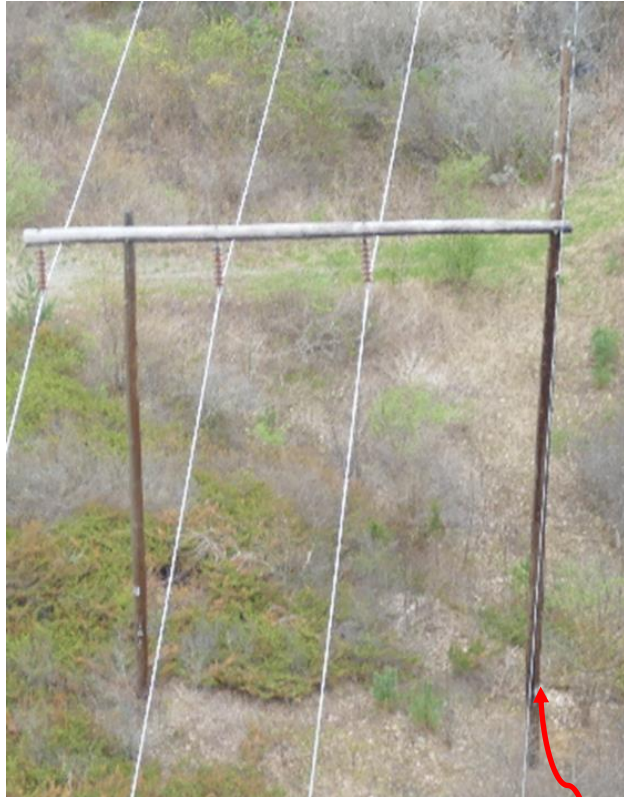
B-154N Structure 57

The poles for these structures are showing signs of decay and deformation

The shield wire leg is deflecting and leaning away from the rest of the structure as the wood deteriorates

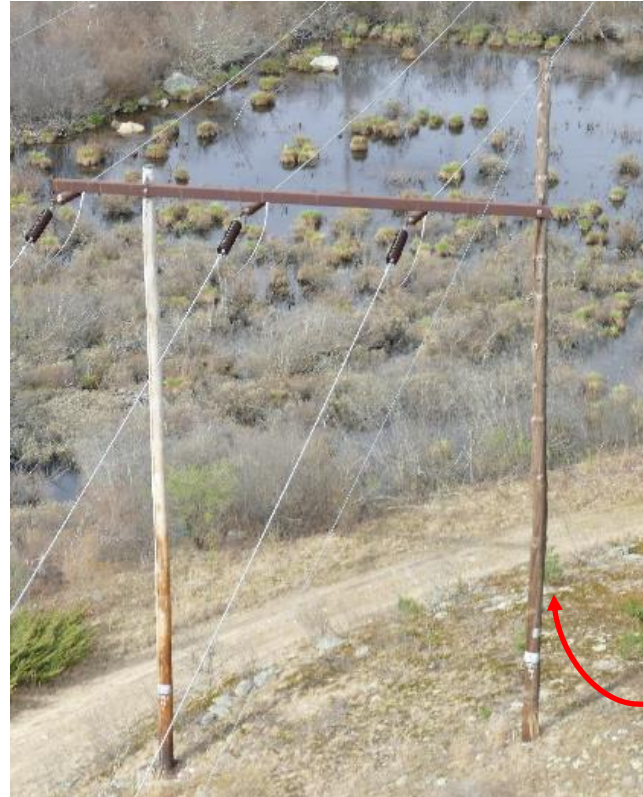
B-154N Structure 88

The legs on these structures are more deteriorated. The opposing leg was replaced in prior maintenance work and the remaining poles are deflecting as they continue to weather
