D-156 115kV Line Asset Condition Refurbishment

Rafael Panos
National Grid
March 19, 2025

Project Summary

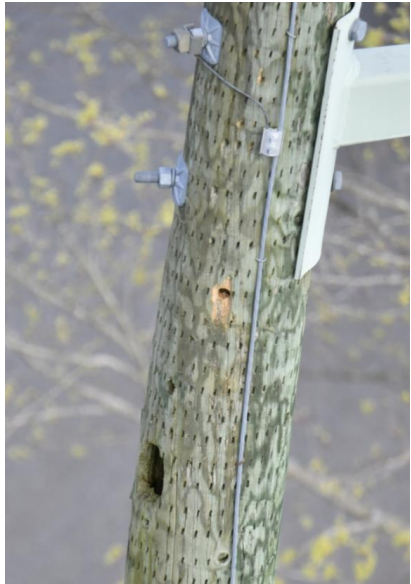
D-156 Str 42

Project Needs and Drivers – Woodpecker Damage

*Multiple instances on most structures including signs of prior repairs at Str 77 which have been ineffective

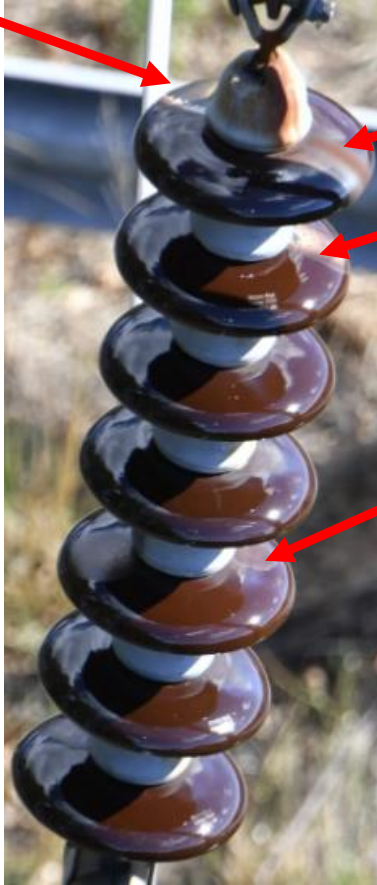
D-156 Str 15

*Damaged insulation due to combination of exposure and insufficient quantity of insulators. Insulation exhibiting burns and chipping. As degradation progresses, the performance of the circuit suffers at an increasing rate. There have been 17 operations in the last ten years, with three events each in two of the last 3 years

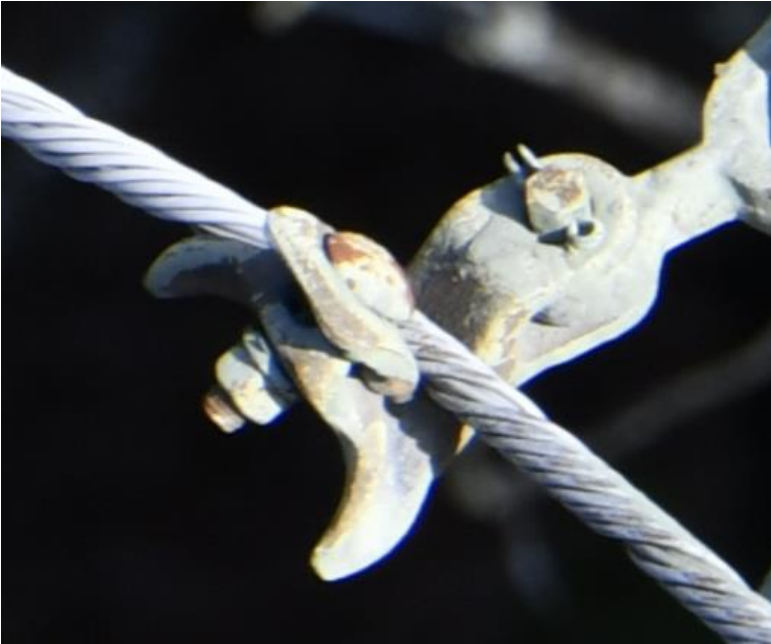
D-156 Str 29

*Improperly installed and now damaged shieldwire attachment

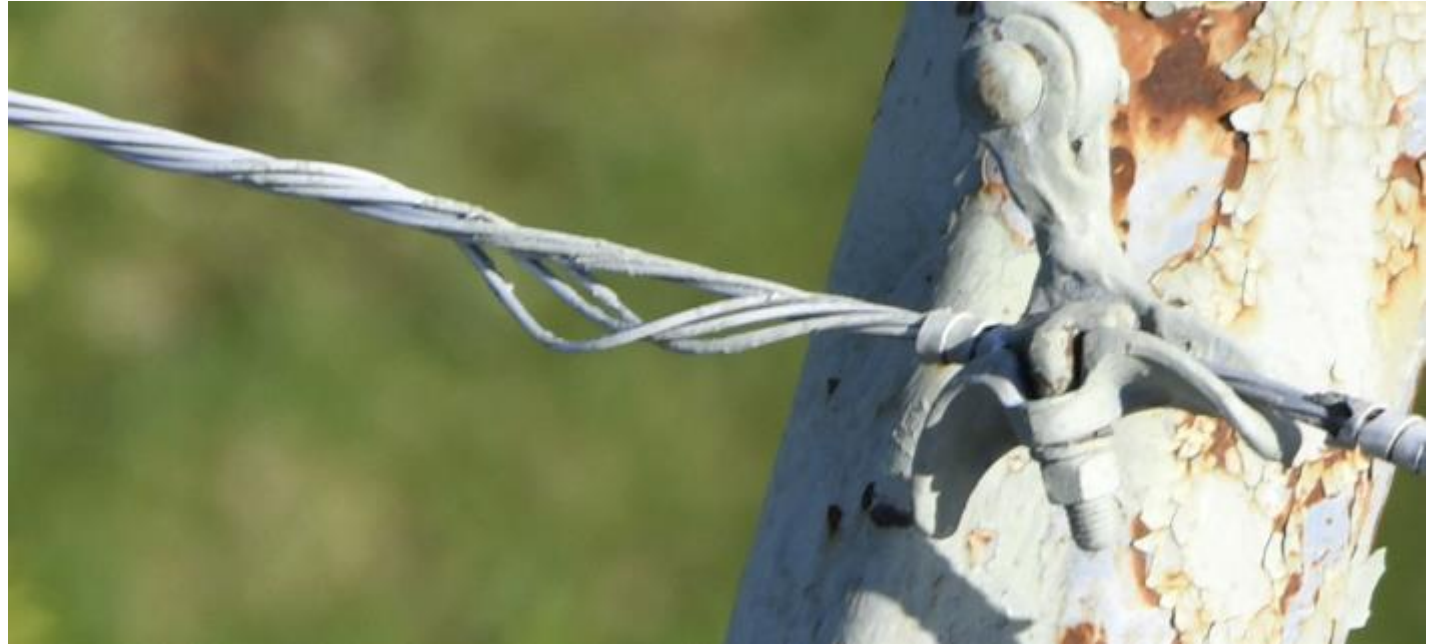
D-156 Str 30

*Broken strands in shieldwire

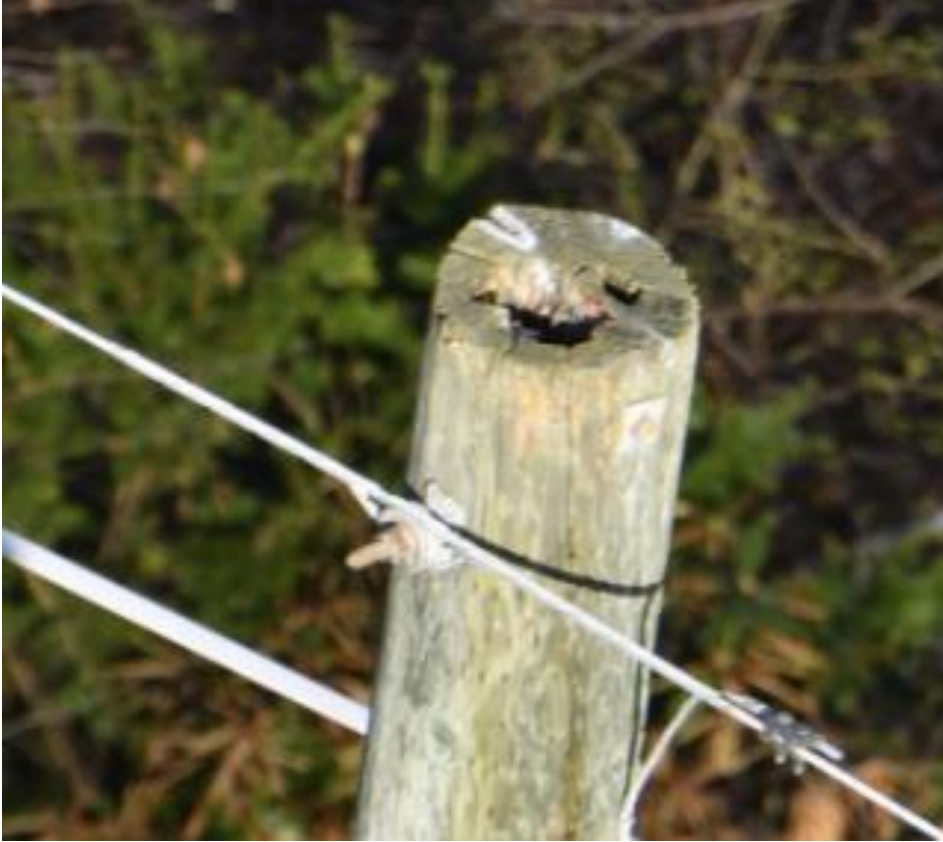
D-156 Str 53

Project Needs and Drivers – Pole Top Decay
