# ISO-NE PAC MEETING

08/26/26

## E-205E and E-205W 230 kV Line Asset Condition Replacement

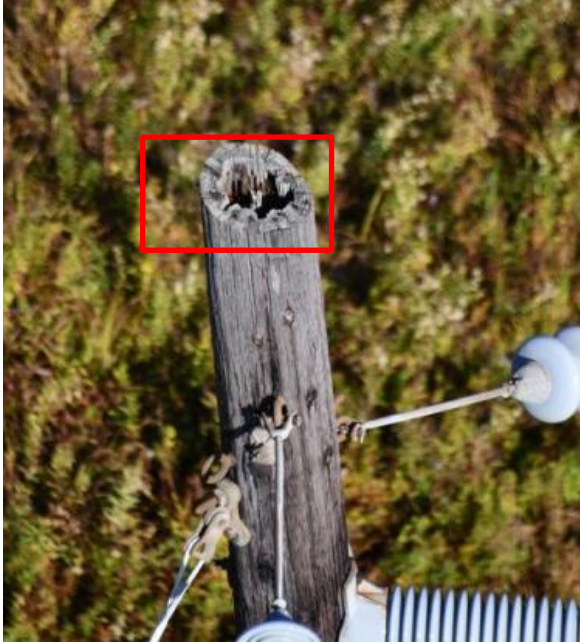
E-205E Str. 53  
Installed 1972  
Grade C – Pole top decay

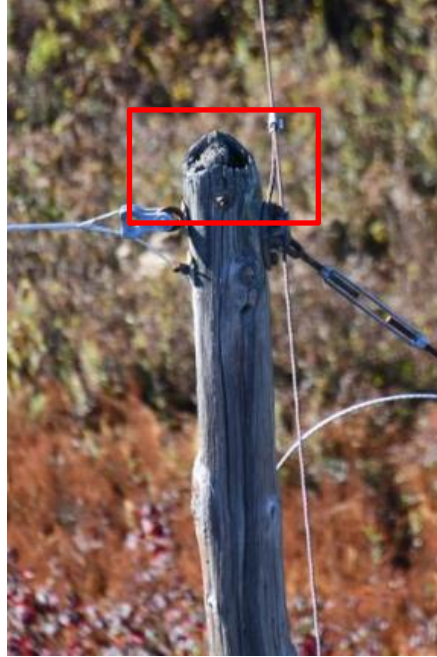
E-205E Str. 280  
Installed 1962  
Grade C – Pole top decay

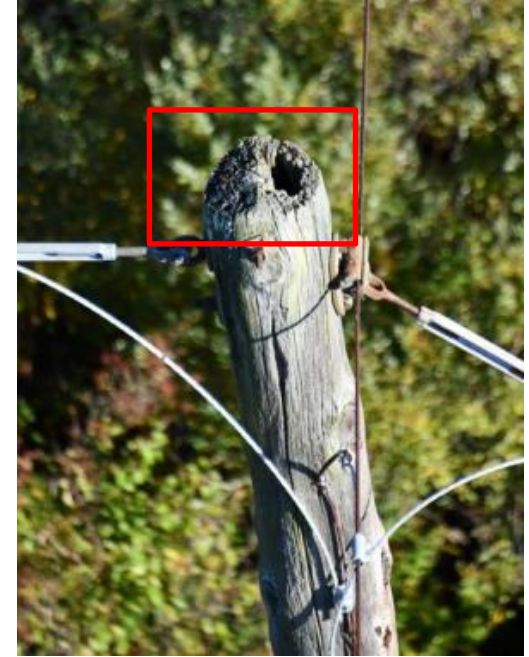
E-205E Str. 283  
Installed 1962  
Grade C – Pole top decay

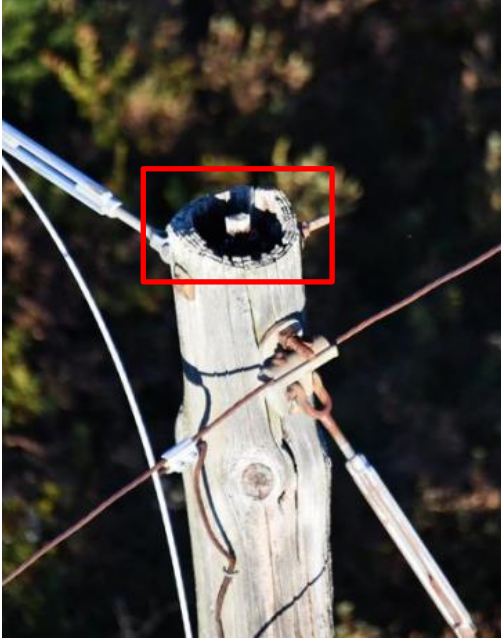
E-205E Str. 288  
Installed 1962  
Grade C – Pole top decay

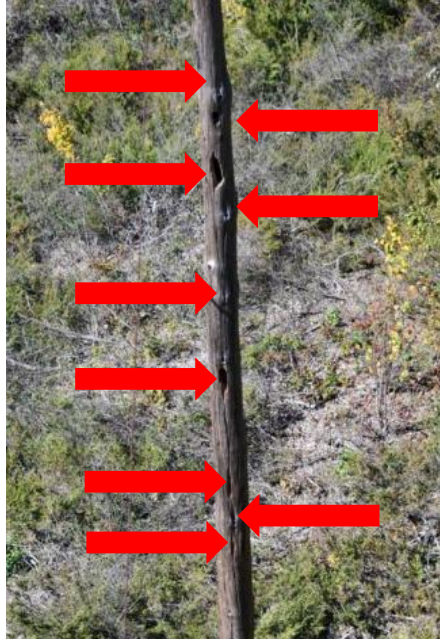
E-205E Str. 355  
Installed 1962  
Grade C – Woodpecker damage

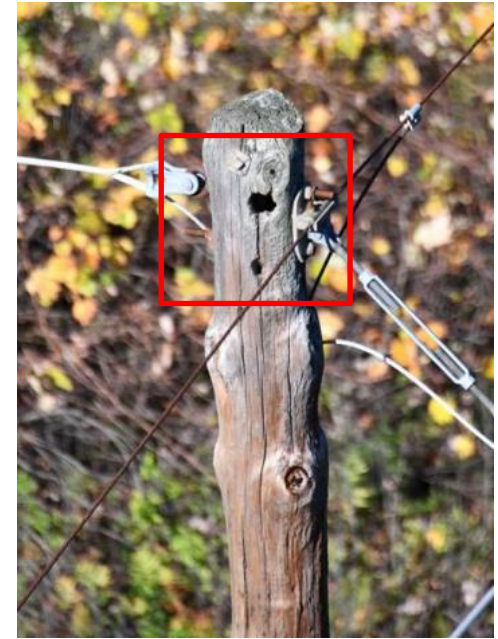
E-205E Str. 378  
Installed 1962  
Grade C – Woodpecker damage

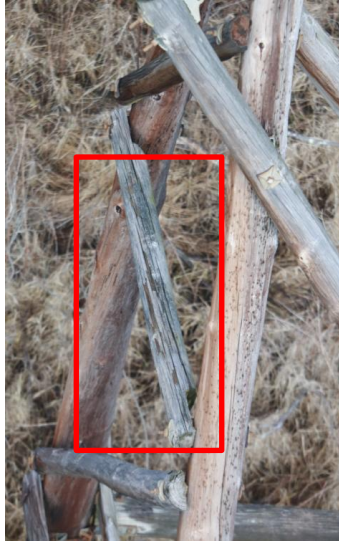
E-205E Str. 423  
Installed 1962  
Grade C – Deteriorated pole

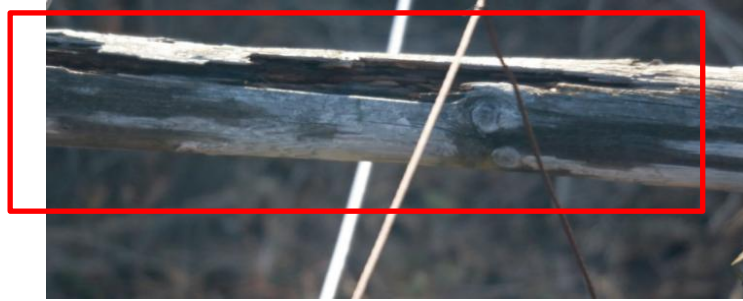
E-205E Str. 440  
Installed 1962  
Grade C – Deteriorated pole

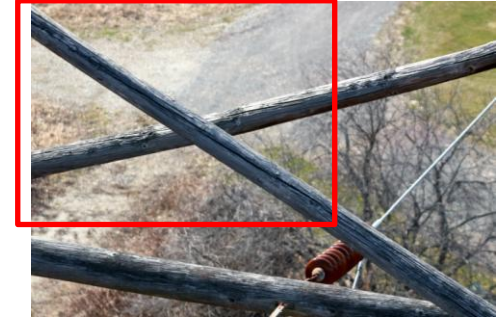
E-205E Str. 471  
Installed 1962  
Grade C – Deteriorated pole

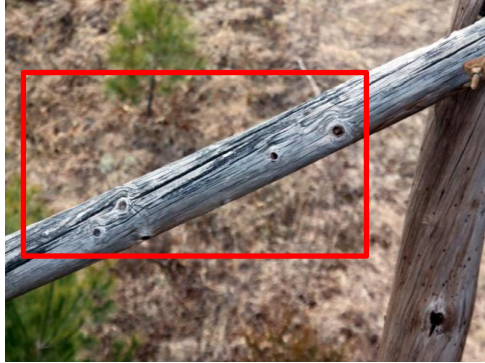
E-205E Str. 479  
Installed 1962  
Grade C – Deteriorated pole

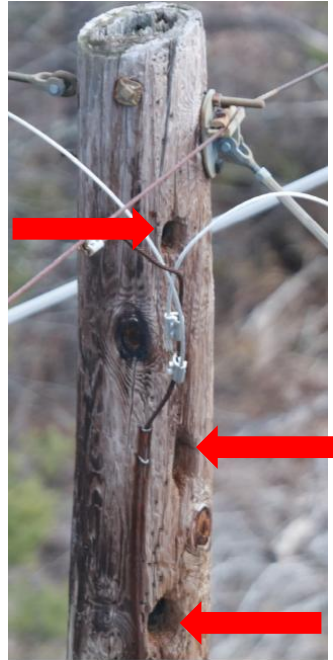
E-205E Str. 511  
Installed 1962  
Grade C – Woodpecker damage

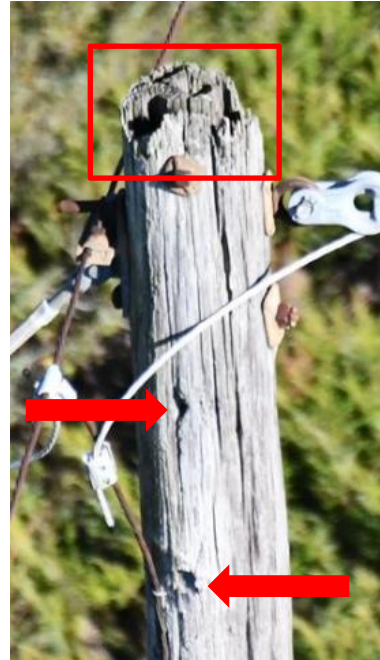
E-205E Str. 514  
Installed 1962  
Grade C – Pole top decay

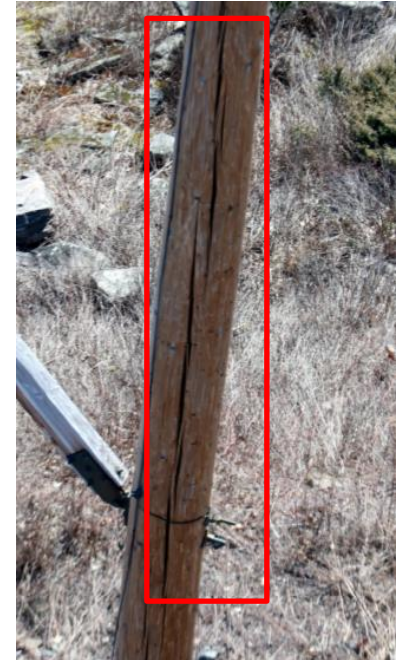
E-205E Str. 547  
Installed 2009  
Grade C – Deteriorated pole

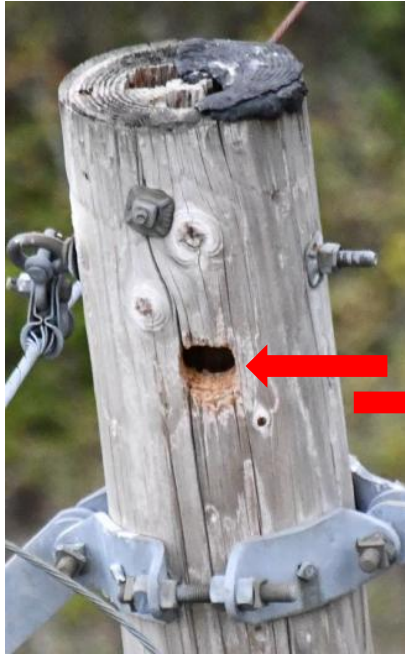
E-205E Str. 569  
Installed 2009  
Grade C – Woodpecker damage

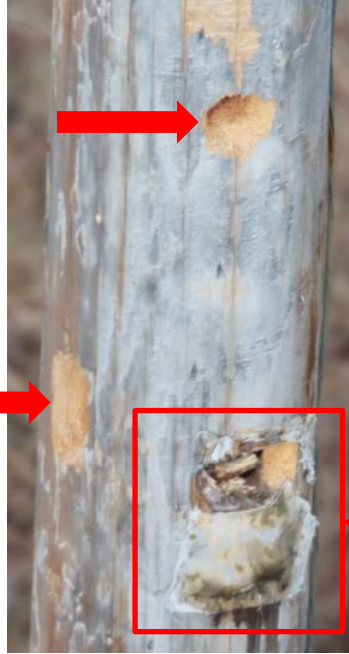
E-205E Str. 676  
Installed 2009  
Grade C – Woodpecker damage

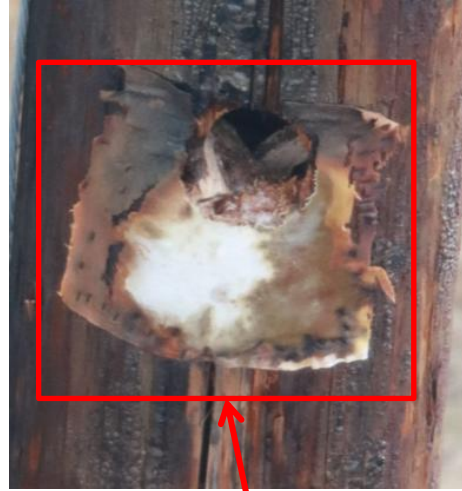
E-205E Str. 677  
Installed 2009  
Grade C – Woodpecker damage

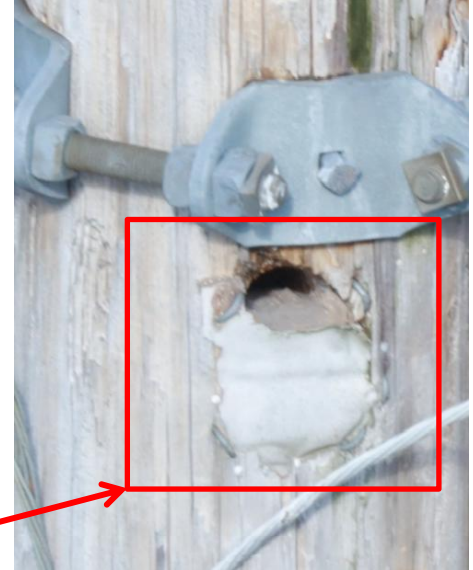
E-205E Str. 684  
Installed 1995  
Grade C – Woodpecker damage

Previously patched  
woodpecker holes

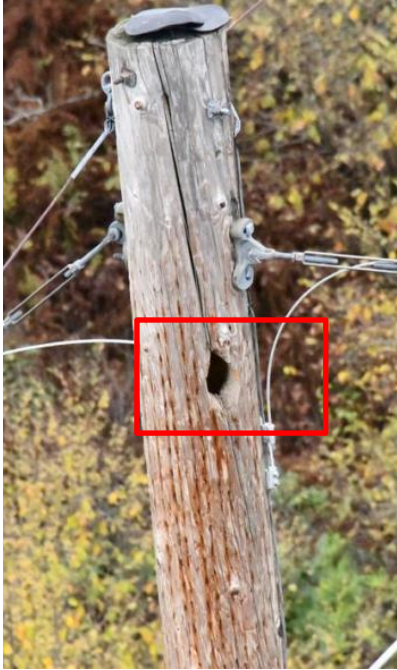
E-205E Str. 701  
Installed 1995

Grade C – Woodpecker damage

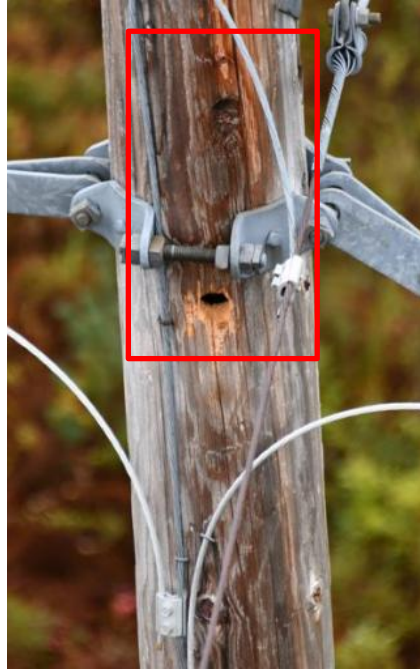
E-205E Str. 711  
Installed 1995

Grade C – Woodpecker damage

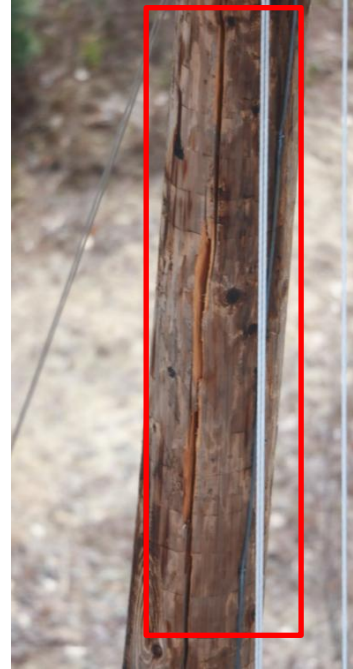
E-205E Str. 739  
Installed 2009

Grade C – Deteriorated pole

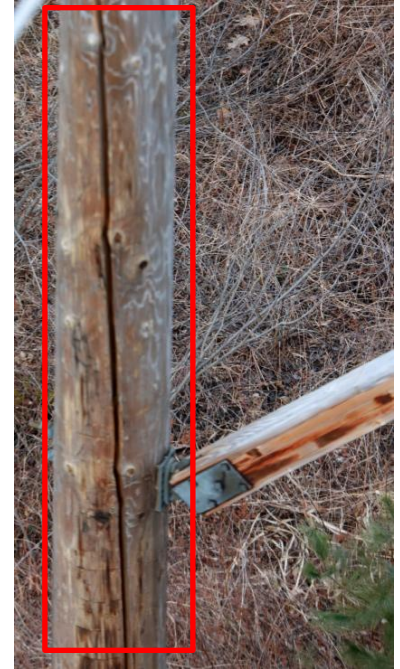
E-205E Str. 785  
Installed 2009

Grade C – Deteriorated pole

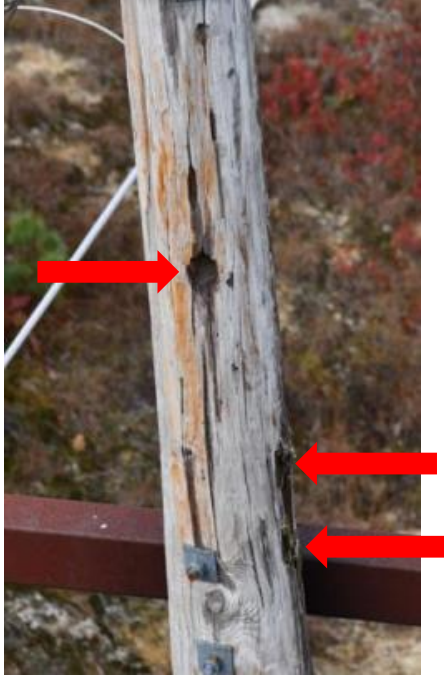
E-205E Str. 773  
Installed 2009  
Grade C – Woodpecker damage

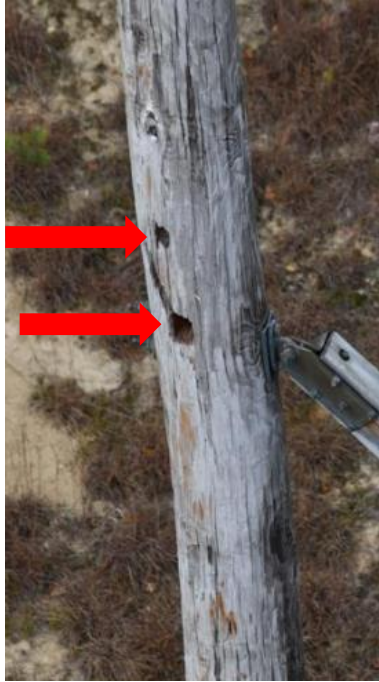
E-205E Str. 773  
Installed 2009  
Grade C – Woodpecker damage

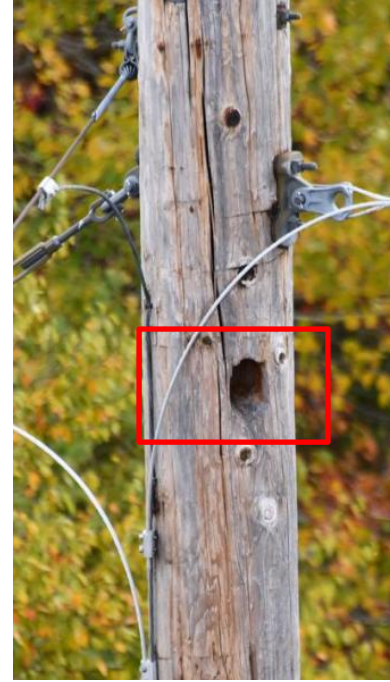
E-205E Str. 776  
Installed 2009  
Grade C – Woodpecker damage

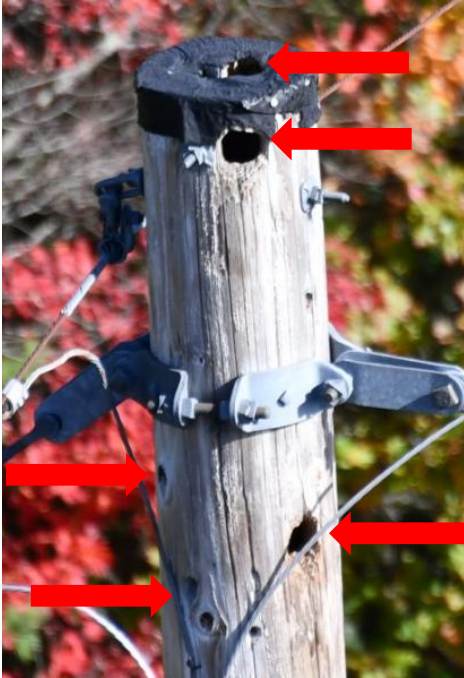
E-205E Str. 830  
Installed 2006  
Grade C – Woodpecker damage

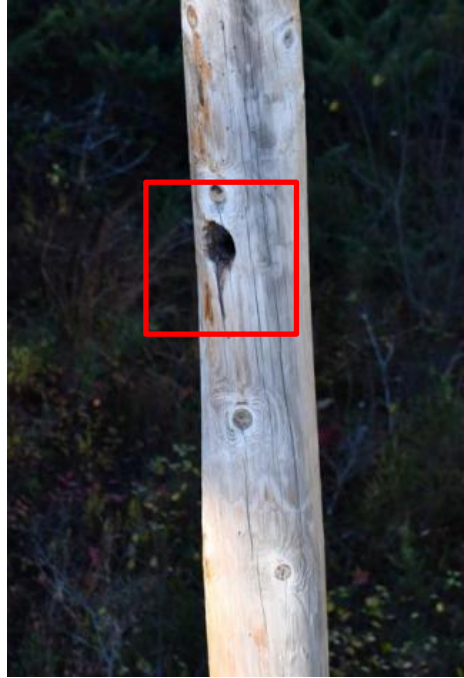
E-205E Str. 851  
Installed 2009  
Grade C – Woodpecker damage

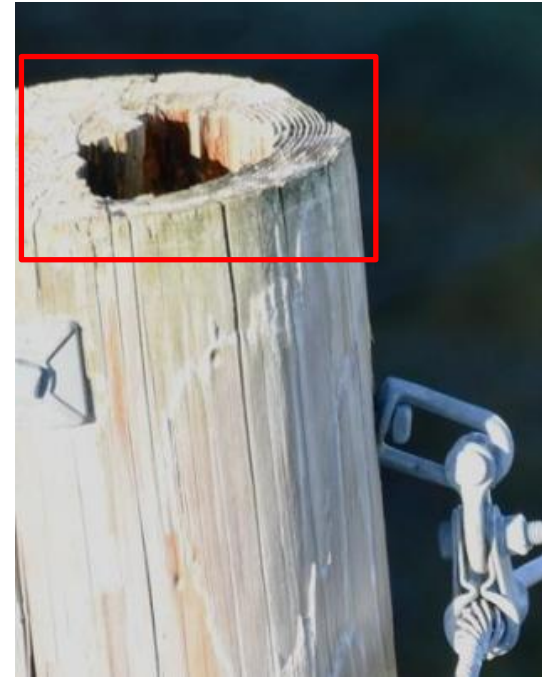
E-205E Str. 868  
Installed 2009  
Grade C – Deteriorated pole top

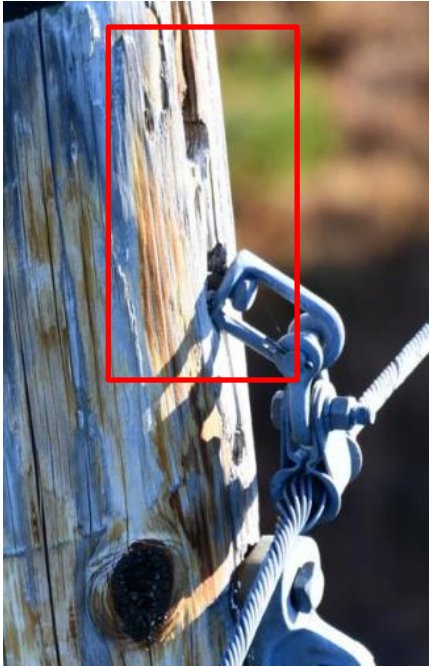
E-205E Str. 868  
Installed 2009

Grade C – Deteriorated pole top

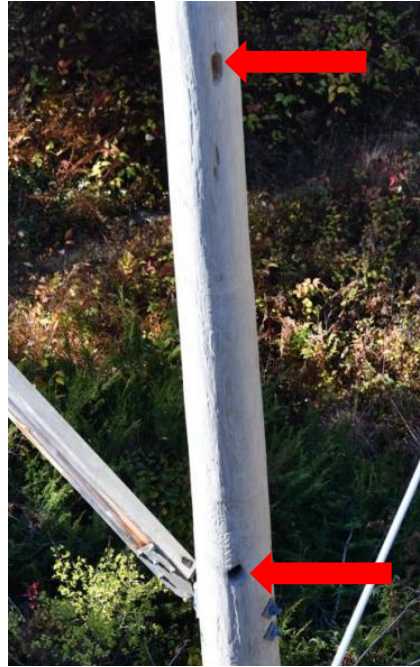
E-205E Str. 917  
Installed 2010

Grade C – Woodpecker damage

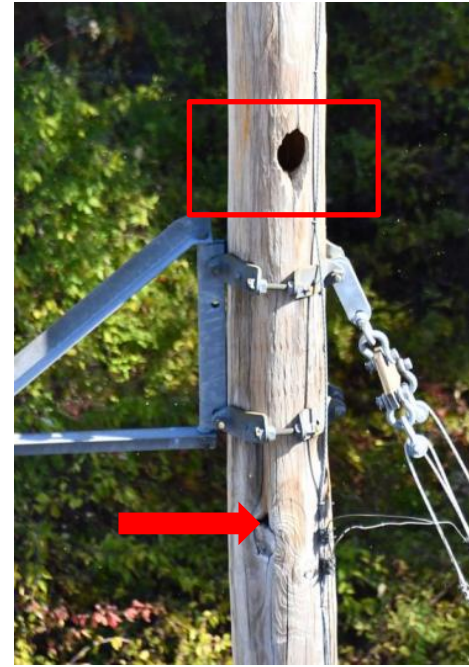
E-205E Str. 1068  
Installed 2009

Grade C – Woodpecker damage

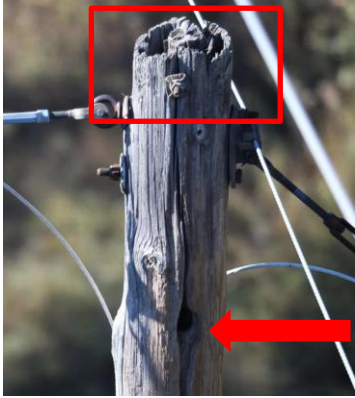
E-205W Str. 12  
Installed 1962  
Grade C – Pole top  
deterioration

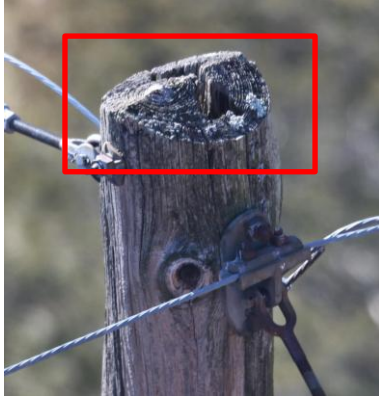
E-205W Str. 21  
Installed 1962  
Grade C – Woodpecker  
damage

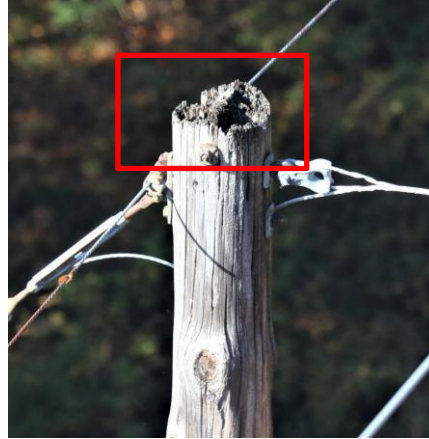
E-205W Str. 38  
Installed 1972  
Grade C – Pole top  
deterioration

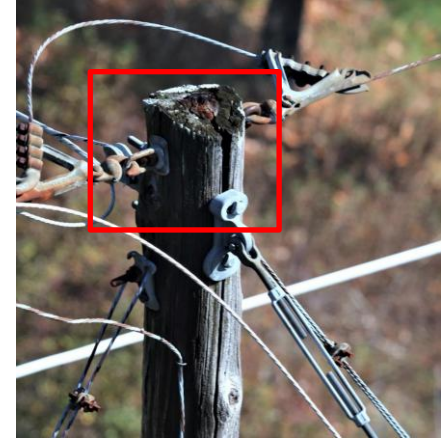
E-205W Str. 43  
Installed 1981  
Grade C – Pole top  
deterioration

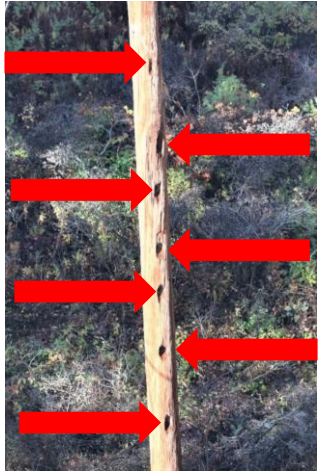
E-205W Str. 50  
Installed 1972  
Grade C – Woodpecker  
damage

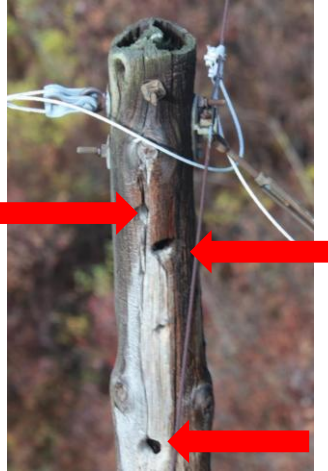
E-205W Str. 63  
Installed 1962  
Grade C – Woodpecker  
damage

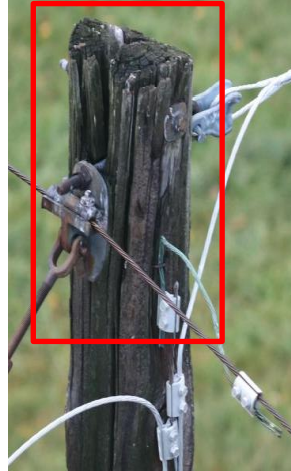
E-205W Str. 68  
Installed 1962  
Grade C – Pole top  
deterioration

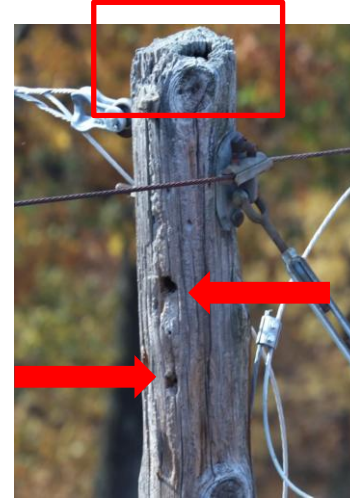
E-205W Str. 74  
Installed 1962  
Grade C – Woodpecker  
damage

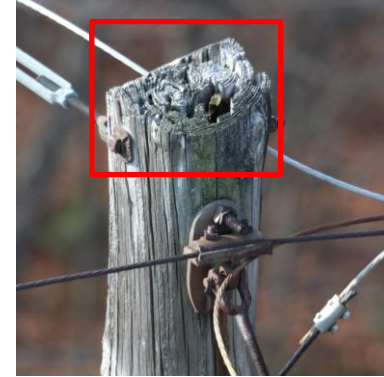
E-205W Str. 99  
Installed 1962  
Grade C – Pole top  
deterioration

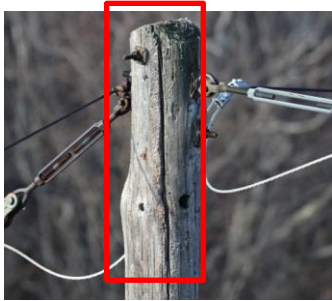
E-205W Str. 134  
Installed 1962  
Grade C – Pole top  
deterioration

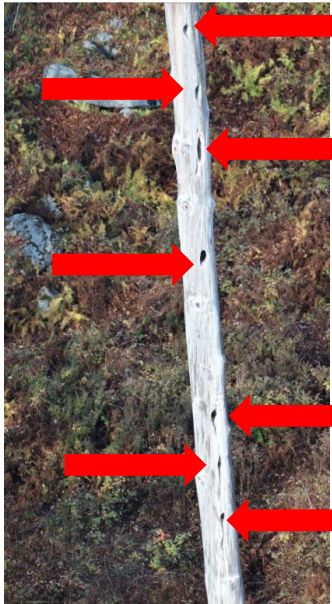
E-205W Str. 135  
Installed 1962  
Grade C – Woodpecker  
damage

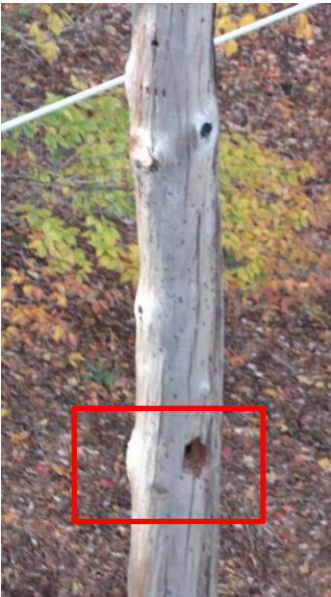
E-205W Str. 160  
Installed 1962  
Grade C – Woodpecker  
damage

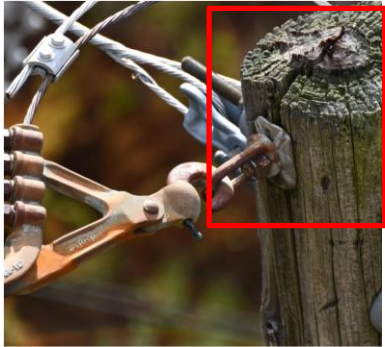
E-205W Str. 167  
Installed 1962  
Grade C – Pole top  
deterioration

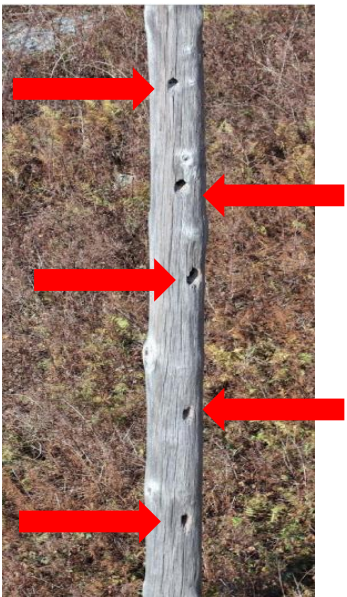
E-205W Str. 197  
Installed 1962  
Grade C – Woodpecker  
damage

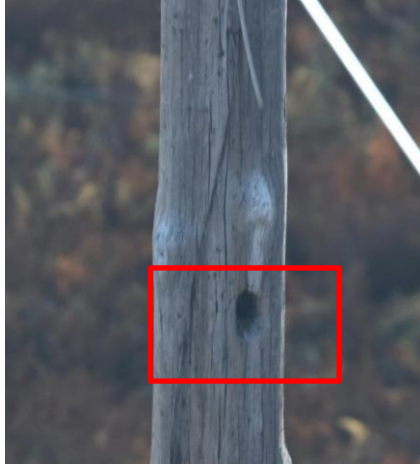
E-205W Str. 203  
Installed 1981  
Grade C – Woodpecker  
damage

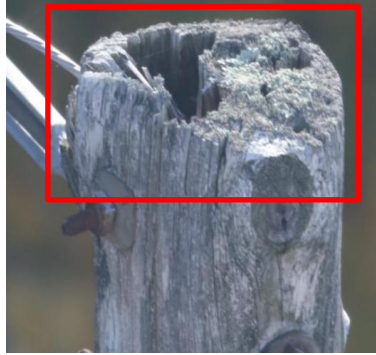
E-205W Str. 215  
Installed 1962  
Grade C – Pole top  
deterioration

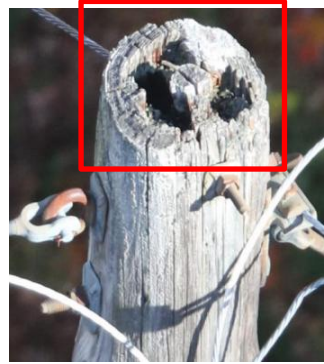
E-205W Str. 223  
Installed 1962  
Grade C – Pole top  
deterioration

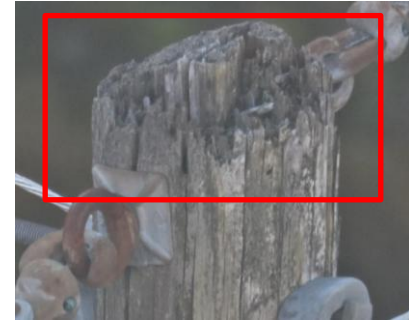
E-205W Str. 225  
Installed 1962  
Grade C – Pole top  
deterioration

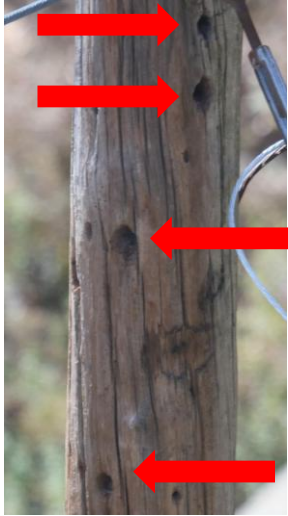
E-205W Str. 238  
Installed 1981  
Grade C – Woodpecker  
damage

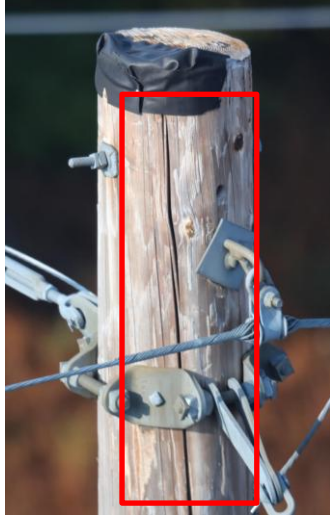
E-205W Str. 256  
Installed 2006  
Grade C – Pole top  
deterioration

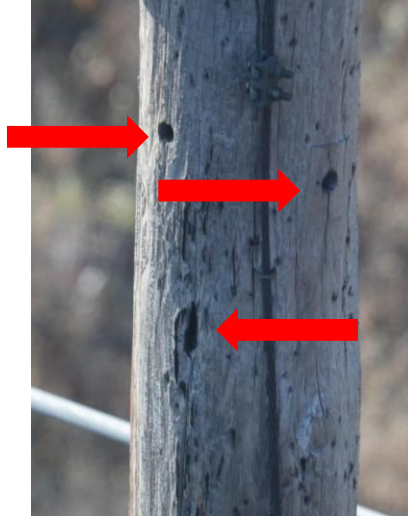
E-205W Str. 261  
Installed 1962  
Grade C – Woodpecker  
damage

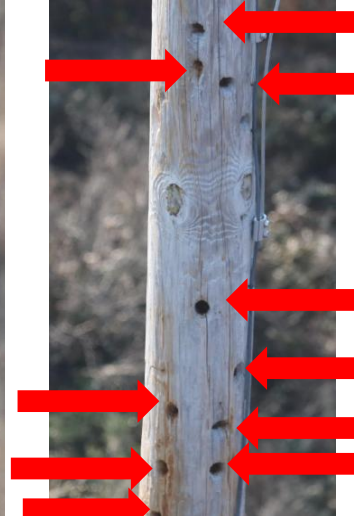
E-205W Str. 262  
Installed 2000  
Grade C – Woodpecker  
damage

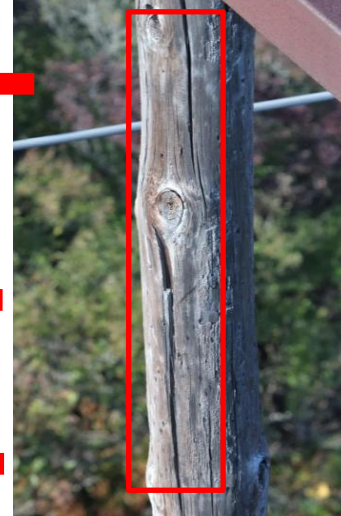
E-205W Str. 263  
Installed 1962  
Grade C – Pole top  
deterioration

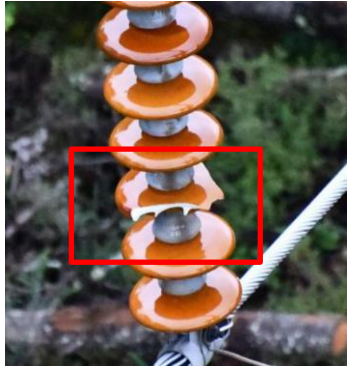
E-205W Str. 30

- Insulators experiencing flashover and damage
- Flashover and damage to insulators indicate **compromised insulation**, which can lead to electrical faults, outages, or equipment damage.

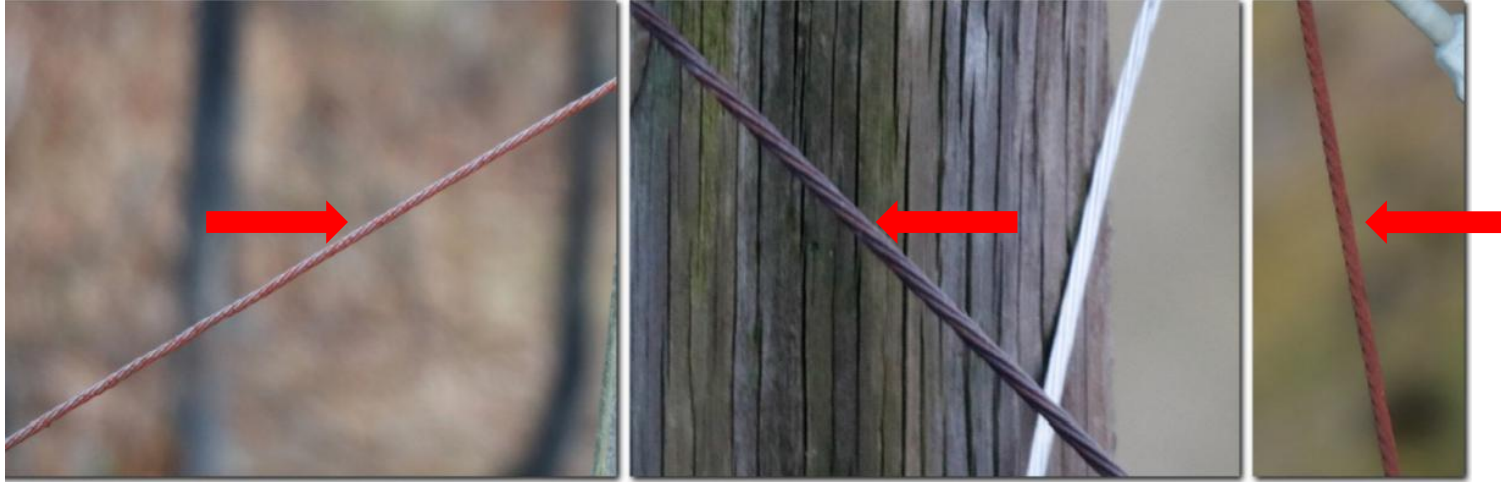
- Corrosion was observed on the full length of shieldwire on both circuits
- Consistent corrosion along the length of the wire indicates it is approaching end of serviceable life

**Entire circuit exhibiting deteriorated shieldwire condition due to corrosion**

- Shieldwire is corroded throughout the circuits and replacement addresses condition concerns. Replacement with OPGW meets the secondary driver of improving communications along the corridor

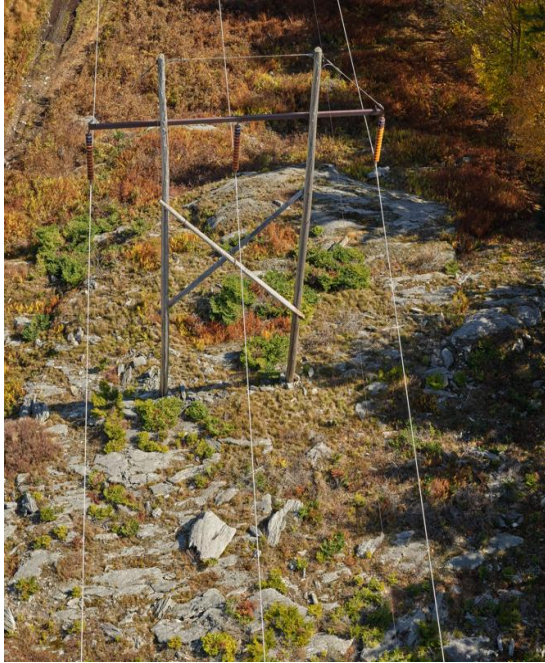
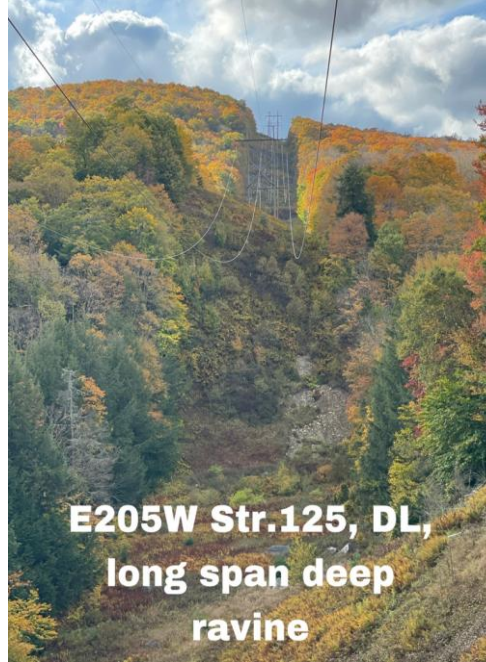
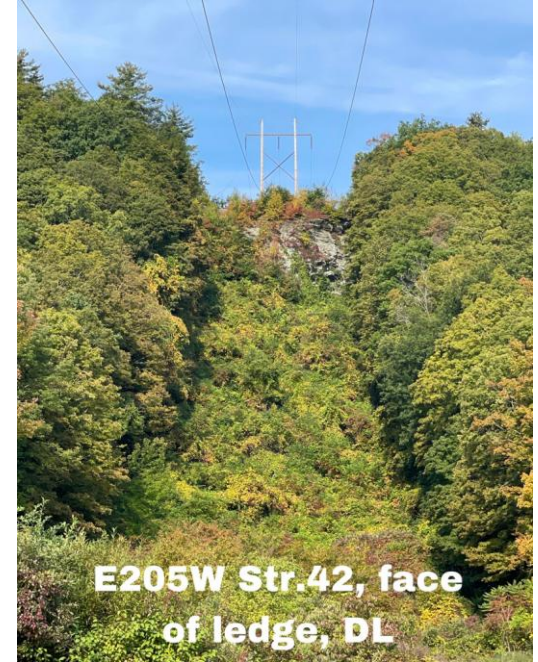
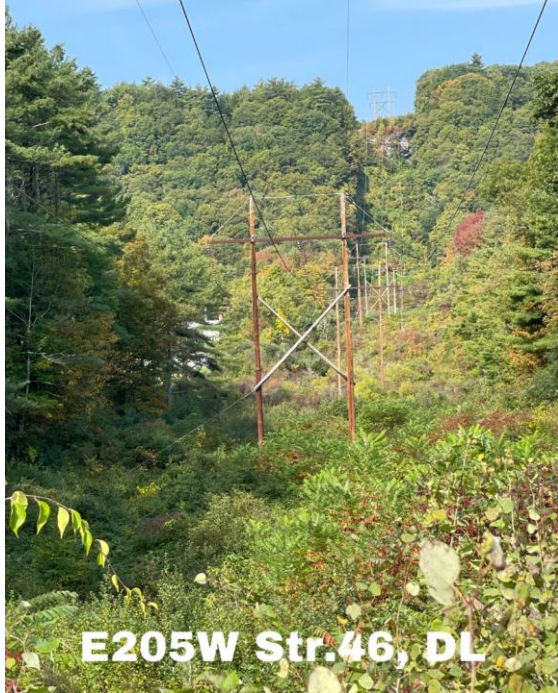
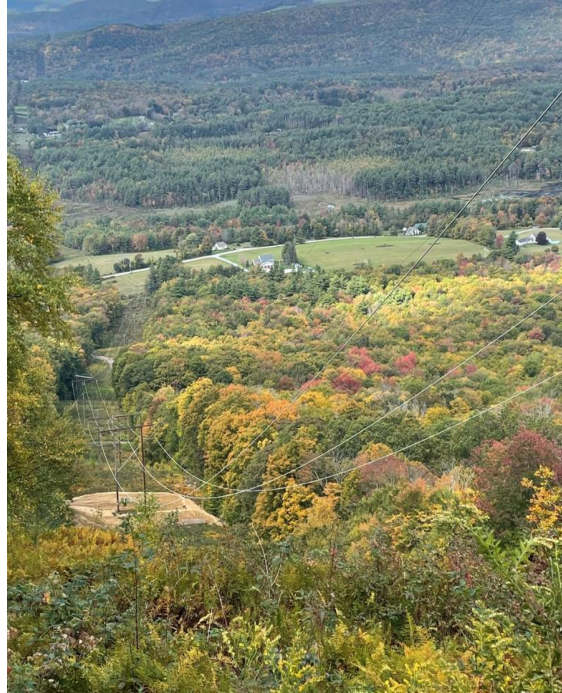
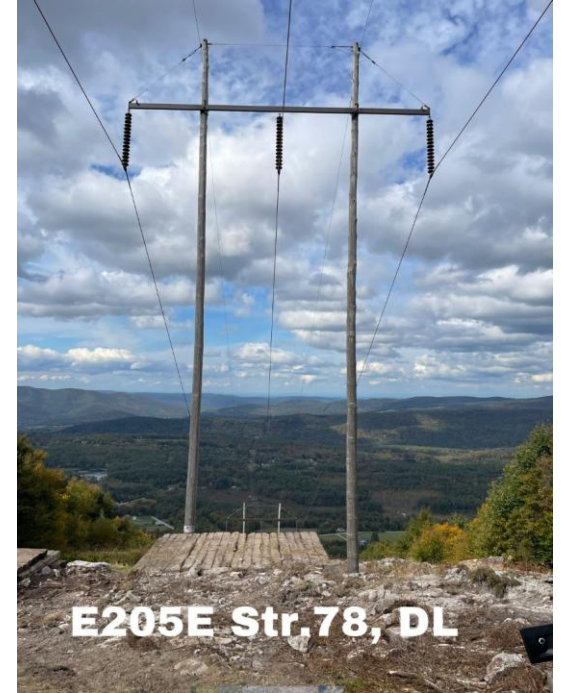
- Access along the ROW is extremely challenging. The terrain is rugged with lots of rock outcrops, sloped terrain and access is further made difficult by limited road crossings to access the ROW.
- Due to challenging terrain, work pads are required at each structure to provide access for construction including foundation installation, setting new structures, removal of existing structures, and overhead linework.

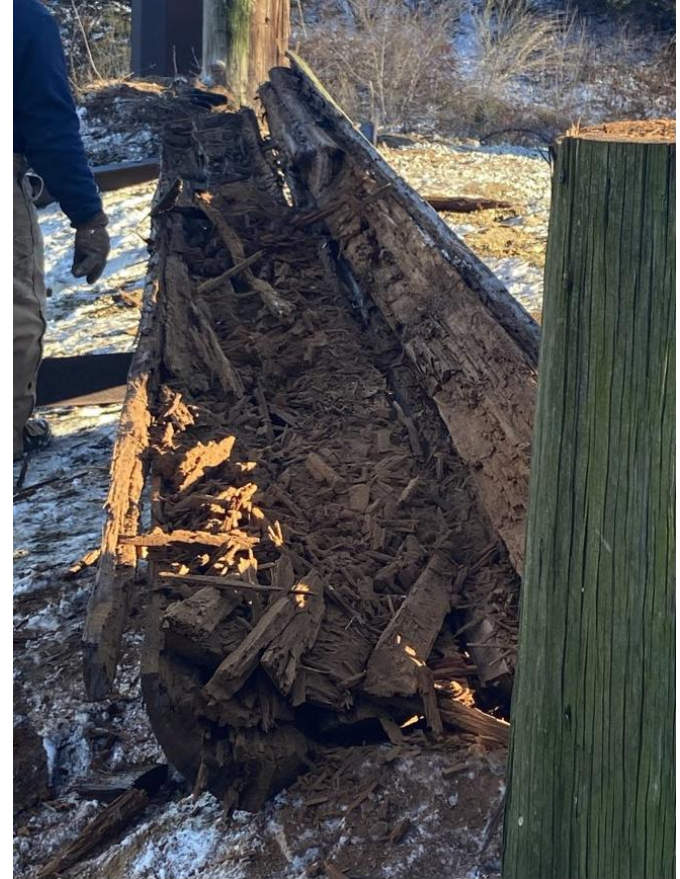
- This structure was removed from service from a different circuit within National Grid's New England territory in 2023
- Some woodpecker damage was visible on exterior of pole, just a hole
- Pole collapsed while being lifted out of place, exposing largely hollow interior with extensive damage
- At time of removal, extent of structural damage was not known before the pole collapsed
- The most common two species of woodpeckers found in National Grid territory have a nesting range of between 3 and 45 acres meaning that removal of a wood pole nesting site places all nearby remaining wood structures at risk of continued damage by the woodpecker population
