Eversource 345-kV Structure Replacement Projects

Planning Advisory Committee Meeting

December, 2017

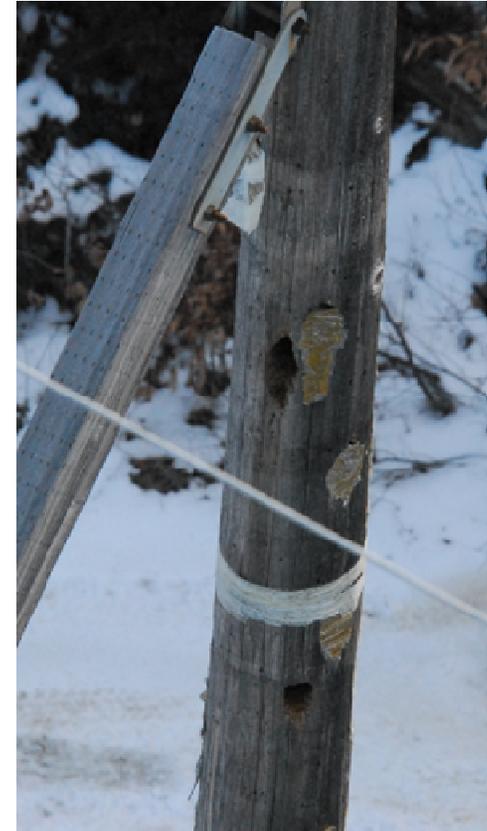
Pole Top Rot

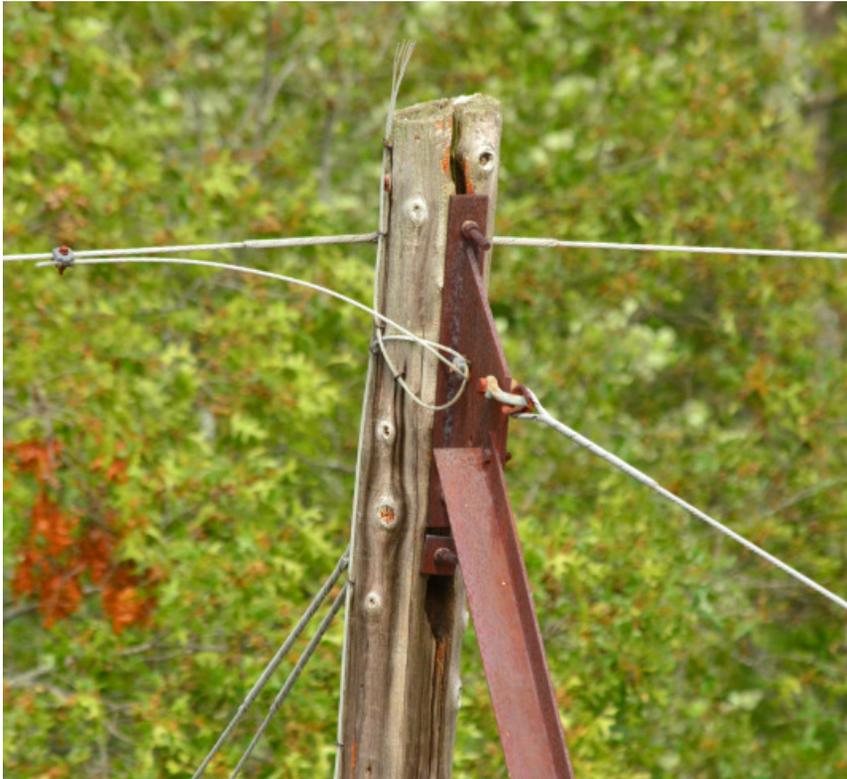
364 Line - CT

Pole Splits

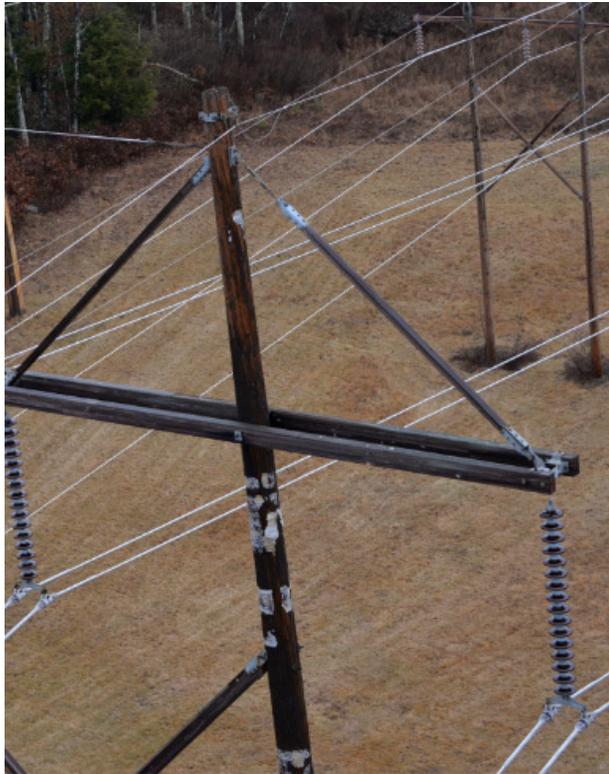
307 Line - NH

Woodpecker Damage

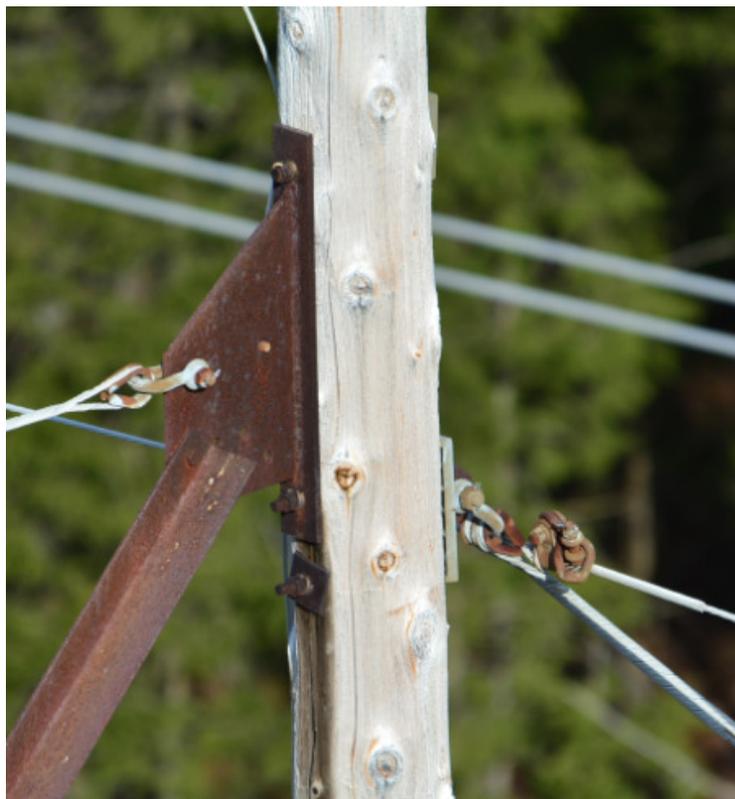
348 Line – CT
Shield Wire Disconnected

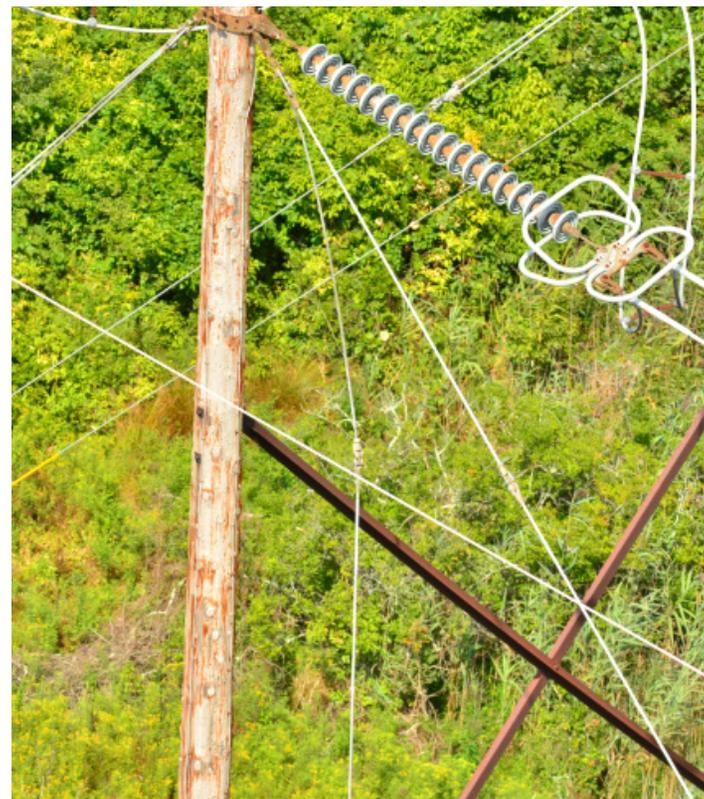
364 Line – CT
Broken Guy Wire
