Eversource 345-kV Structure Replacement Projects

Planning Advisory Committee Meeting

August 8, 2019

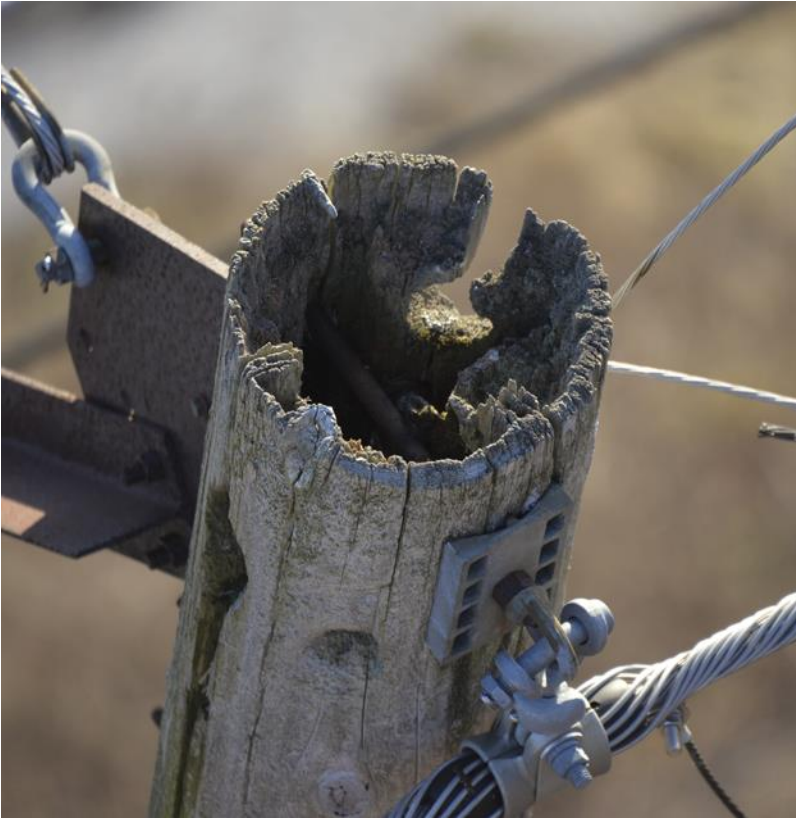
321 Line – CT

Pole Top Rot

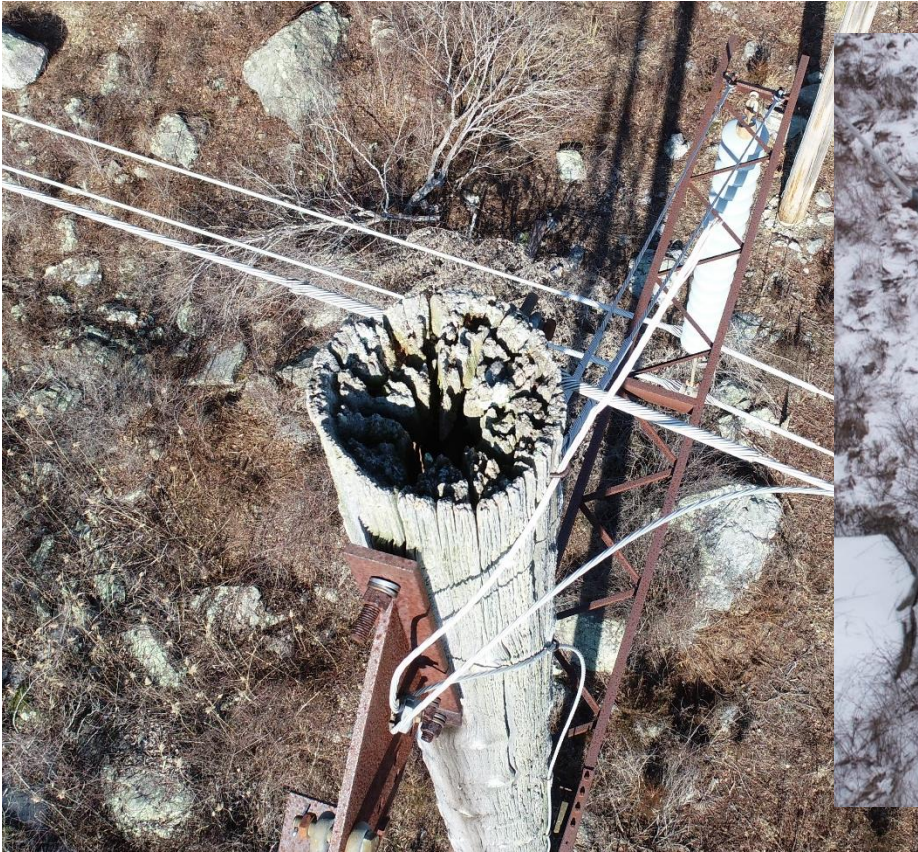
348 Line – CT

Pole Top Rot

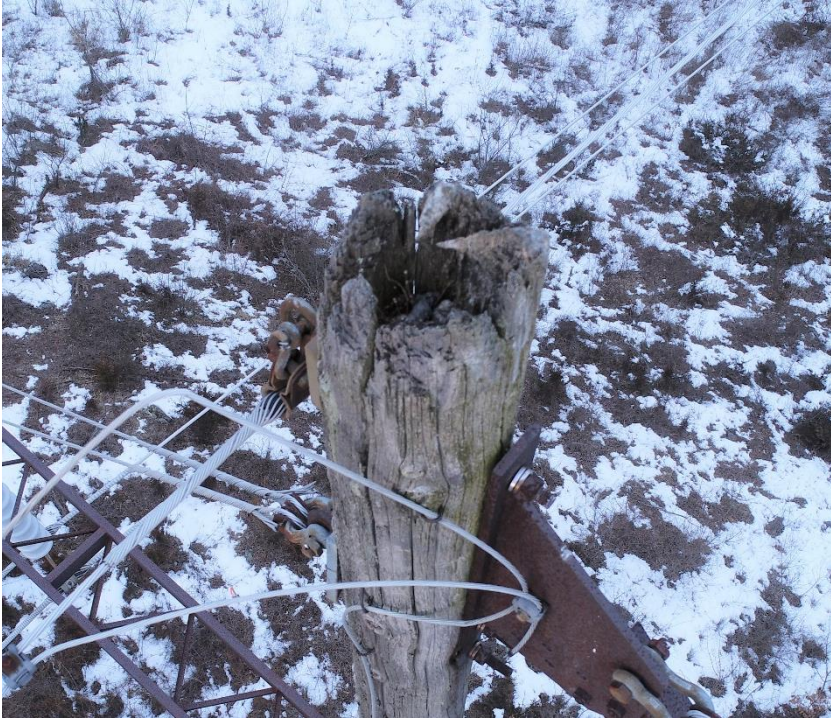
3041 Line – CT

Pole Top Rot

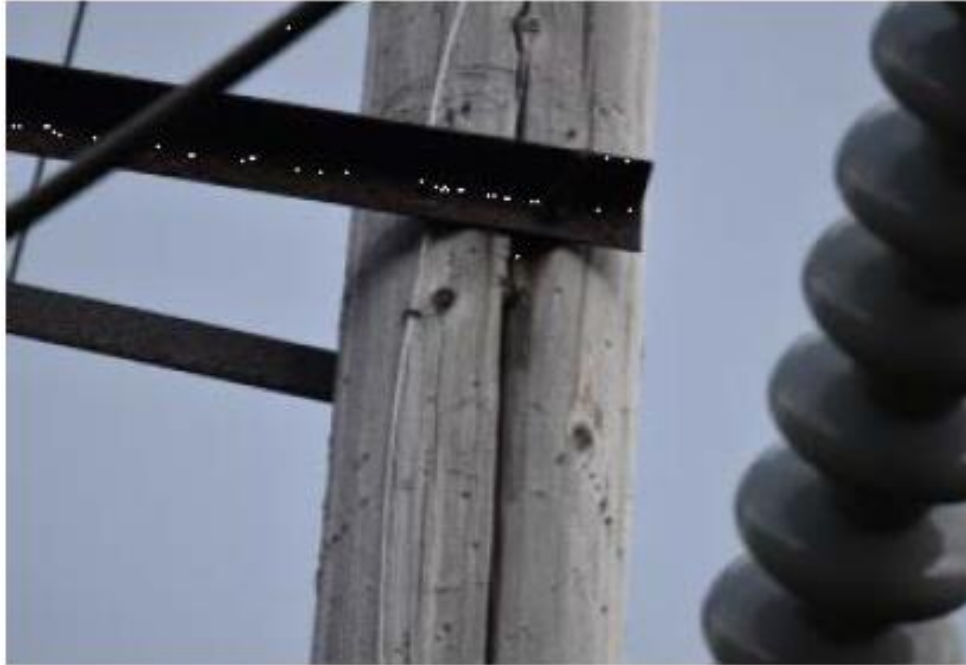
393 Line – WMA

Pole Splits

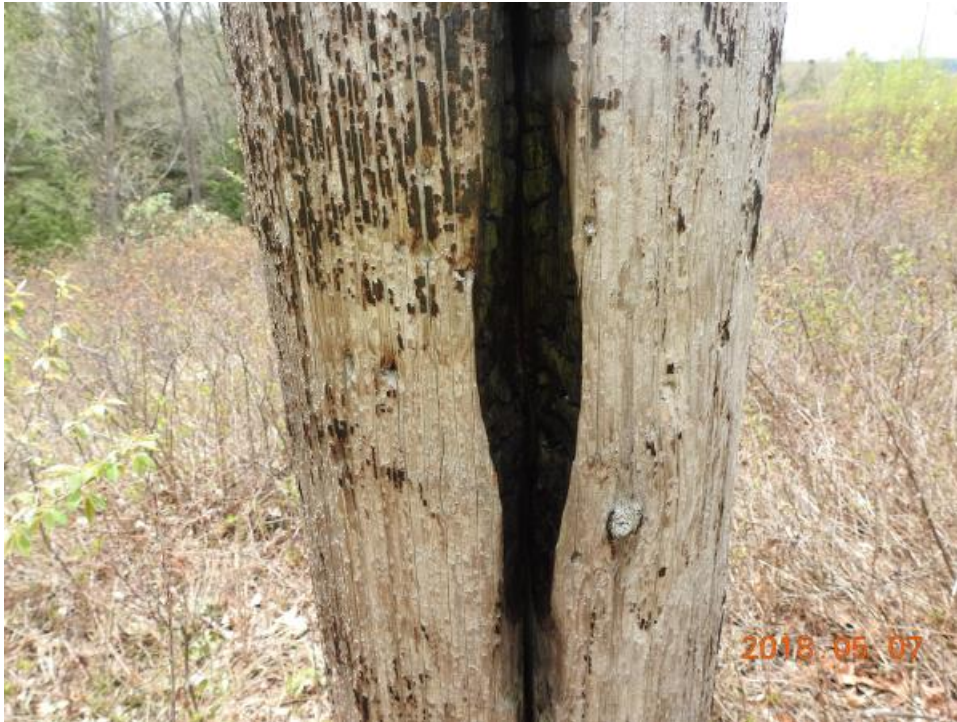
381 Line – NH

Pole Splits

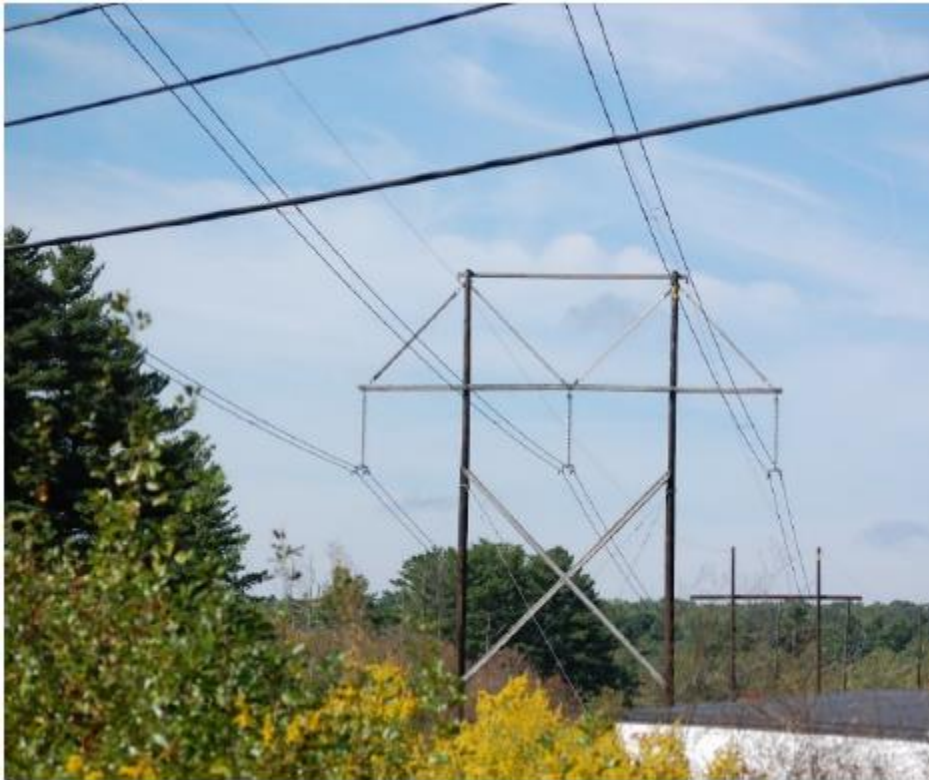
Cross Arm Damage

Bowed Cross Arm
336 Line – EMA

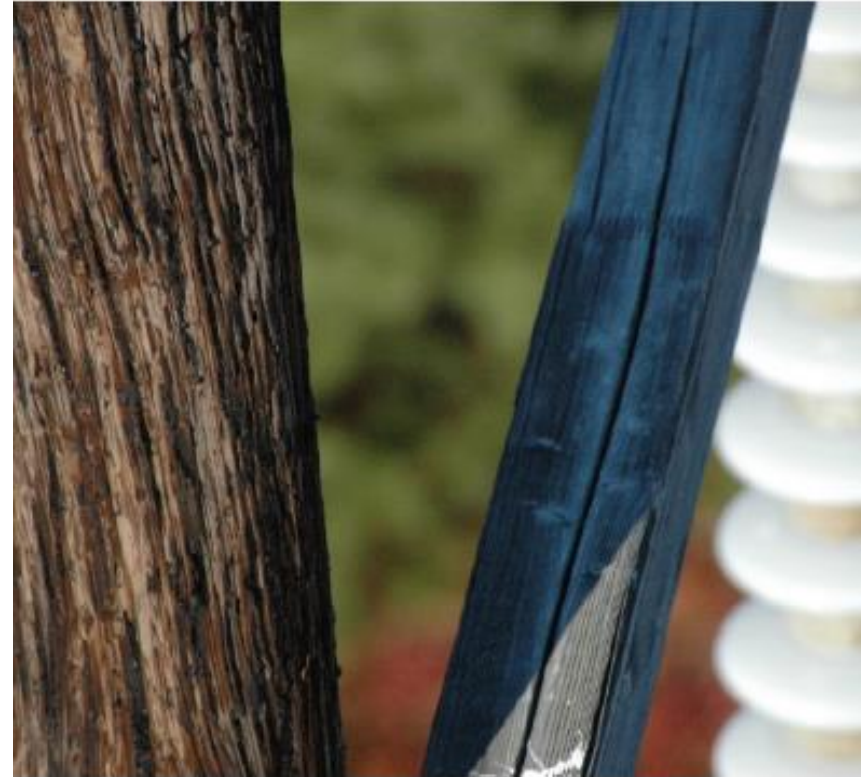
Longitudinal Split along Arm
3361 Line – EMA

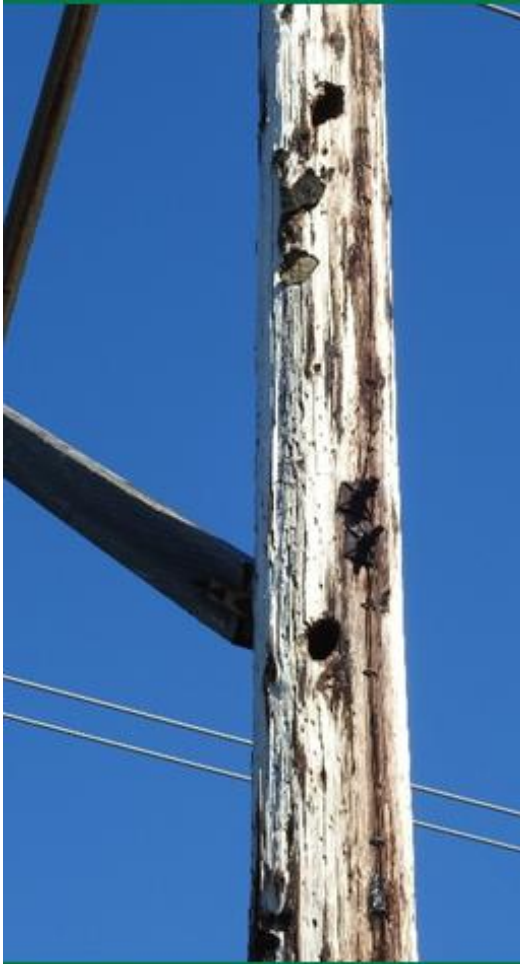
326 Line – NH

Woodpecker Damage

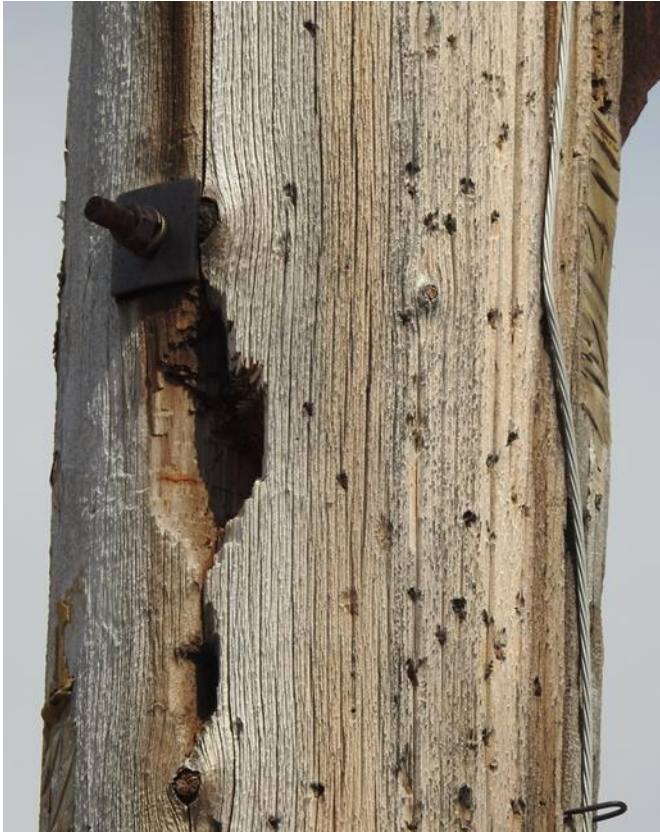
354 Line – WMA

Woodpecker Damage contd.

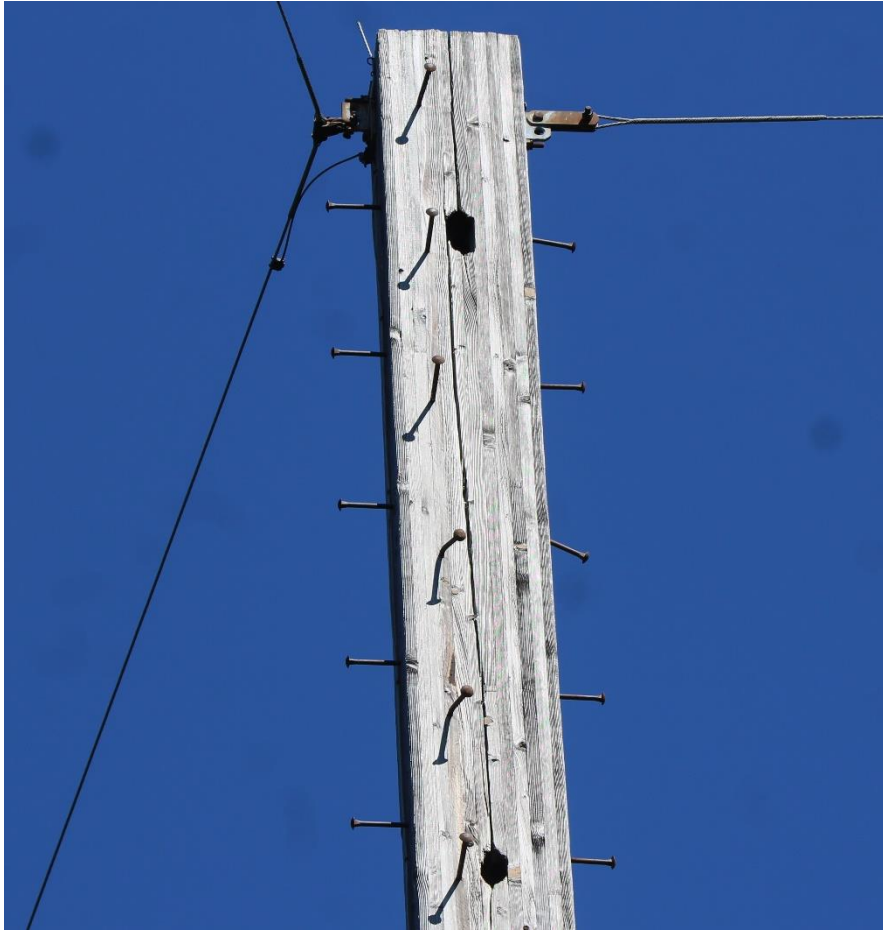
3041 Line - CT

Woodpecker Damage contd.
