# Transmission Line Refurbishment Projects

## K22, K24 and K34 Lines

Planning Advisory Committee Meeting  
February 17, 2021

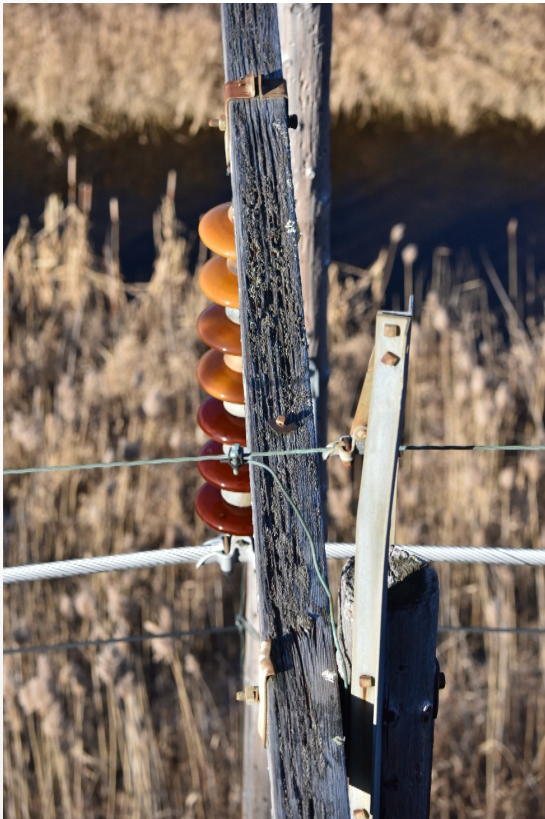
K22 Line Rotten Crossarm

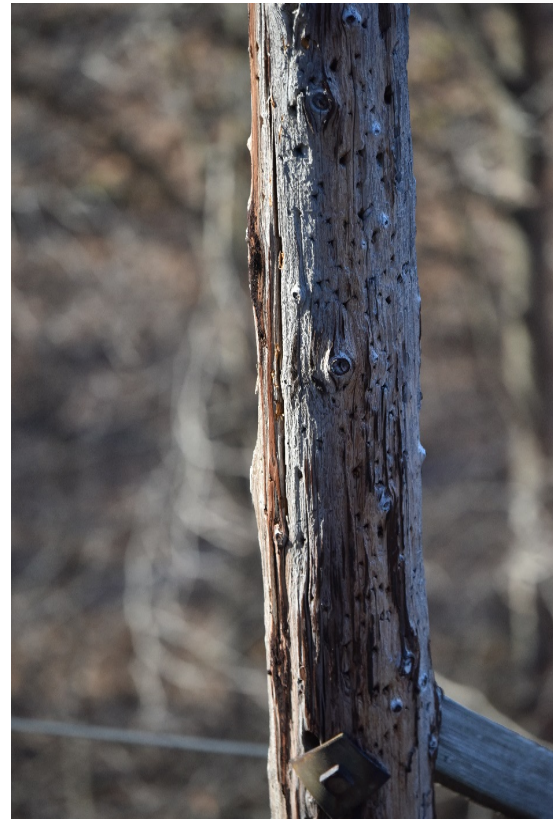
K22 Line Severely Weathered Pole

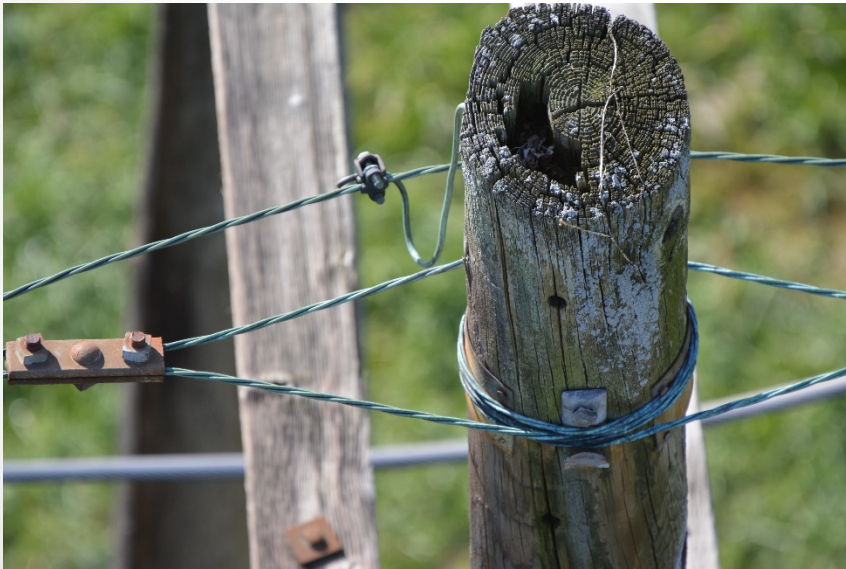
K24 Line Rotten Pole Top

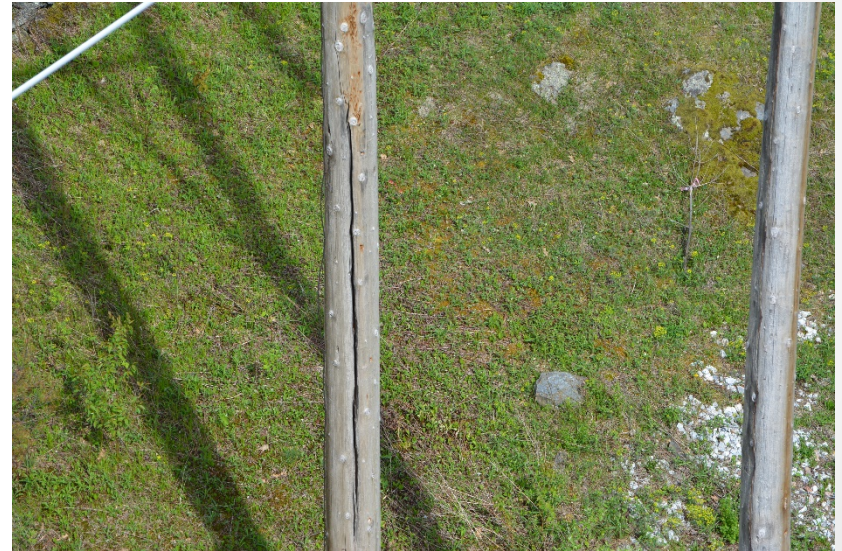
K24 Line Severe Pole Check

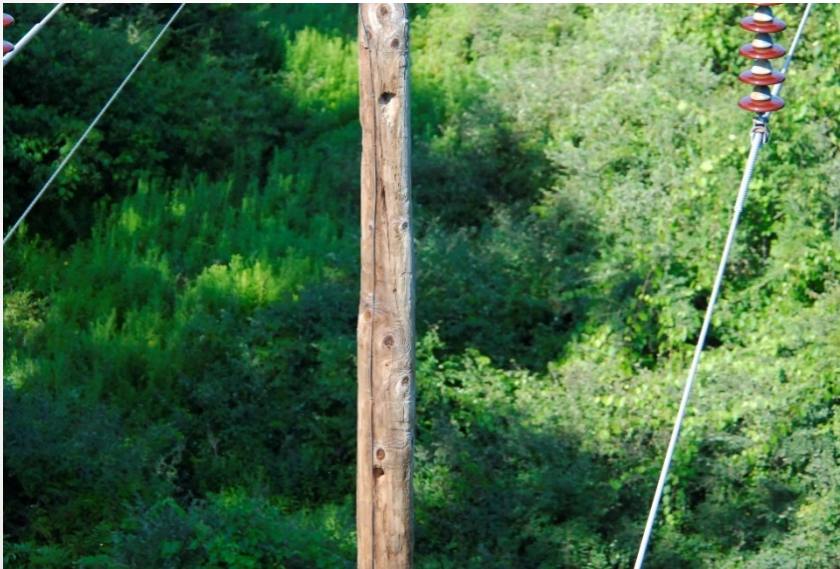
K34 Line Woodpecker Damage

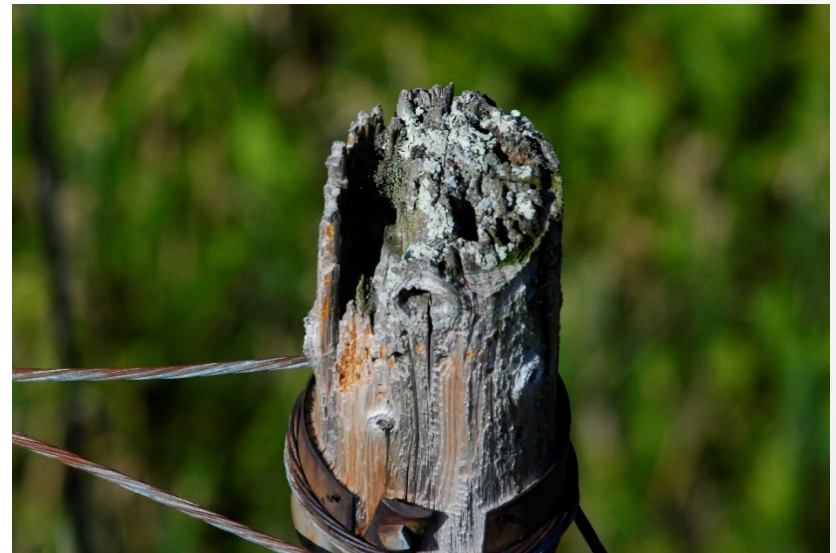
K34 Line Rotten Pole Top
