# **Eversource NH 115-kV Laminated Wood Structure Replacement Program Phase I**

Planning Advisory Committee Meeting

March 17<sup>th</sup>, 2021

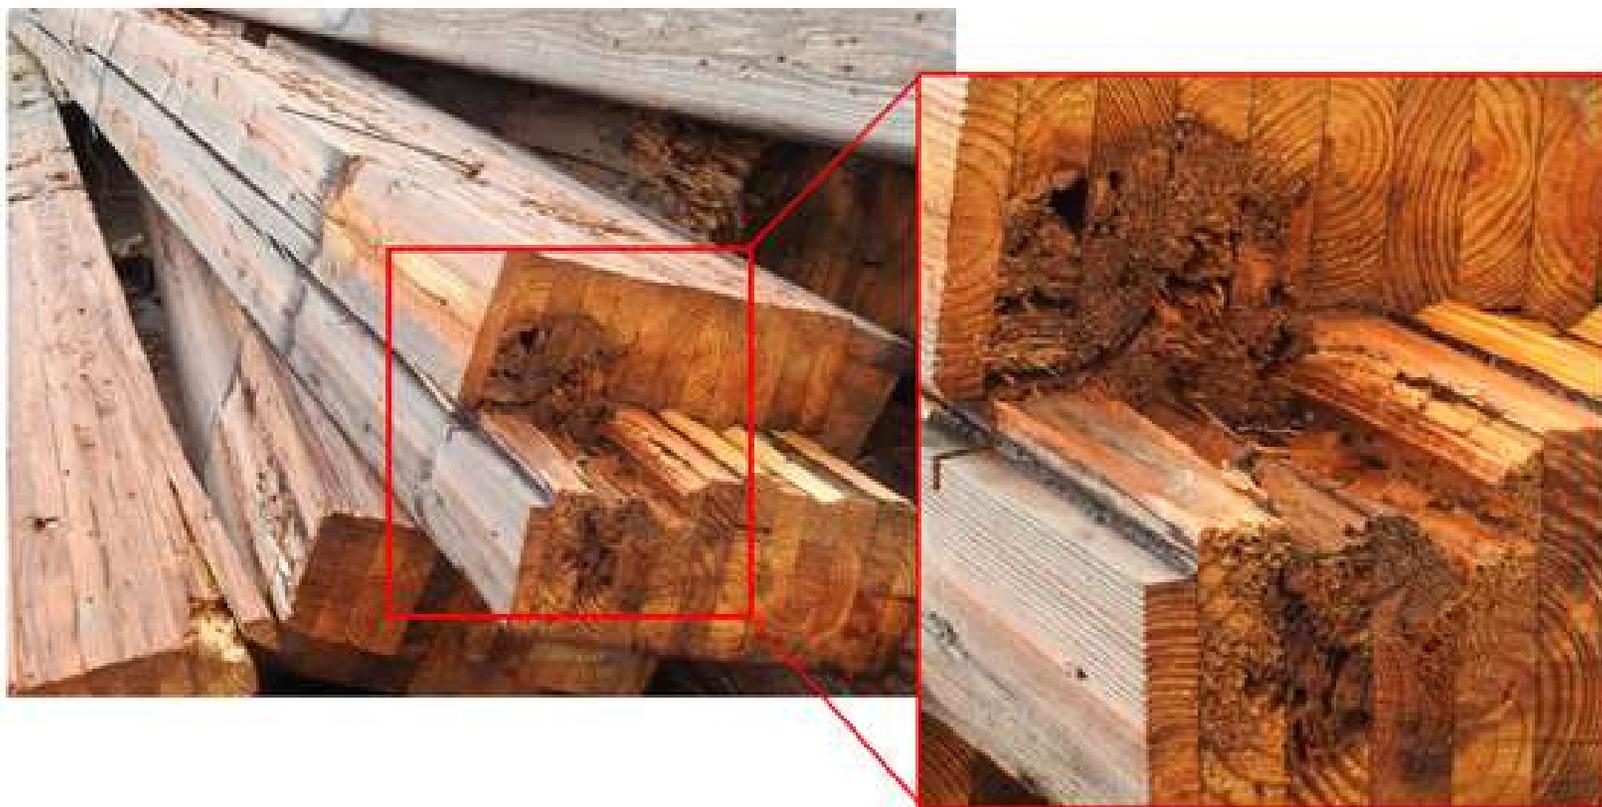
Sample Laminated Structure Base –  
Sawdust from Insect Damage –  
G128 Line

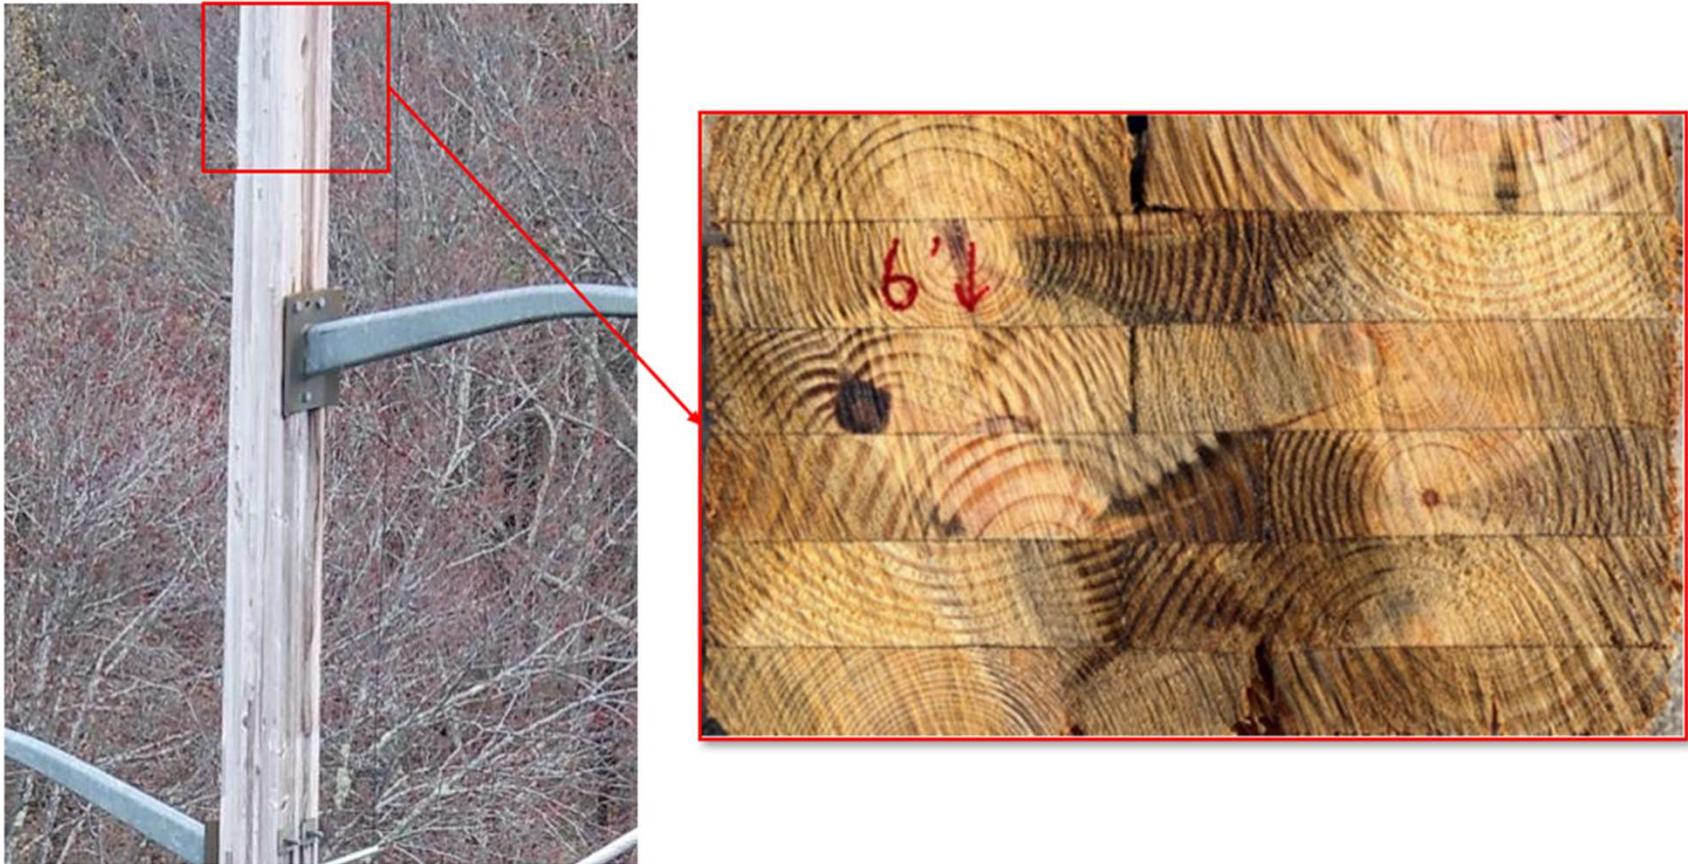
Comparison of 2019 Visual Inspection (Left) and 2020  
Cross-Section Photos Showing Internal Splitting (Right)  
G128 Line, Structure #75

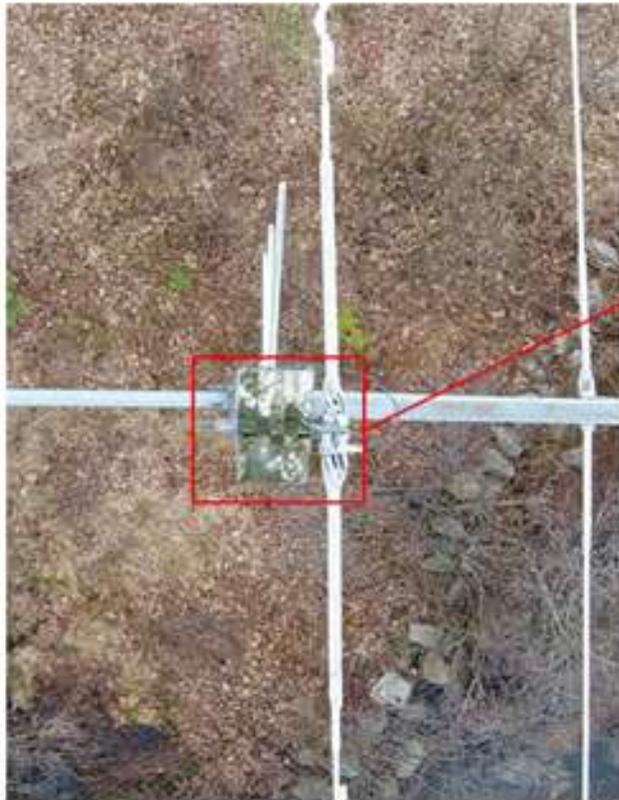
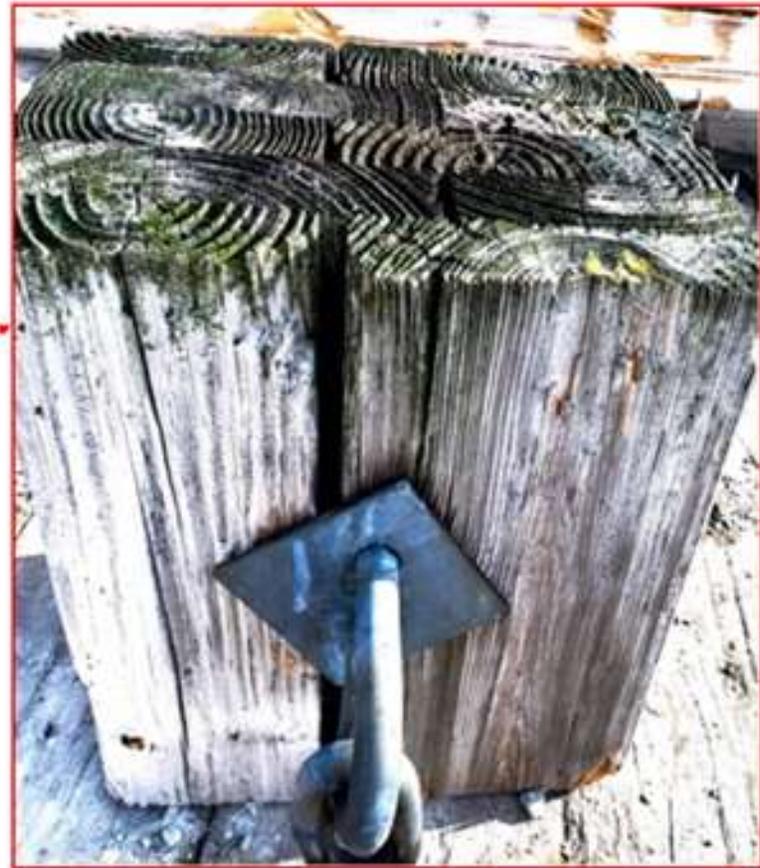
Comparison of 2019 Visual Inspection (Left) and  
2020 Cross-Section Photos (Right) –  
G128 Line, Structure #76

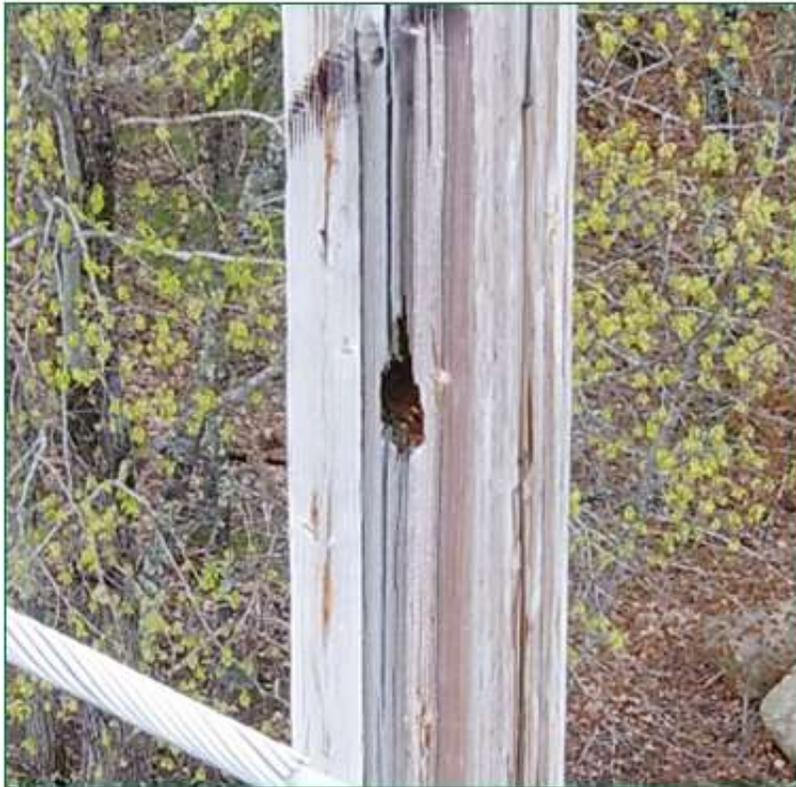
Woodpecker Damage –  
G128 Line, Structure #57

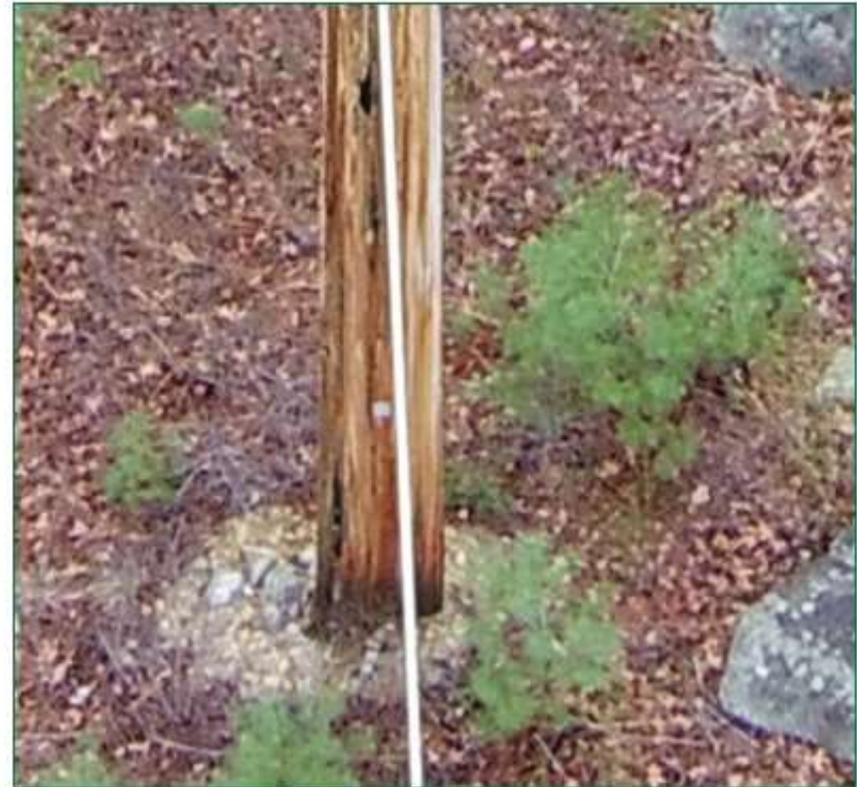
Woodpecker Damage –  
G128 Line, Structure #63

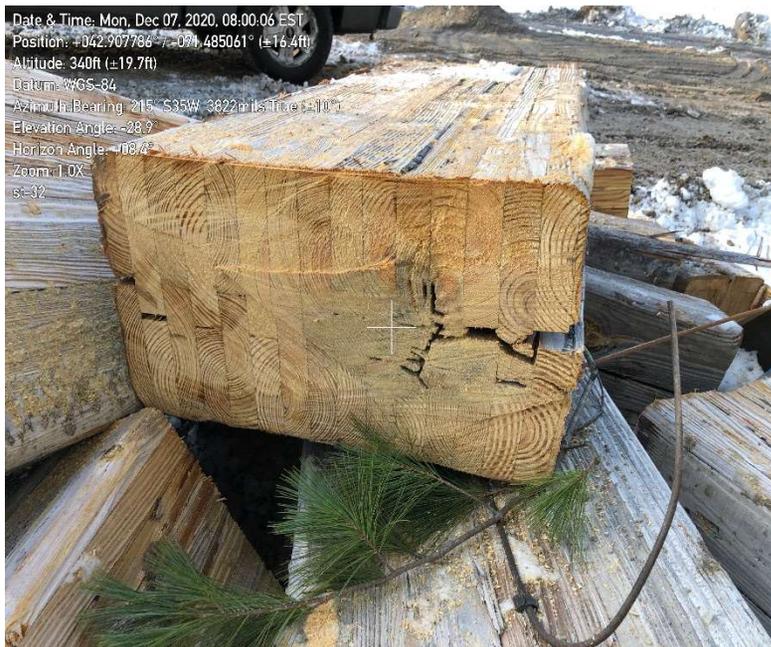
Rot and Splitting at Joints –  
K105 Line, Structure #32

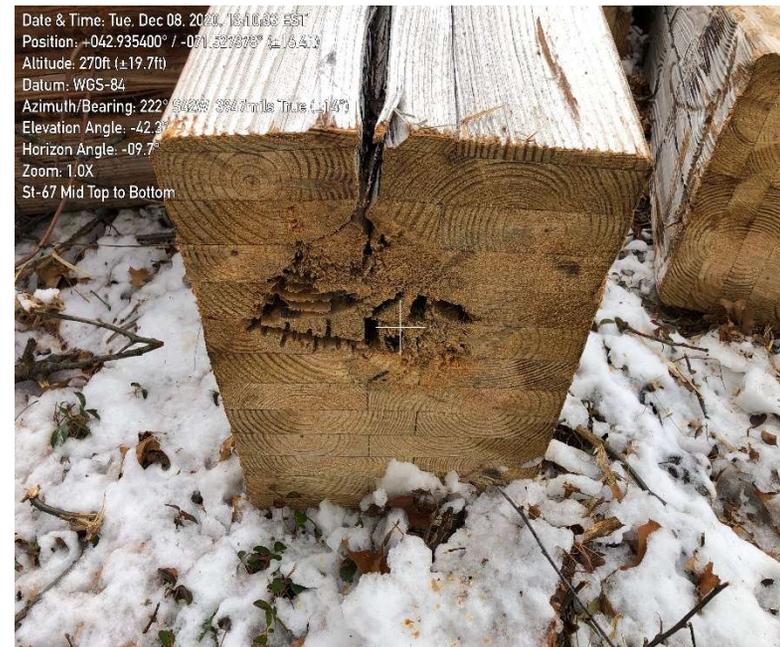
Extensive Rot –  
K105 Line, Structure #67

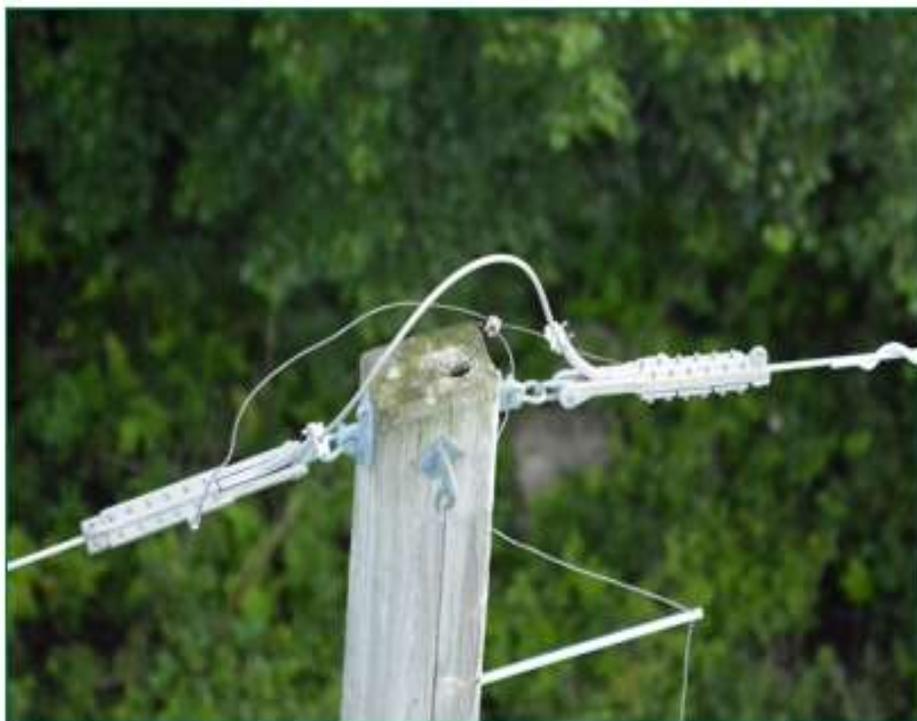
Rotten Pole Top –  
K105 Line, Structure #20

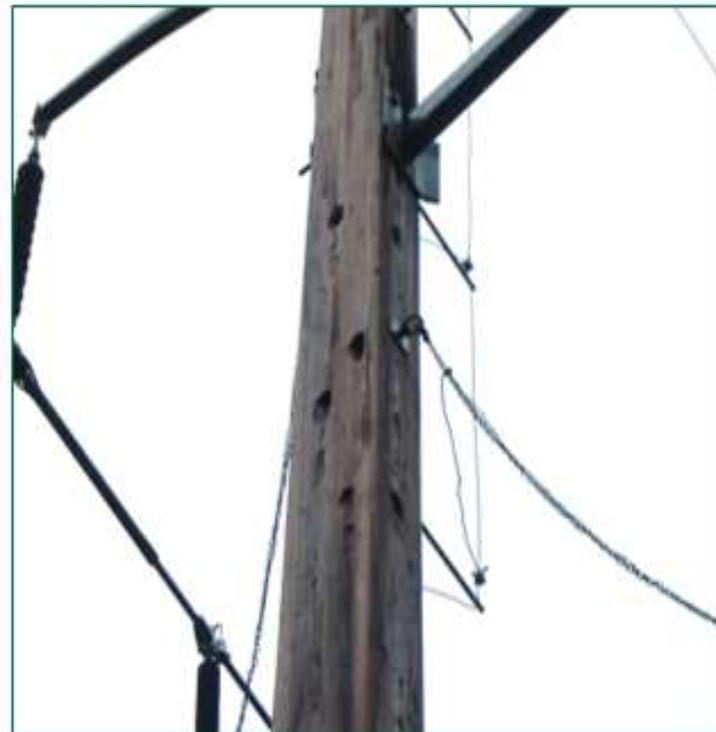
Woodpecker Damage –  
K105 Line, Structure #54

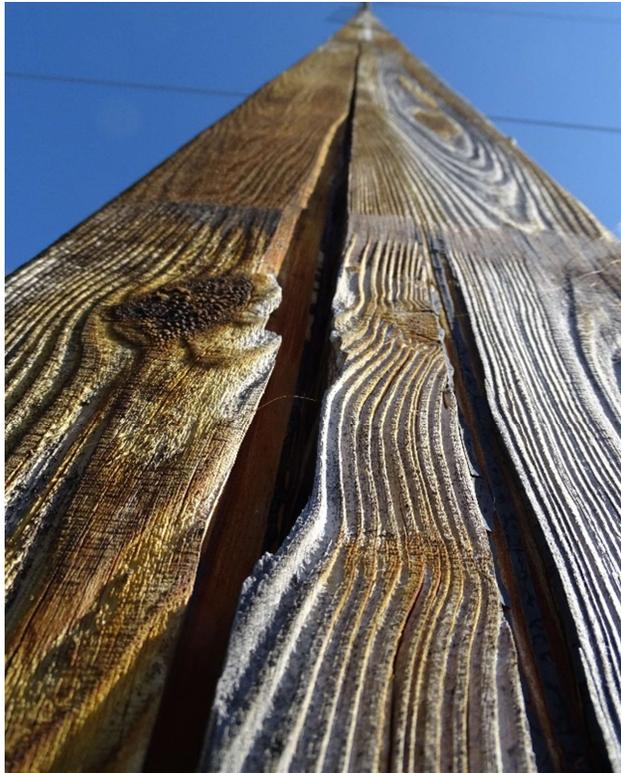
Side Crack –  
L175 Line, Structure #122

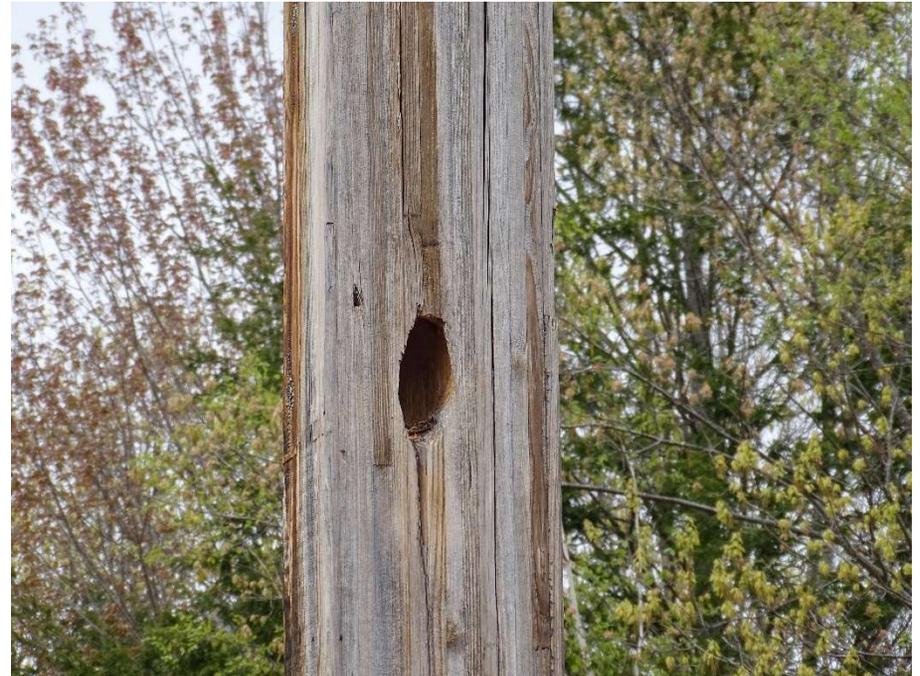
Crack Through Woodpecker Hole –  
L175 Line, Structure #139

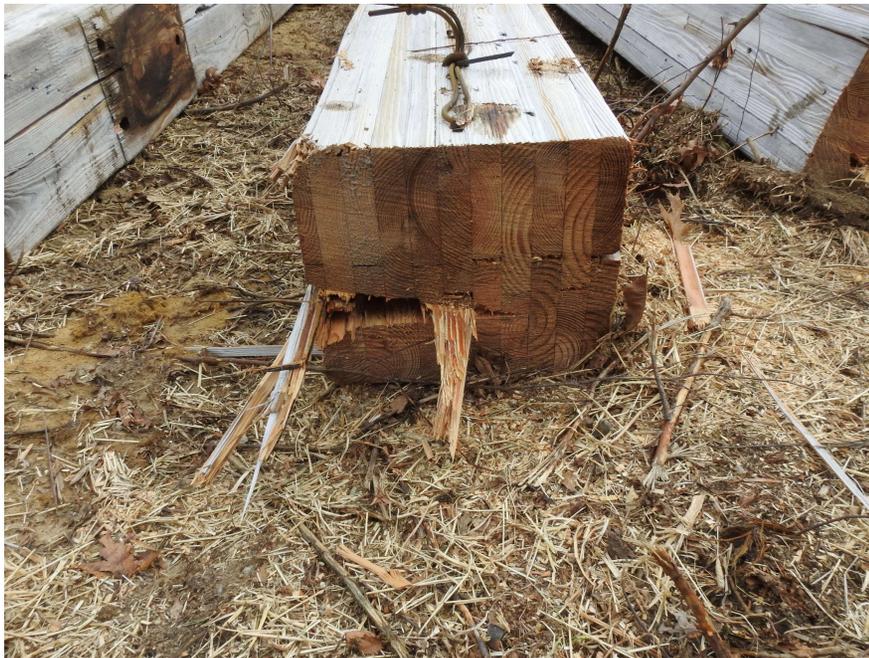
Large Crack –  
X116 Line, Structure #133

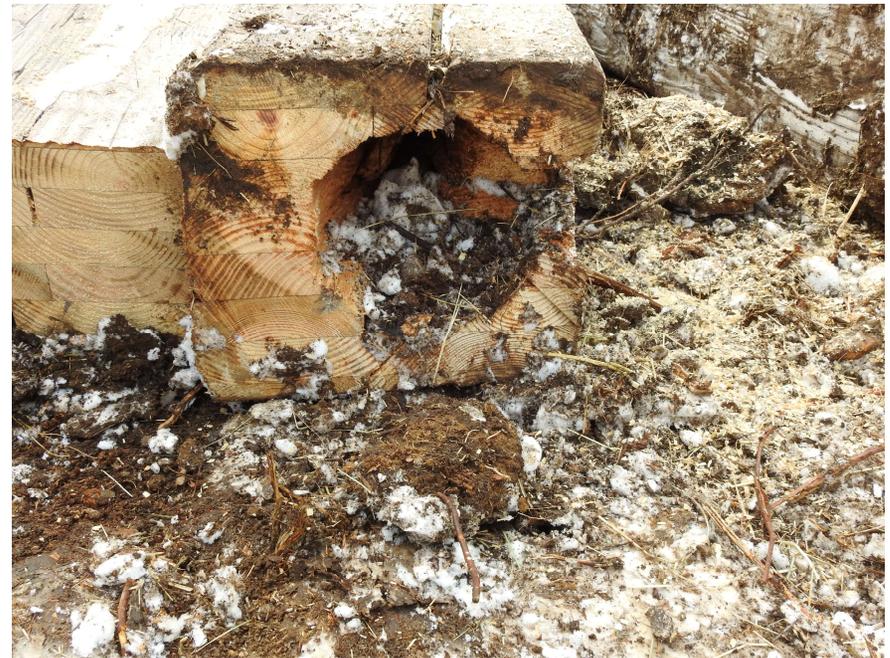
Extensive Rot –  
Z119 Line, Structure #137
