# Transmission Line Refurbishment Projects

## K43 Line

Planning Advisory Committee Meeting  
April 20, 2023

# K43 Line

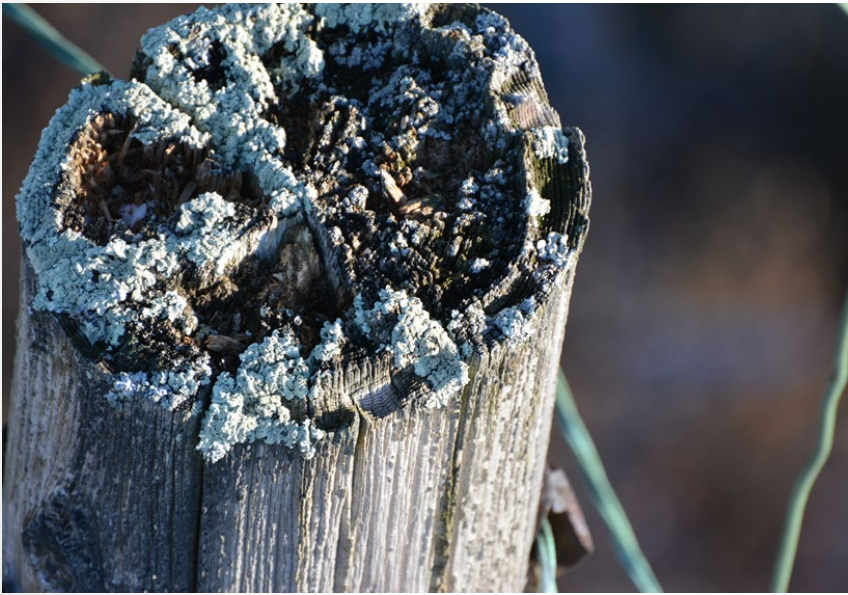
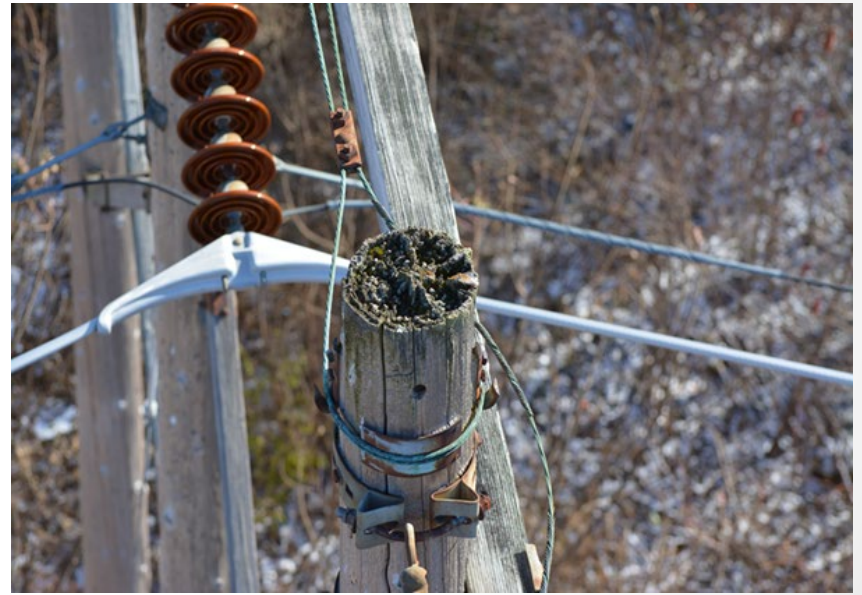
## Pole Rot

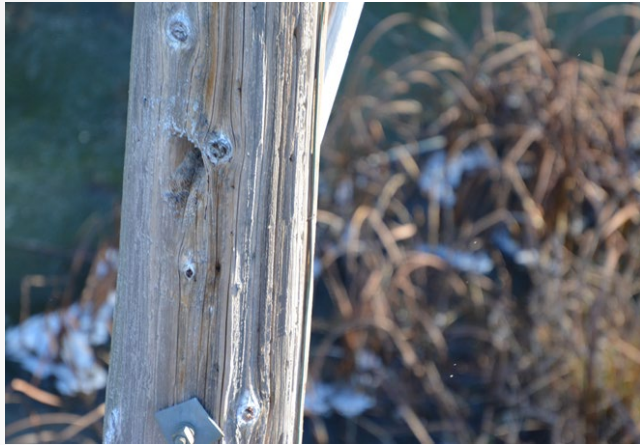
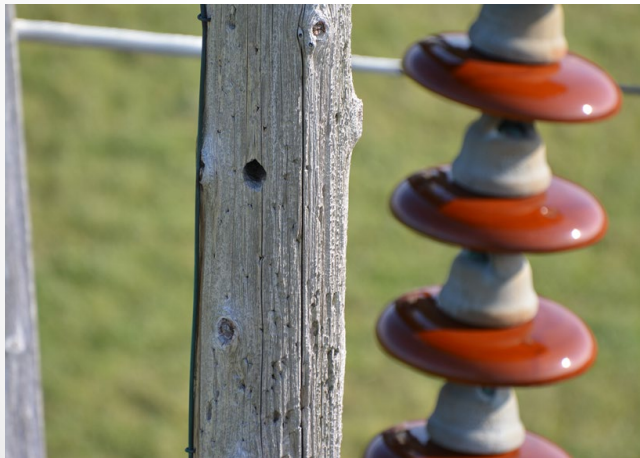
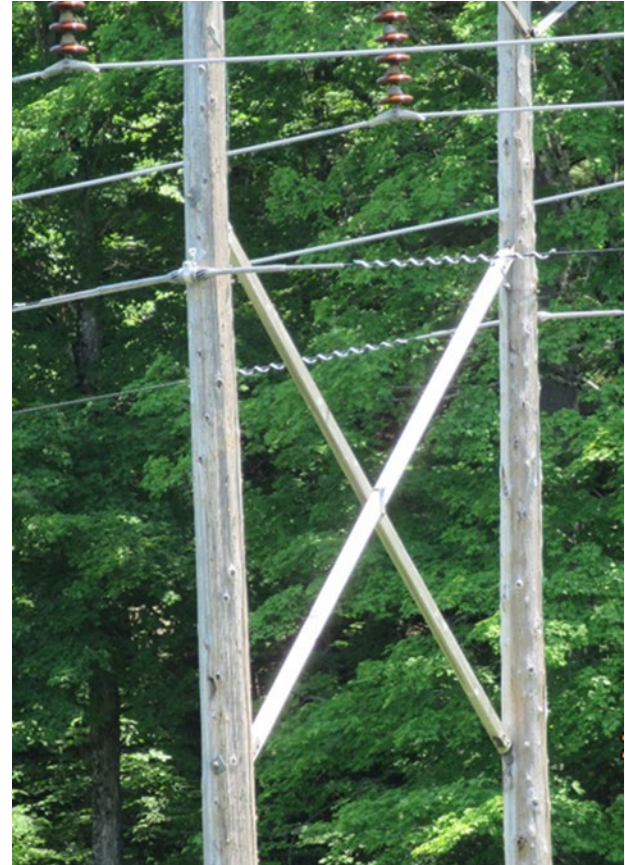
## Weathered Poles and Woodpecker holes

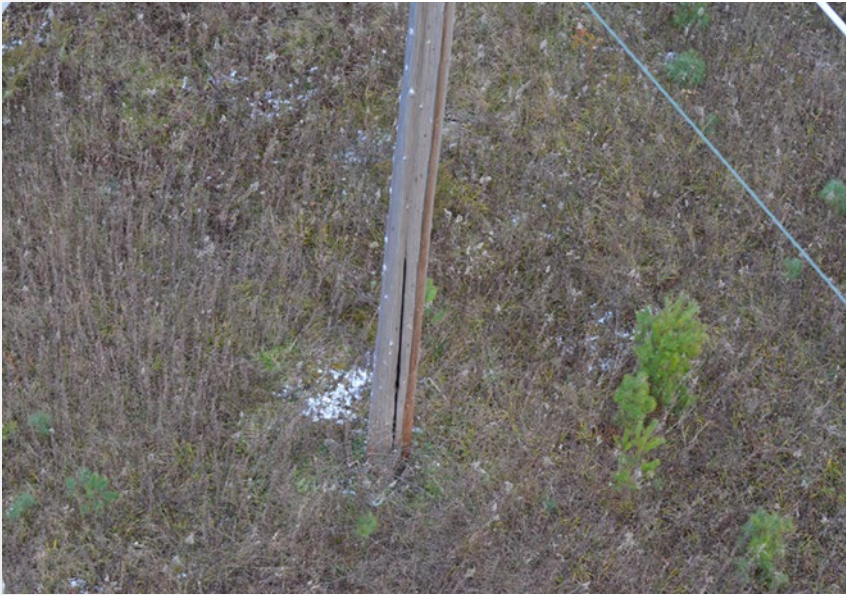
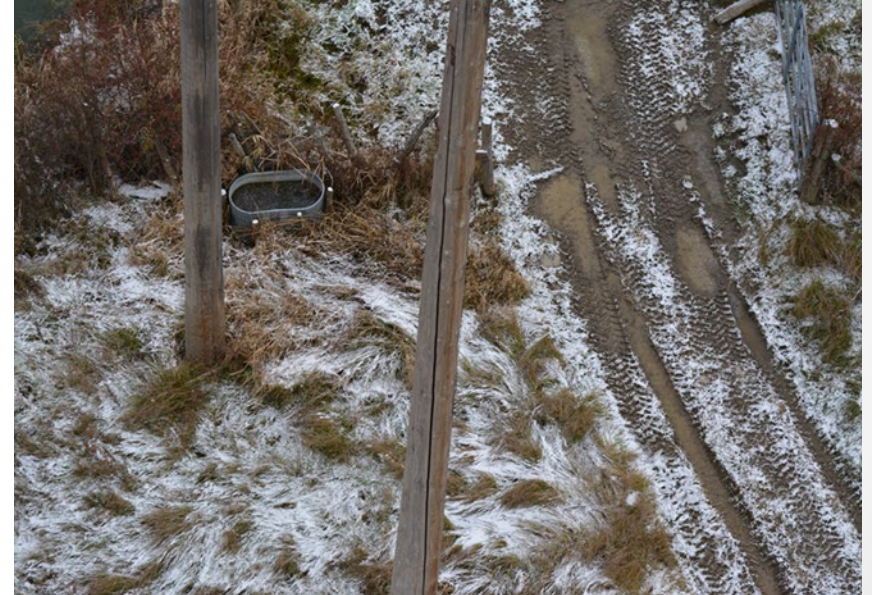
## Cracked poles
