# ISO-NE PAC MEETING

05/18/2023

## Adams #21 Substation Relocation

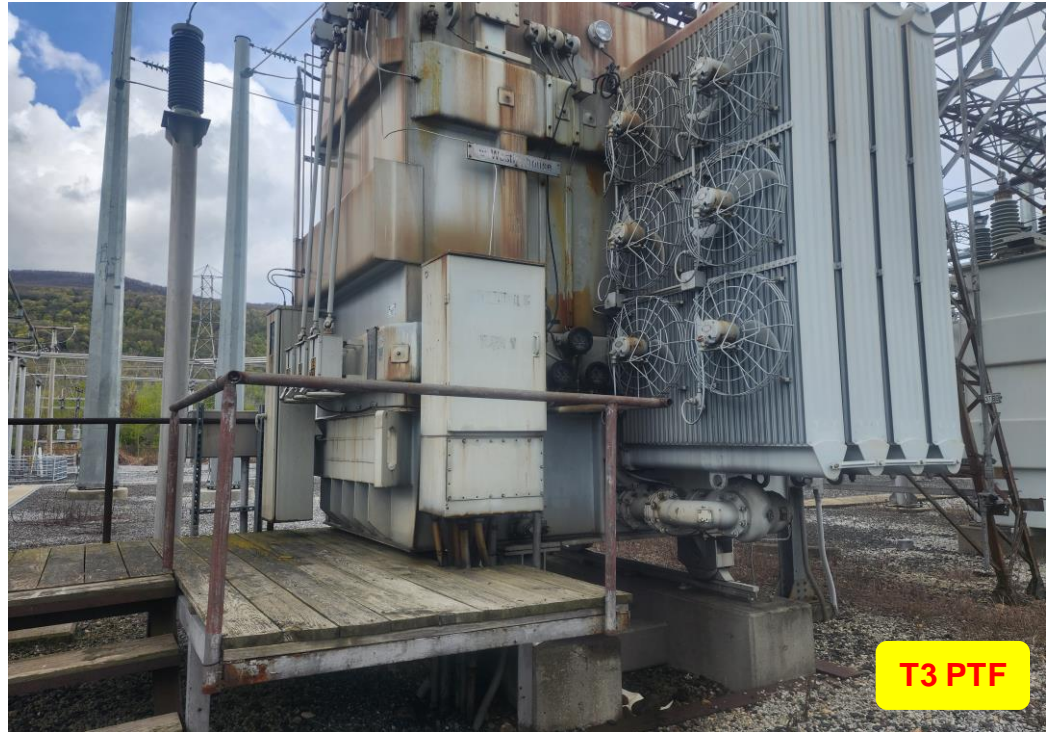
- Adams substation was built in 1917 and in 1960's 115kV sources were added. It consists of 115kV, 69kV, 23kV, 13kV assets, and serves over 18,200 customers
- T3 115kV transformer was installed in 1963 with no secondary oil containment. Recent inspection showed nitrogen leak around the flange
- T4 115kV transformer was installed in 1991, vintage surge arresters need to be replaced

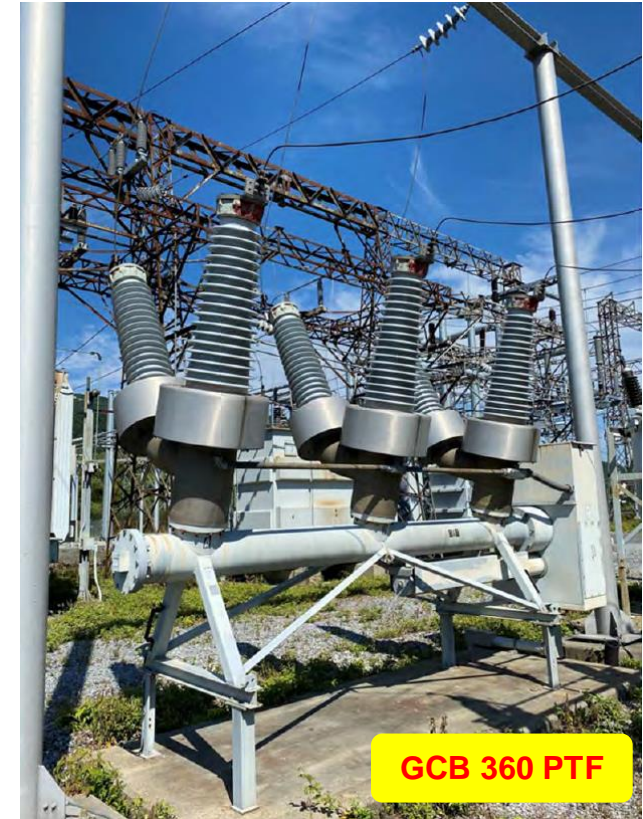
- 69kV gas circuit breaker was manufactured in 1998 and installed in 2002, recent inspection highlighted hydraulic and SF6 issues
- 69kV Switches 3T69, 361, 911 were installed in 1973 and difficult to maintain and operate
- 23kV equipment bus, breakers, cable trays and switches have had numerous asset concerns often operating in excess humidity and stone dust contamination
- Deteriorated control cables due to site condition, high ground water table combined with cycles of freezing and thawing damage control cables in Trenwa or cable trays
- Equipment operated under environmental conditions of excess humidity and stone dust beyond their recommended specifications

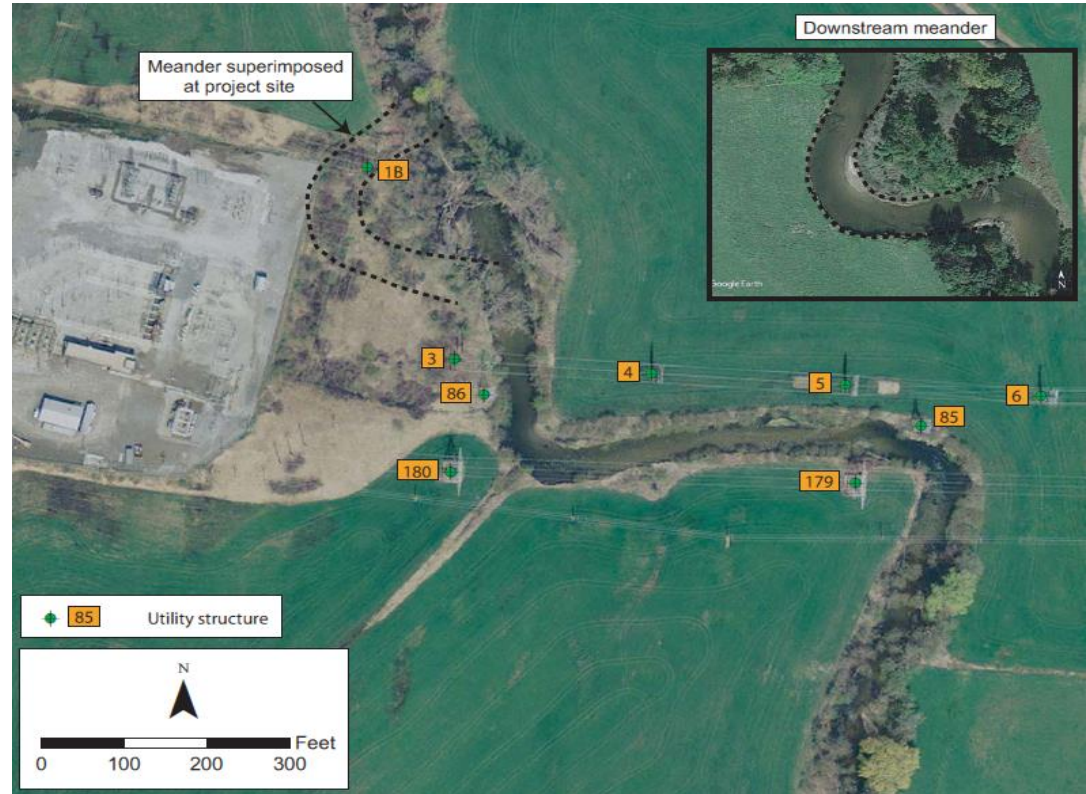
- The existing substation is in wetland area and adjacent to Hoosic River, within 100-year FEMA flood zone
- In close proximity to an active lime quarry exposing equipment to excess amounts of stone dust
- New study has shown river is encroaching the site boundaries due to a new meander formation
- Access limitation and operational concerns during a flooding event (i.e., 2007, 2014, 2015, 2018 floods)

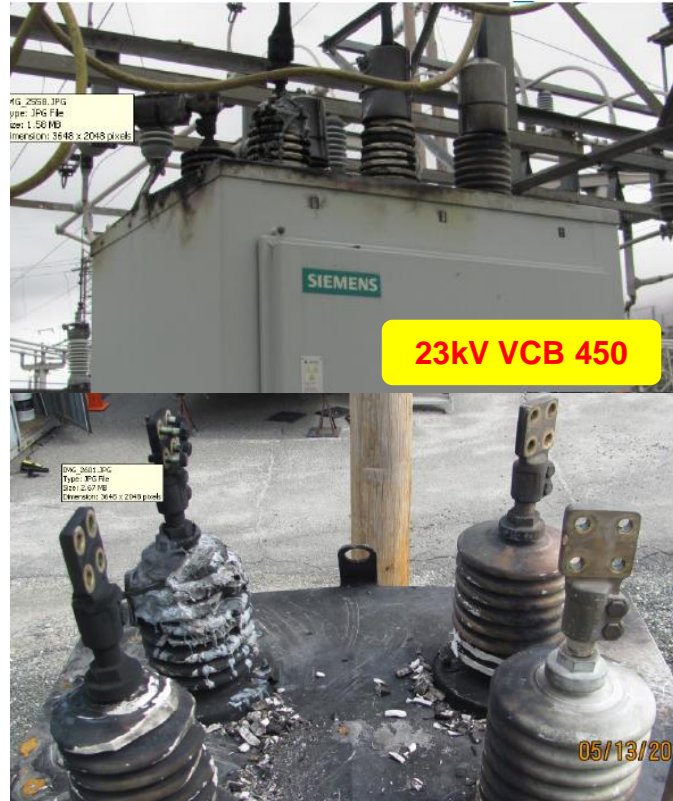
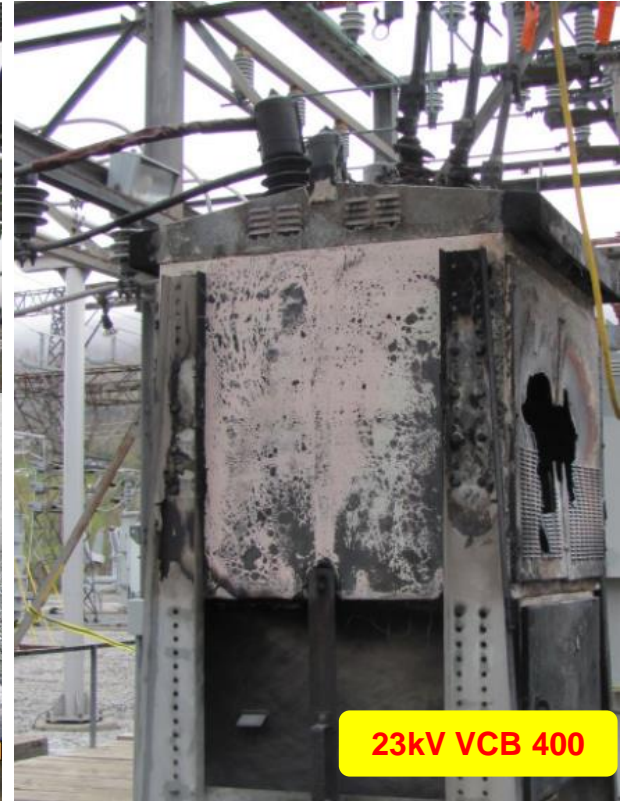
- Substation has flooded several times and resulted in equipment failure (circuit breakers flashover) & loss of all 18,200 customers for durations ranging from 2-7.5 hours.
- To date, only distribution equipment has failed due to flooding, and vacuum breakers seem to be the most impacted by humidity and dust

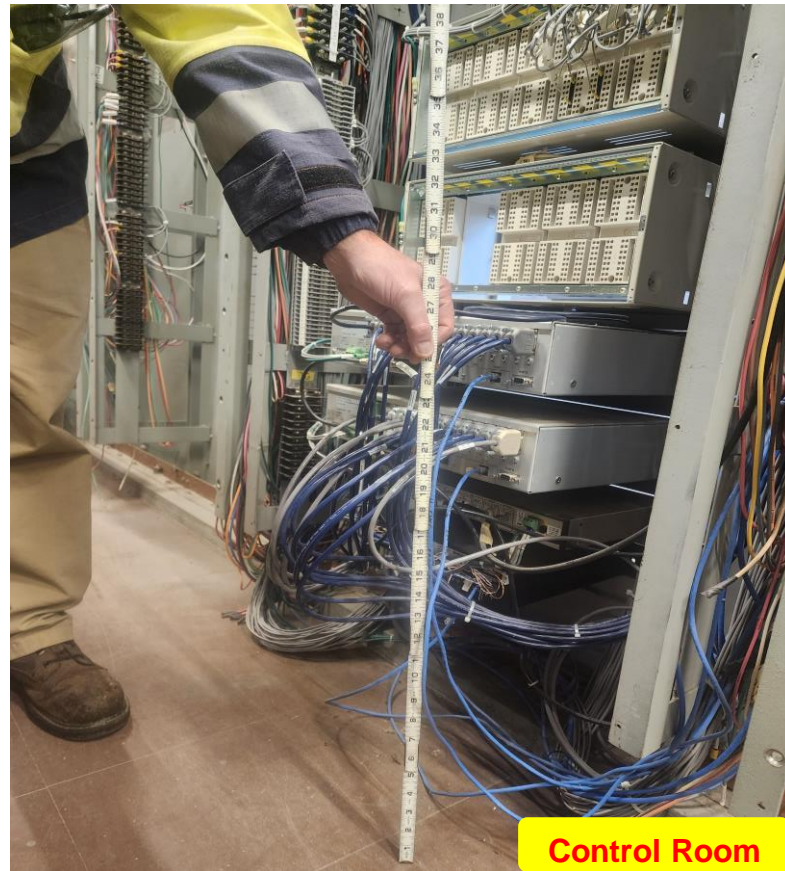
- Substation elevation: 718' – 721' above sea level
- FEMA 1983 100-year elevation: 722' to 723' , adjusted 100-year & 500-year peak flood after hydrologic study by GeoEnvironmental Inc (GZA): 723'3" & 725'
- Control room floors are at 722'11" and 721'10" elevations. A 100-year flood here would result in ~ 4" and 18" water, a 500-year flood would be at ~ 28" and 42"
  - Most of the control panels have been installed on the floor, so flooding the control room would short-circuit multiple pieces of equipment, including relays, resulting in the loss of protection on major equipment

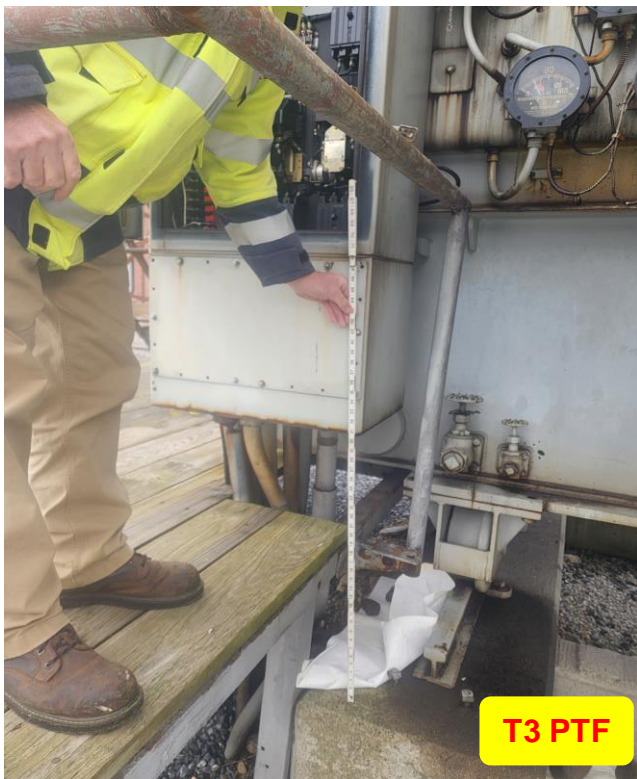
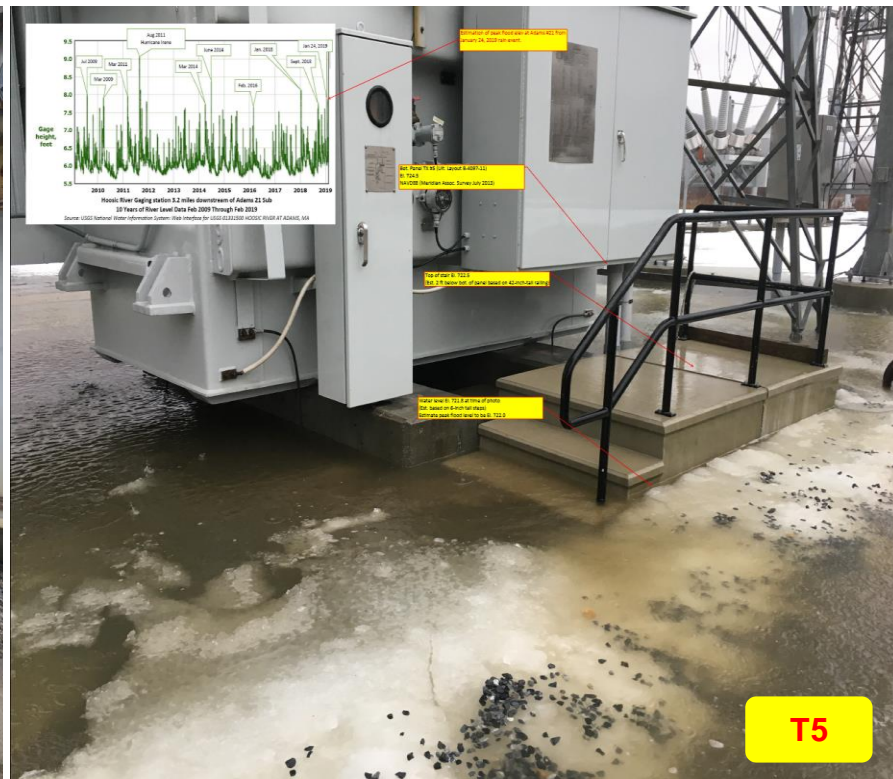
- Sensitive transmission equipment panel elevations in the yard range from 723'8" – 726'; however, over 75% of them are installed under 725'

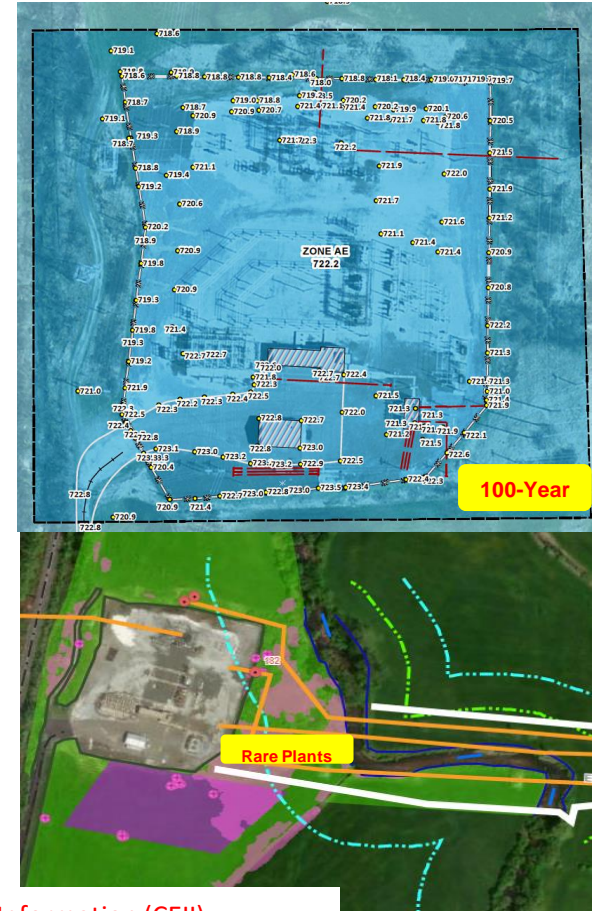
- Substation is within 100-year flood zone, surrounded by wetlands, rare plants and wetland mitigation areas on all sides (except access).
- Substation site considered at High Risk for extreme participation and riverine flooding events by the Resilient MA Action Team's Climate Resilience Design Standard Tool (EOEEA).
- Maintenance projects are heavily scrutinized by regulatory agencies given these constraints.
- Any modifications to “future-proof” the substation to increase resilience from more frequent flooding/climate impacts would undergo significant agency scrutiny and require detailed alternatives analysis, including the evaluation of alternate sites.
