Northern New Hampshire Rebuilds 115 kV Lines B112, Q195, U199

Planning Advisory Committee Meeting

May 18th, 2023

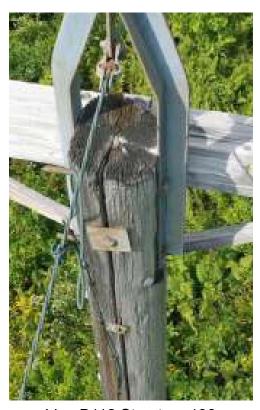
Line B112 Structure 138 Split Pole Top

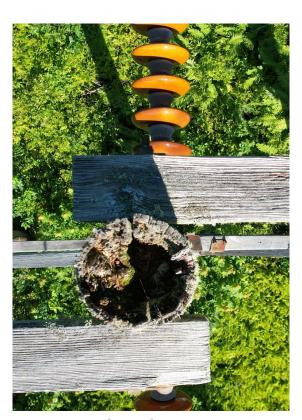
Line Q195 Structure 99 Significant Pole Top Rot

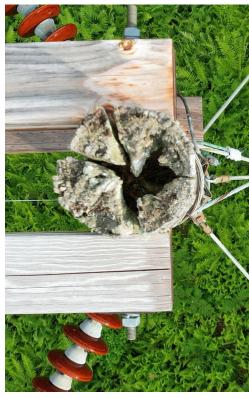
Line U199 Structure 15 Pole Top Split and Rotting

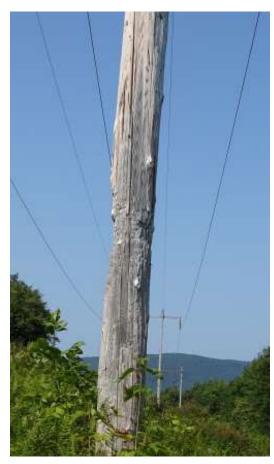
Line B112 – Structure 99 Significant Decay

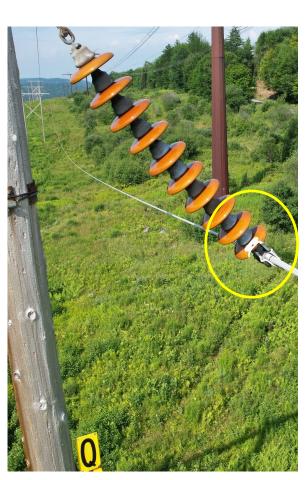
Line Q195 – Structure 200 Broken Insulator

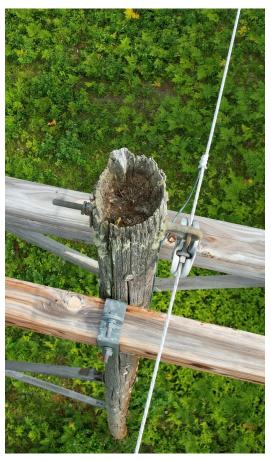
Line U199 – Structure 17 Significant Pole Top Rot

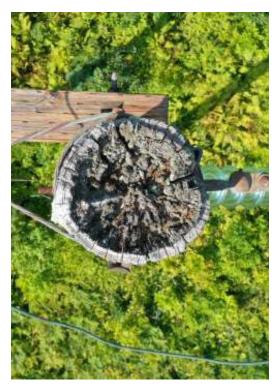
Line B112 – Structure 30 Pole Top Rot

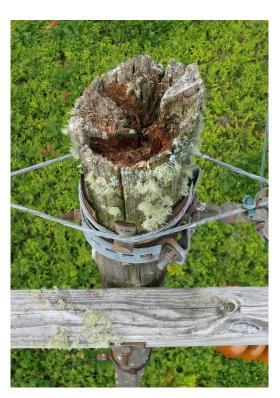
Line Q195 – Structure 193 Pole Top Split, Rot

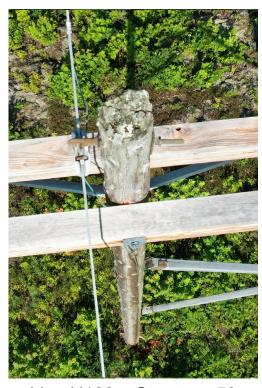
Line U199 – Structure 50 Pole Top Split, Checking
