July 25, 2023

UI's 115kV Derby Junction to Ansonia Line Rebuild Project:

PAC Update

Presentation to:
ISO-NE PAC

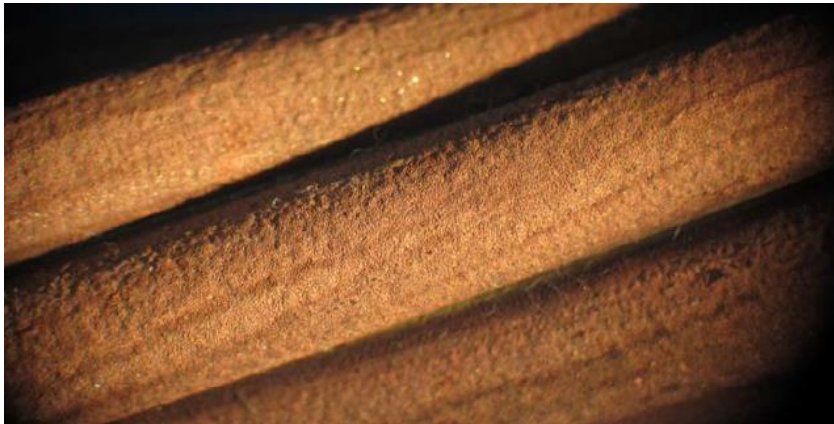
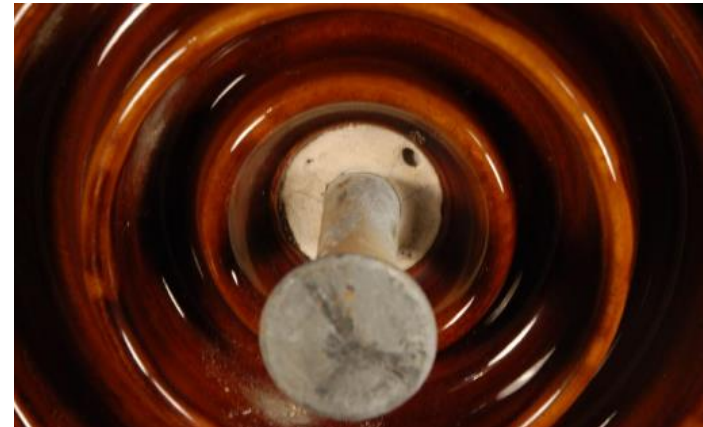
- Surface contamination and pitting observed
- The tested breaking strength of the conductor has decreased and is reaching end of life

- Several sampled insulating bells failed electrically

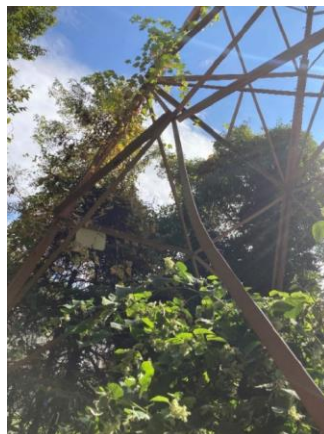
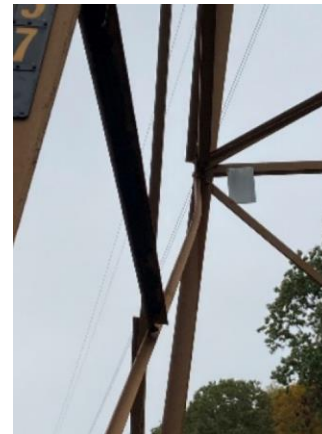
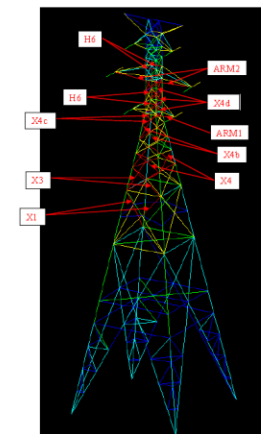
- Field inspections found a variety of deficiencies:
 - Tension only members in compression (10)
 - Deflected tower peaks (3)
 - Bent/deflected tower arms (expected from ice event)
 - Inadequate shield-wire support (21)
 - Exposed metal has led to corrosion on parts of structures (28)

- Structural modeling in PLS CADD / TOWER using NESC 1961 revealed 6 towers with members exceeding their capability with the 300 kcmil conductor
 - Information only: 2012 NESC identified 3 additional structures

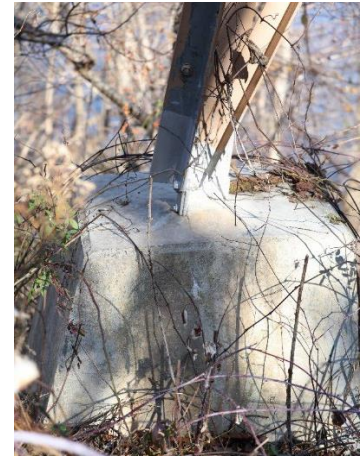
- Field inspections found a variety of deficiencies:
 - Spalling (6)
 - Anchor-bolt/plate galvanic corrosion (4)
- Various Foundations not easily accessible
 - Grillage-type and cannot be inspected without excavation (8)
 - Legs encased in concrete (3)
 - Customer back-filled over foundation (1)

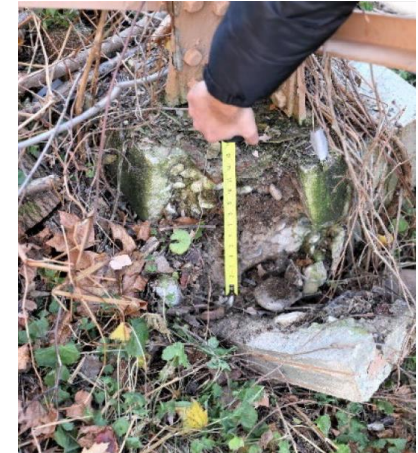
- Anchor Bolts
 - In-service anchor bolts do not have a corresponding ACI compliant pull-out calculation.
 - Review of 1920's vintage construction drawings show a very slight hook.
 - Non-standard anchors in tension (19)
- Failed concrete breakout checks (16)
