Line 1759 Asset Condition Structure Replacement and Copperweld Retirement Project

Eversource Energy

August 20, 2025

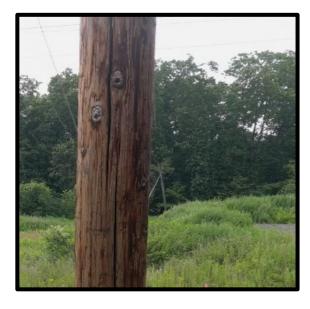
Structure 9019:

Pole Splitting
