S-171, S-171S, & T-172S 115 kV Structure Replacements and Lightning Mitigation

ISO-NE Planning Advisory Committee Meeting

August 2025

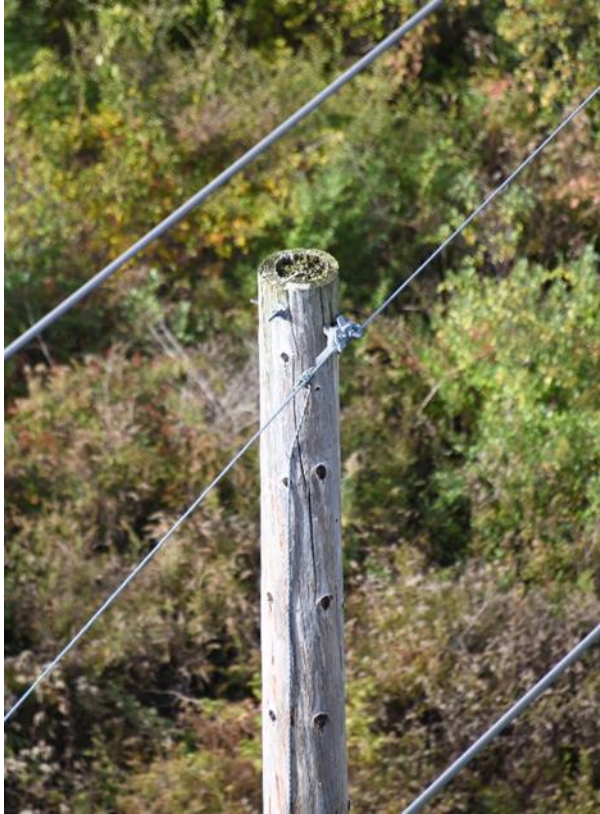
S-171S Structure 224
Pole Top Rot

Wood Pole Replacement and Lightning Mitigation	
Description	<p>S-171, S-171S, T-172S 115kV Wood Pole Replacement and Lightning Mitigation</p> <ul style="list-style-type: none">• Replace four (4) wood H-frames and twelve (12) 3-pole wood structures along S-171, S-171S, and T-172S with steel monopoles, install 10.3 miles of OPGW, replace all insulators and hardware where OPGW is installed, improve grounding at any structure that does not meet the minimum ground impedance requirement of 25 ohms or less
Primary Needs Addressed	<p>Structures</p> <ul style="list-style-type: none">• The identified wood structures with woodpecker damage, pole top rot, cracked crossarms, splitting poles, and other forms of decay will be removed and replaced with steel monopoles <p>Shield wire</p> <ul style="list-style-type: none">• Dual shield wire will provide improved shielding angle<ul style="list-style-type: none">• This will allow customers to see less outages due to lightning strikes• Better grounding using ground rods or ground drills to limit equipment damage, create safe working conditions

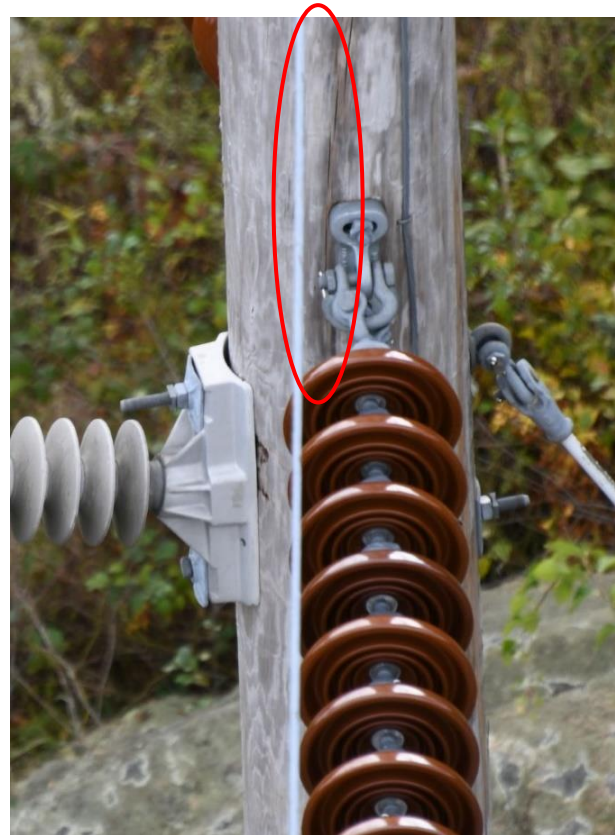
S-171 Structure 133
Pole Cracks

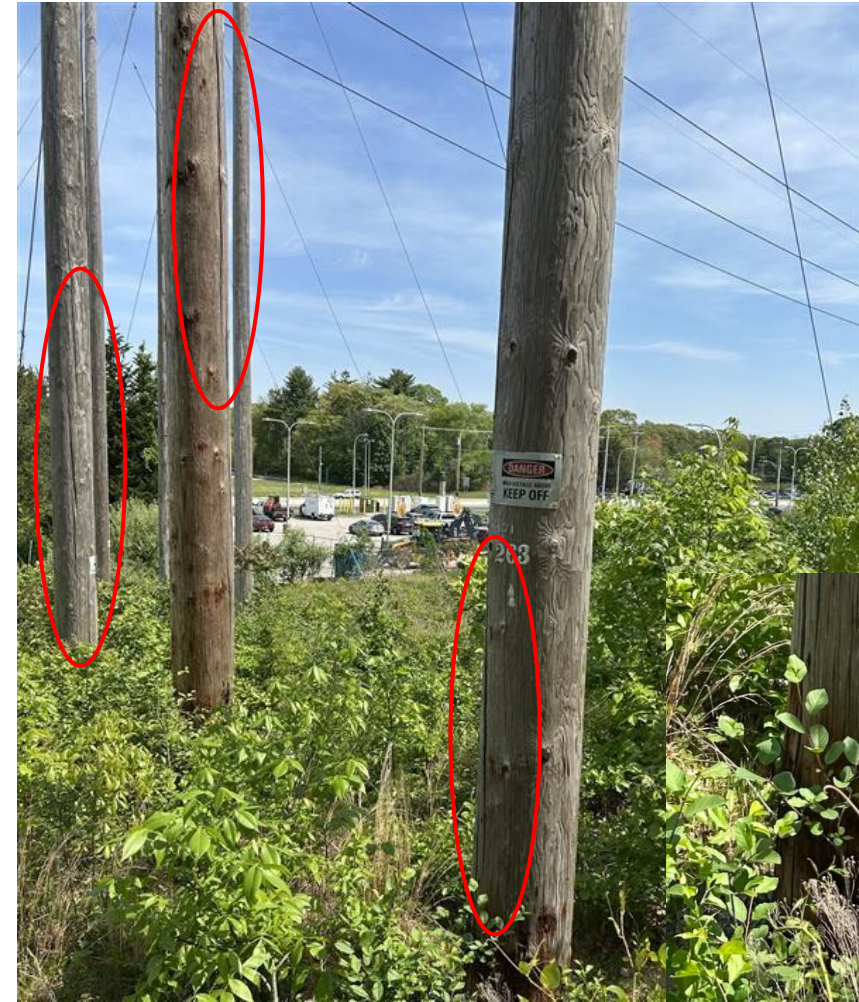
S171S Structure 263
Pole Cracks and Pole Base Deterioration

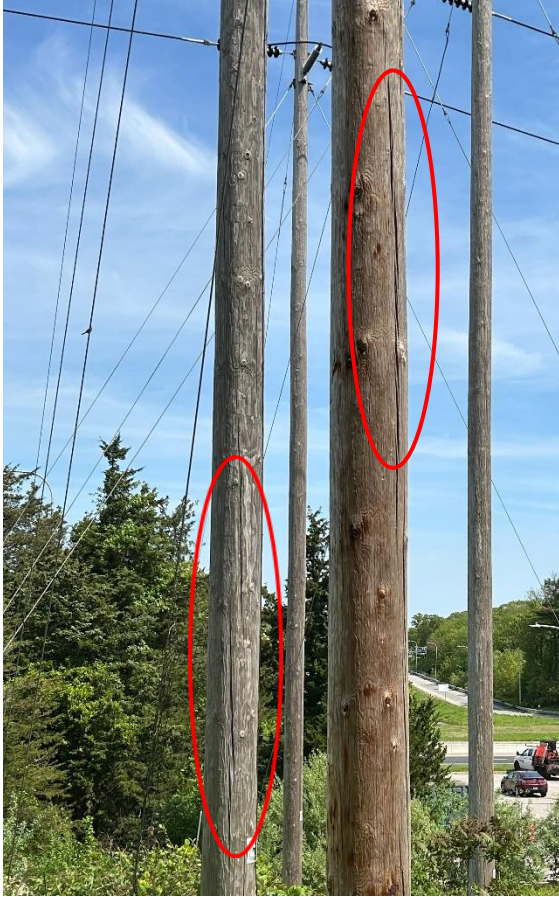
S-171S Structure 263 - Back
Pole Cracks

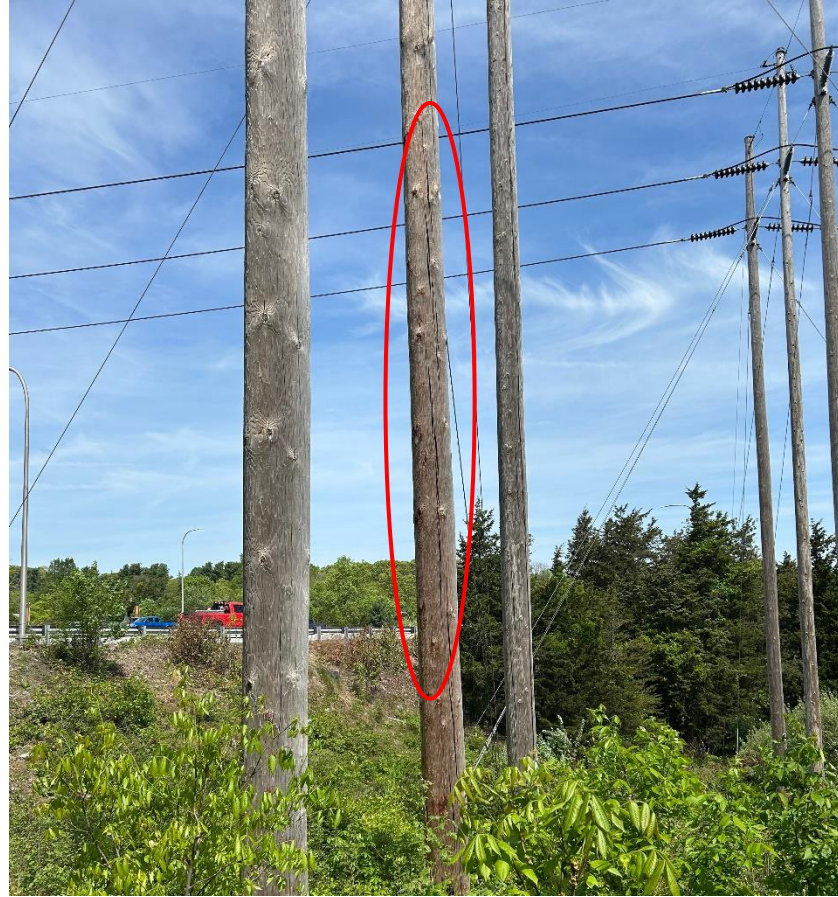
S-171S Structure 263 - Front
Pole Cracks

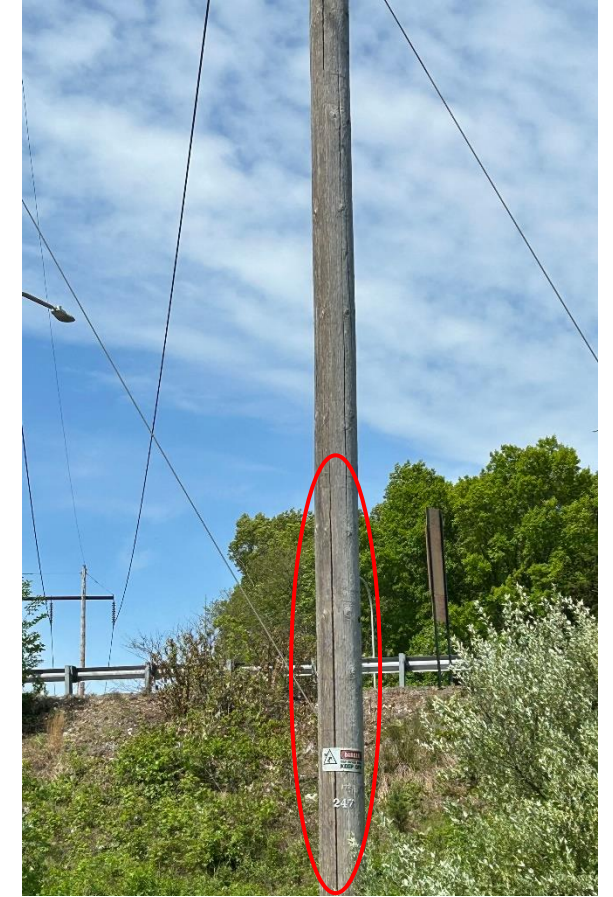
T-172S Structure 247
Pole Cracks

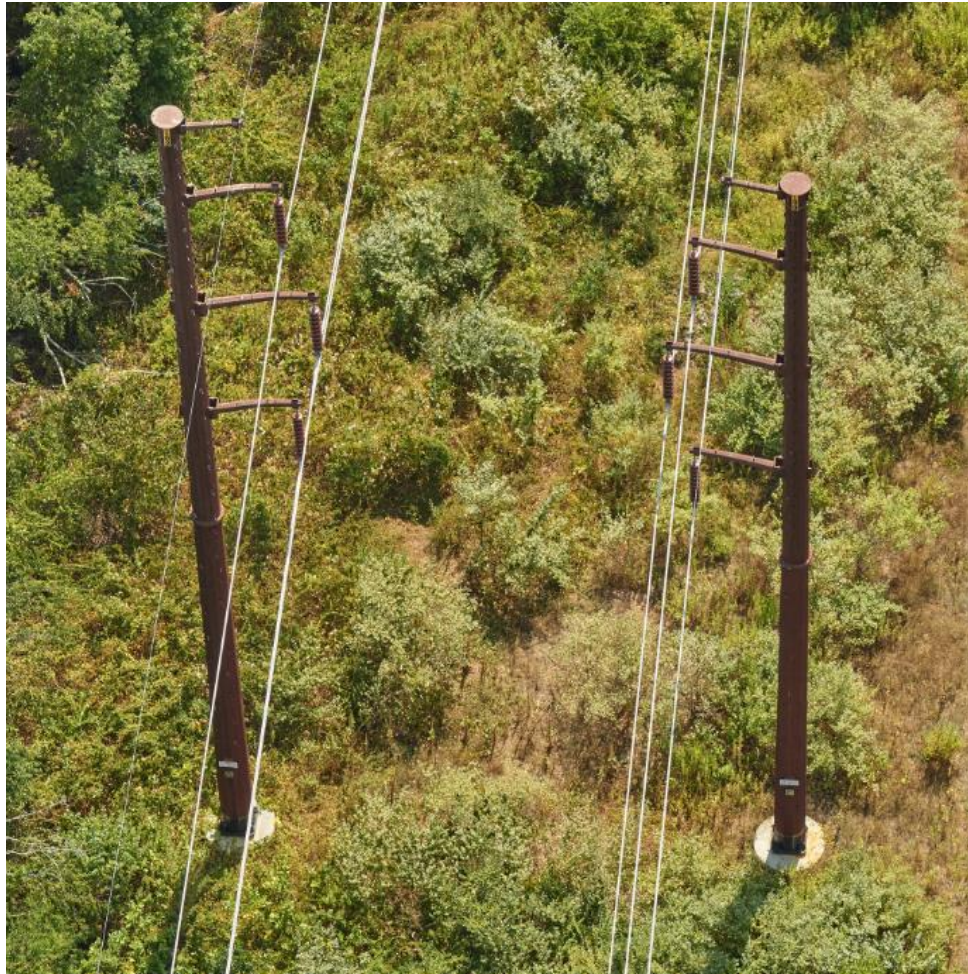
Shield Wire Concerns	
Primary Concerns	
Line Performance	<ul style="list-style-type: none">• Lines fail to meet current RIE lightning performance criteria<ul style="list-style-type: none">• Inadequate lightning protection can increase flashover on structures, resulting in momentary or permanent outages• ~20,000 customers impacted in a single outage in 2023 on T172S• Dual shield wire will provide better shielding angle from lightning strikes<ul style="list-style-type: none">• Will result in fewer outages• Better grounding using ground rods or ground drills to limit equipment damage, create safe working conditions
Secondary Concerns	
Line Performance	<ul style="list-style-type: none">• OPGW installation allows for direct protective relaying between the substations via fiber, the implementation of our new communication network, and the ability to communicate with Motor Operated Load Break Air Break Switch

T-172S Str 162 and S-171S
Str 180 Current Layout
