ISO-NE PAC MEETING

Belmont #98 Asset Replacements

National Grid Belmont #98 Asset Replacements - 1/27/2025

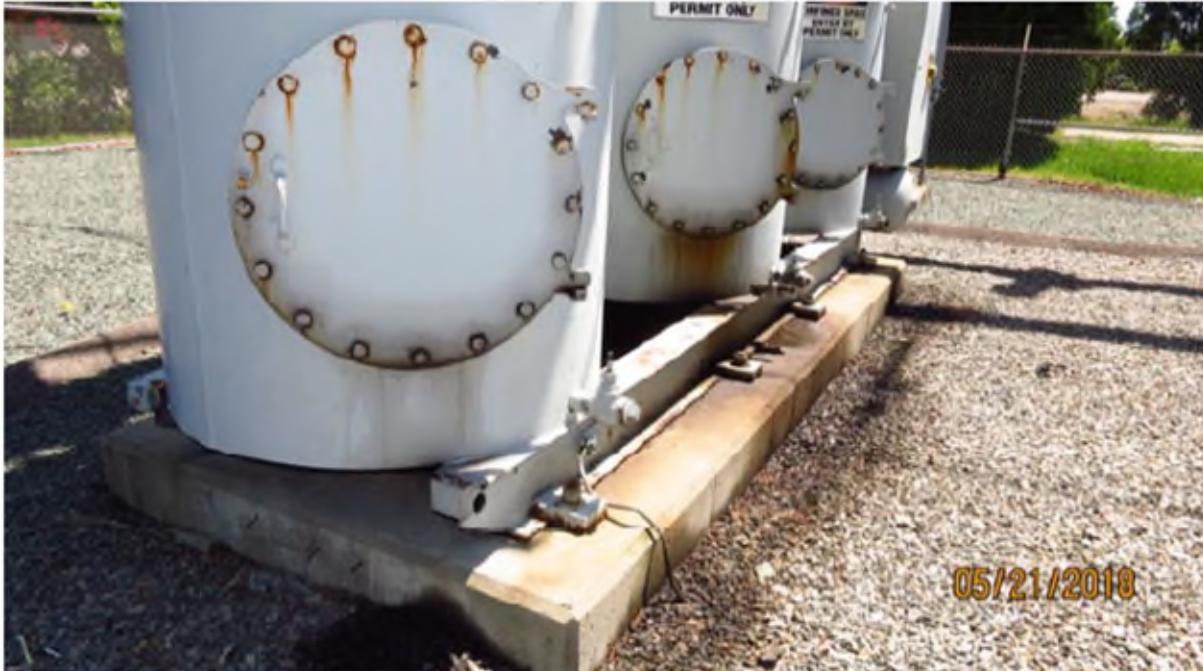
- The 9801 breaker has a history of oil leaks and air system trouble and noticeable rusting in the housing.
- The 9802 breaker has history of air system trouble and noticeable rusting in the housing.
- Difficult to source spare parts due to model and vintage.
- Replacing the disconnect switches with motor operated disconnects (MOD) to allow for automatic load restoration after a failed breaker operation.

Signs of oil leak on the B-phase of the 9801 breaker

Description	<ul style="list-style-type: none">Replace the 115 kV 1600 A 9801 & 9802 OCBs with 2000 A VCBs and relaying.Replace the breaker isolation disconnect switches (9801-1, 9801-2, 9802-1, 9802-2).Remove the 9801 disconnect switch and the grounding switch attachment 9801-1G.Replace the 98-1 transformer disconnect switch with 115 kV circuit switcher.Install conduit from control enclosure to the U2 structure for existing OPGW fiber interconnection and tie-in to control enclosure.
Primary Needs Addressed	Yes
Secondary Needs Addressed	None
Advanced transmission technologies to be considered	None
Cost Estimate and Accuracy	\$7.3 M PTF (+/-25%) , \$1.4 M non-PTF (+/-25%)
Impact on transmission needs or concerns from recent studies	None
Key standards or criteria affecting design if different than current design	Replacement of OCBs with VCBs
