Scobie Pond 345 kV Trench Replacement & Control House Expansion Project

Project Update

Planning Advisory Committee Meeting

August 20, 2025

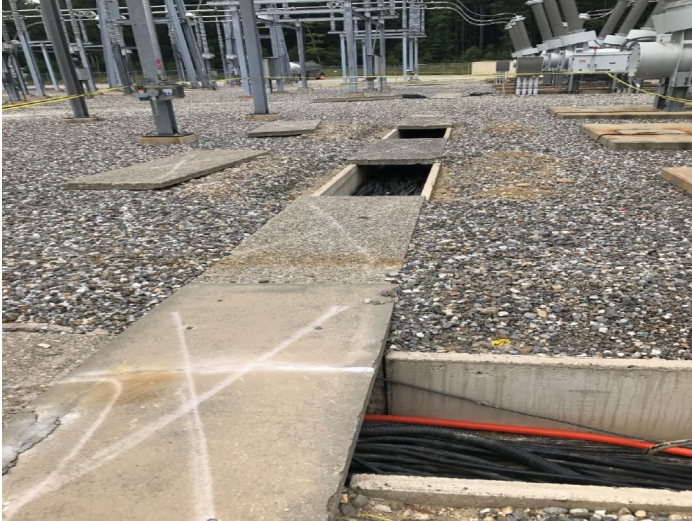
Covers In Need of Replacement
Depicted by "X"

- Installed around 1970
- Intended to be light duty and not intended to be driven over except in specified locations
- Existing concrete covers show signs of cracking, covers often break when removed and can no longer be used resulting in uncovered sections until repair/replacement can be made
- Existing cable trench side walls and boxes are deteriorating and cannot support trench covers
- Secondary cabling compromised in exposed trench sections, failing concrete walls and covers presents risk to the installed cables and personnel

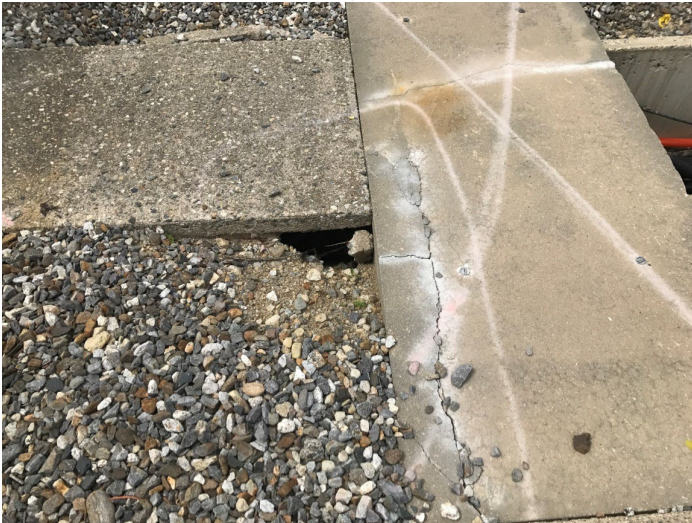
Cracking of Concrete Cover

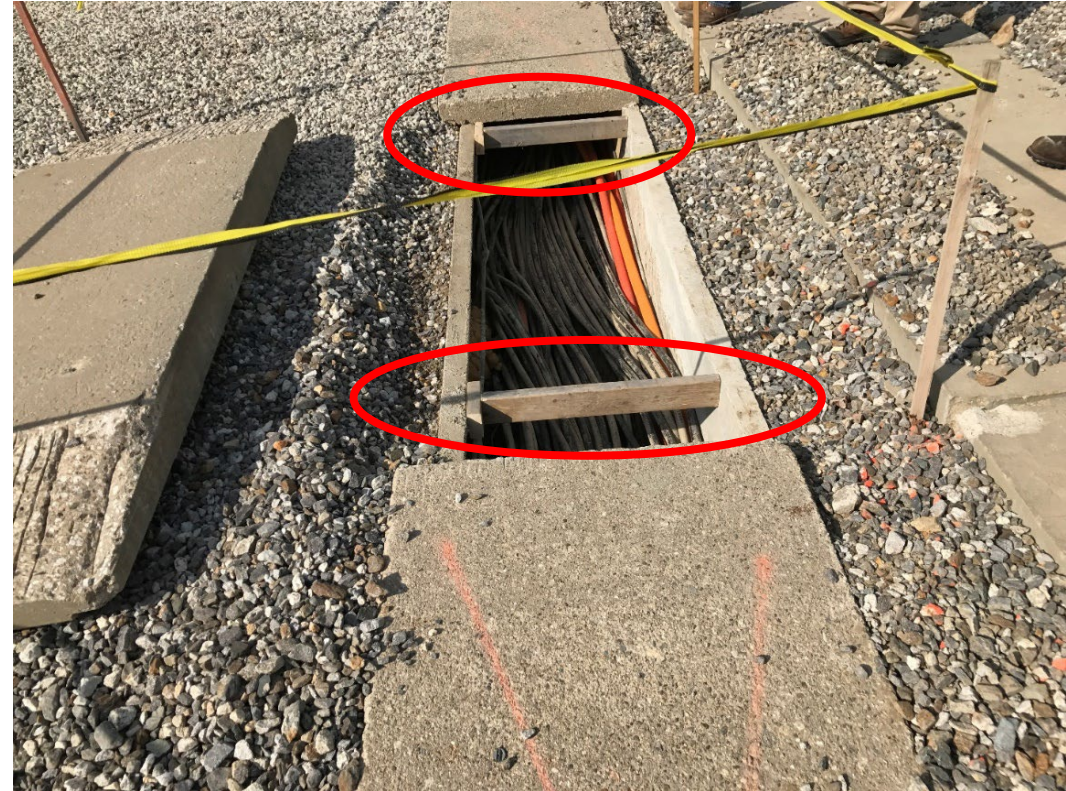
Left Sidewall Collapsing Into
Trench and Braced with 2'x4's

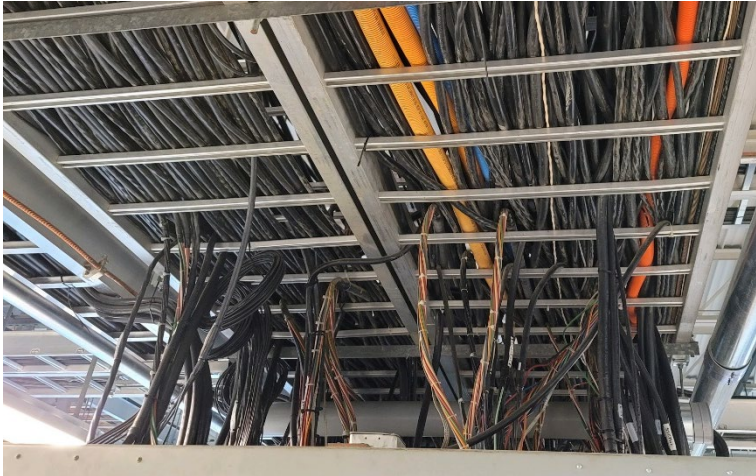
Overfull Cable Trays

- Through many years of upgrades, cable trays have become congested and does not currently meet NPCC Directory 4 requirements
- Some secondary control equipment (such as DC panelboards) pre-dates control house construction, is obsolete and no longer supported by manufacturer
