# Horton Cove Asset Condition and OPGW Project

Planning Advisory Committee Meeting

July 22, 2020

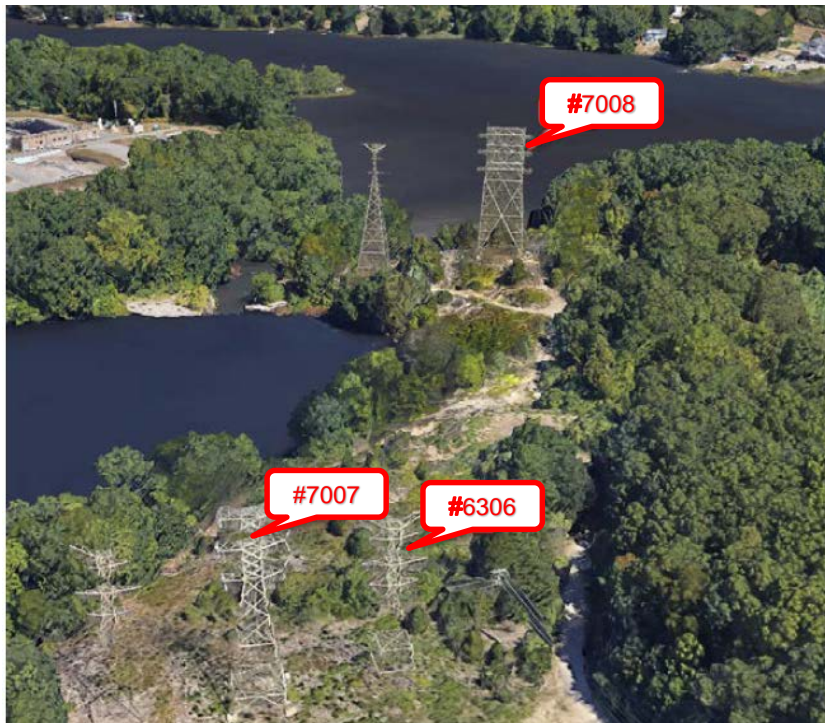
South of Horton Cove (Looking North-East)

Structure #7008 – Quad-Circuit Lattice Tower  
Structures #6306/7007 – Double-Circuit Lattice Towers

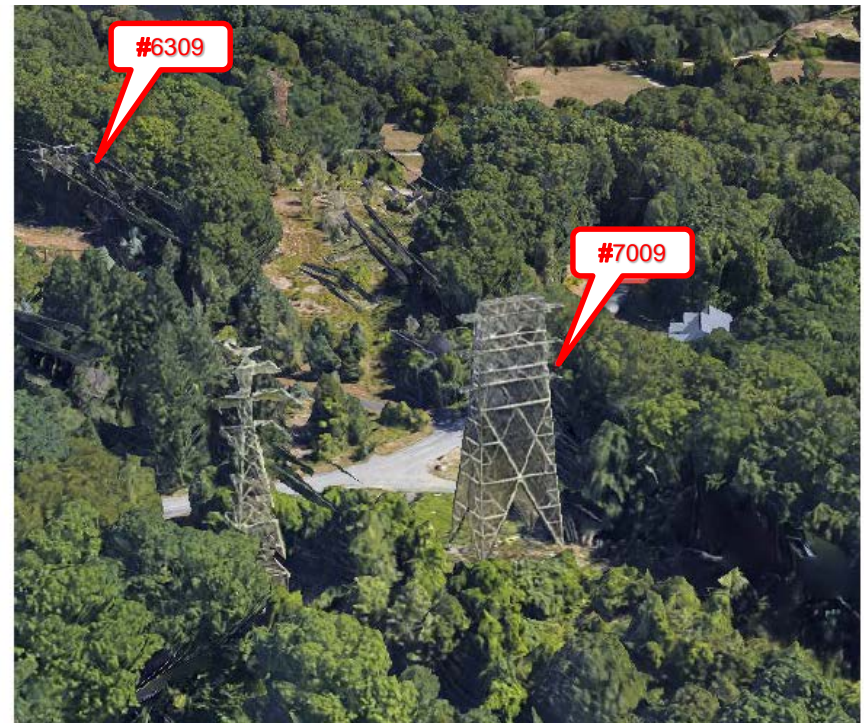
North of Horton Cove (Looking East)

Structure #7009 – Quad-Circuit Lattice Tower  
Structure #6309 – Single-Circuit H-Frame

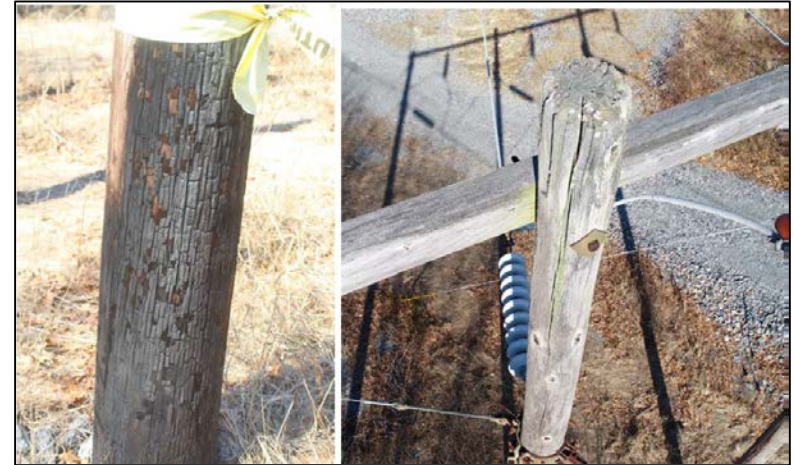
- H-frame and lattice structures are deteriorating and outdated
  - Split pole tops and cracks
  - Woodpecker damage
  - Deteriorating steel components
- Temporary fix (“bushing-buddies”) on quad-circuit lattice towers to address deteriorating steel plates
  - Deterioration is continuing and bushing-buddies were not intended to be a permanent solution

Structure #8343 – Split pole tops, woodpecker damage, cracks, burnt at base

- Replace 11 existing quad, double, and single circuit structures with 2 Double-Circuit Steel Monopoles, 12 Single-Circuit Steel Monopoles, and 5 Single-Circuit Steel H-Frames
- Installation of lightning arrestors
- Installation of counterpoise

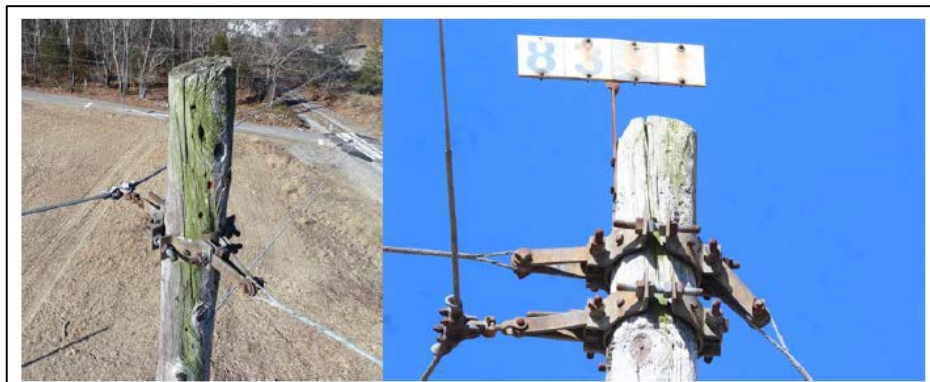
Structure #8345 – Split pole tops, woodpecker damage
