# Branford 11J A3 Bus Replacement Project

Planning Advisory Committee Meeting

February 17<sup>th</sup>, 2021

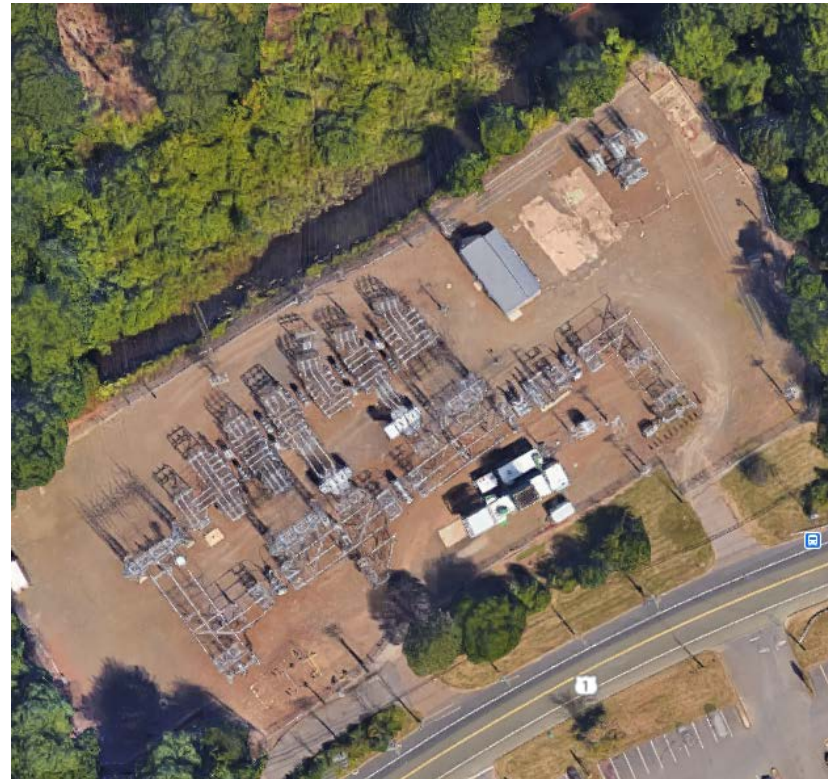
- Branford 11J is a 115/23-kV substation located in southern CT
- Branford 11J A3 bus contains 400' of 3-phase (1,200' total) self-contained fluid filled (SCFF) cable
- This is the only SCFF cable on the Eversource CT transmission system
- Station also contains an NRG-owned combustion turbine (~22 MVA)
