Connecticut Structure Replacement & OPGW Installations - Revised

Planning Advisory Committee Meeting

July 27th, 2023

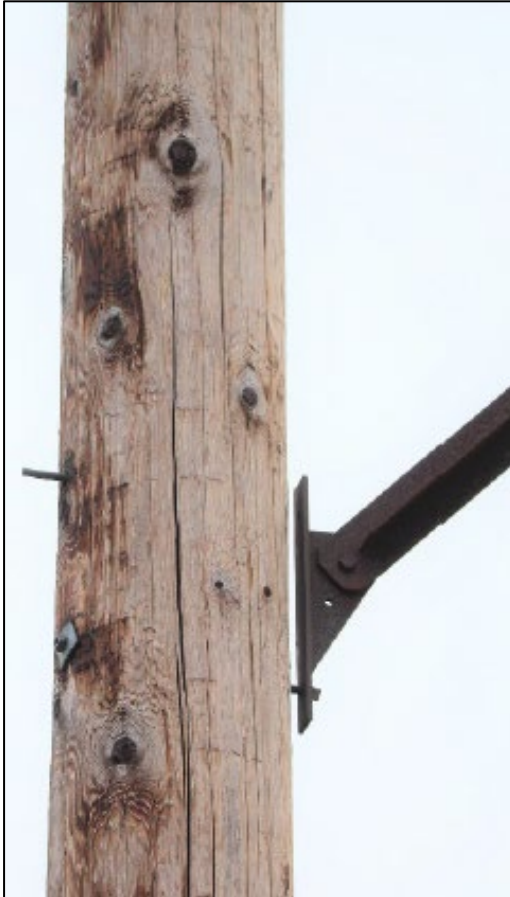
Line 364 Structure 5555
Loose Hardware

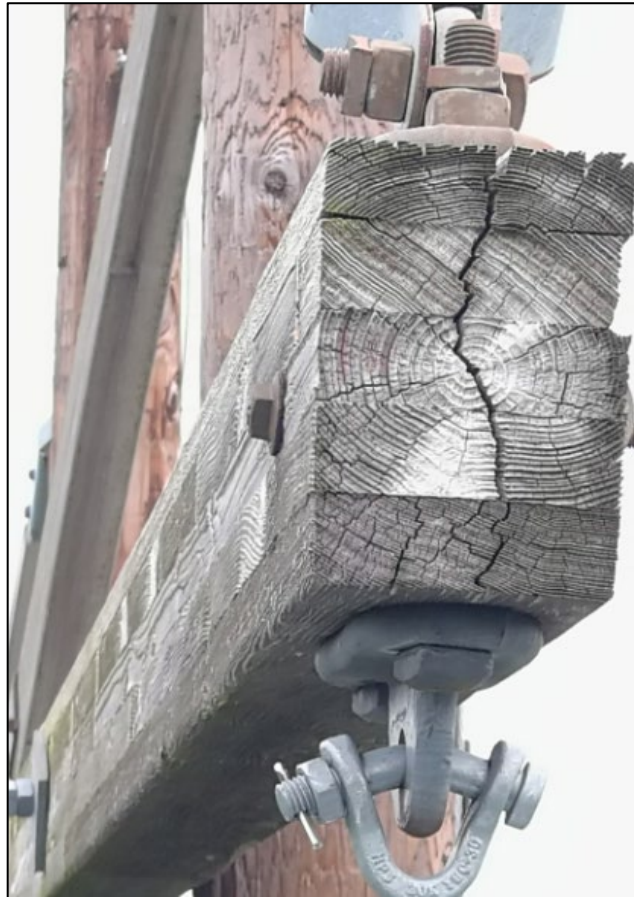
Line 1726 Structure 8084
Crossarm Cracking

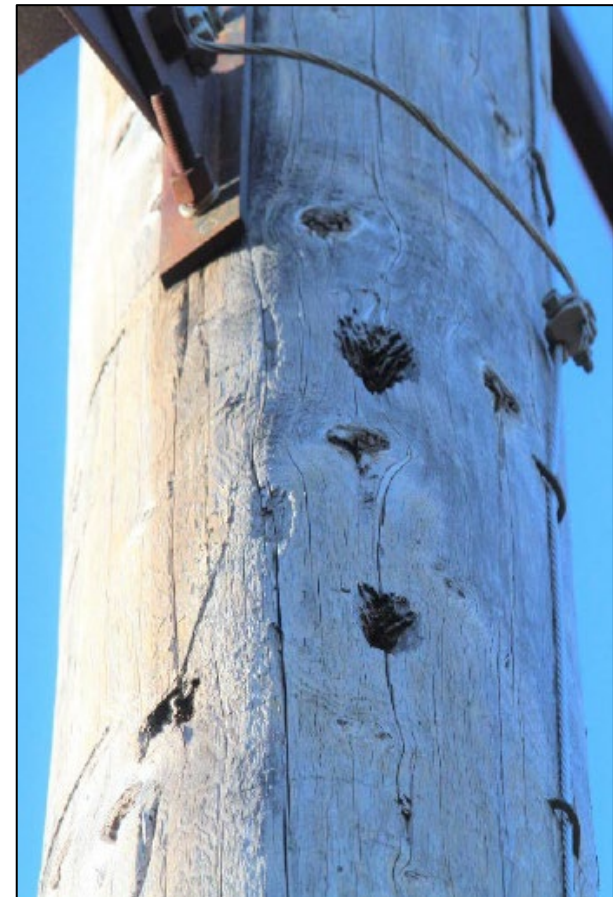
Line 364 Structure 5557
Woodpecker Damage
