MEPCO S396/3001

End of Life Strategy PAC Presentation

06/15/24

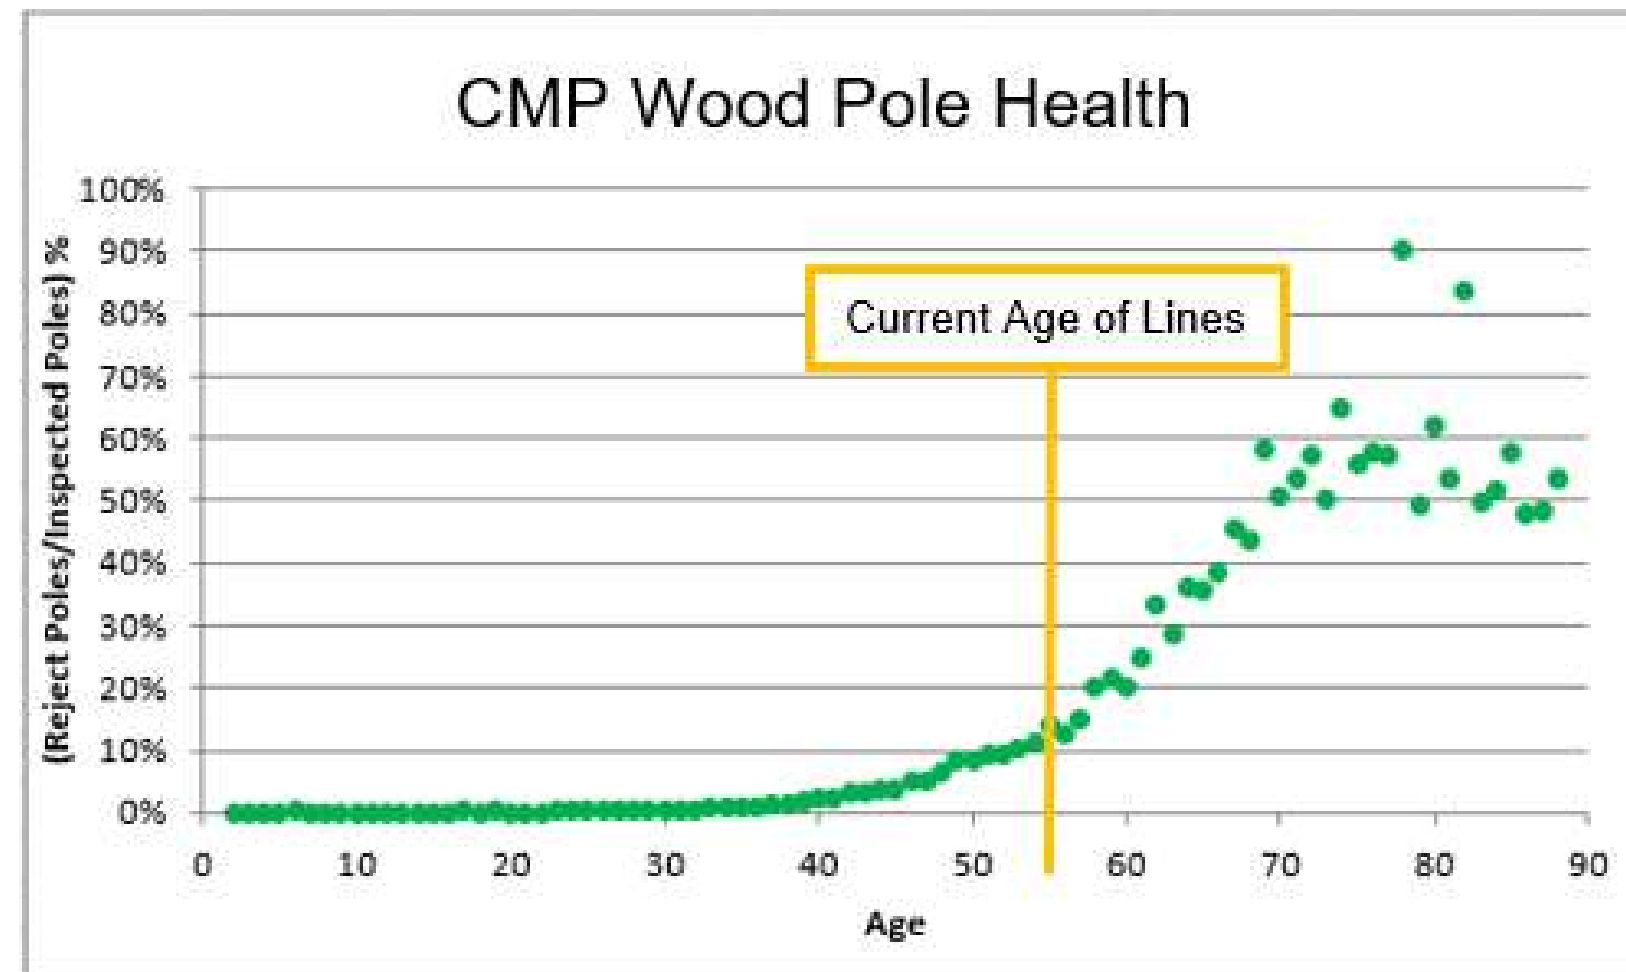
Pole Health

This figure illustrates that wood poles decline exponentially after approximately 60 years of age⁽¹⁾. The estimated reject rate for a 54-year-old pole is 15%.

(1) The data is comprised of the historical reject rate of wood poles on CMP's system.

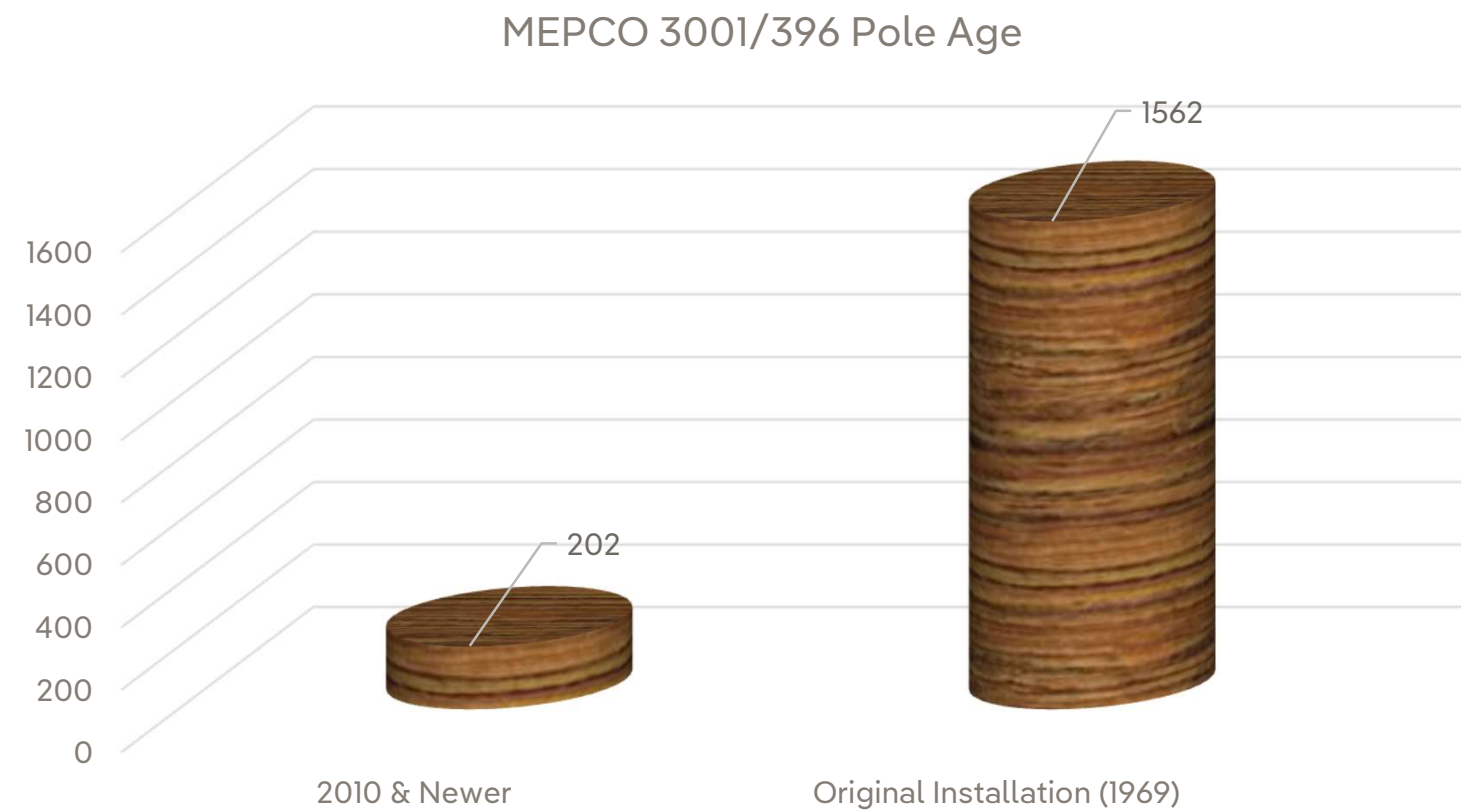
MEPCO S396/3001 Pole Age

This figure illustrates that regular structure maintenance/replacements started in 2010. The majority of poles date back to the original installation in 1969 (approximately 54 years of age).
