# ISO-NE PAC MEETING

08/26/26

## E-205E and E-205W 230 kV Line Asset Condition Replacement

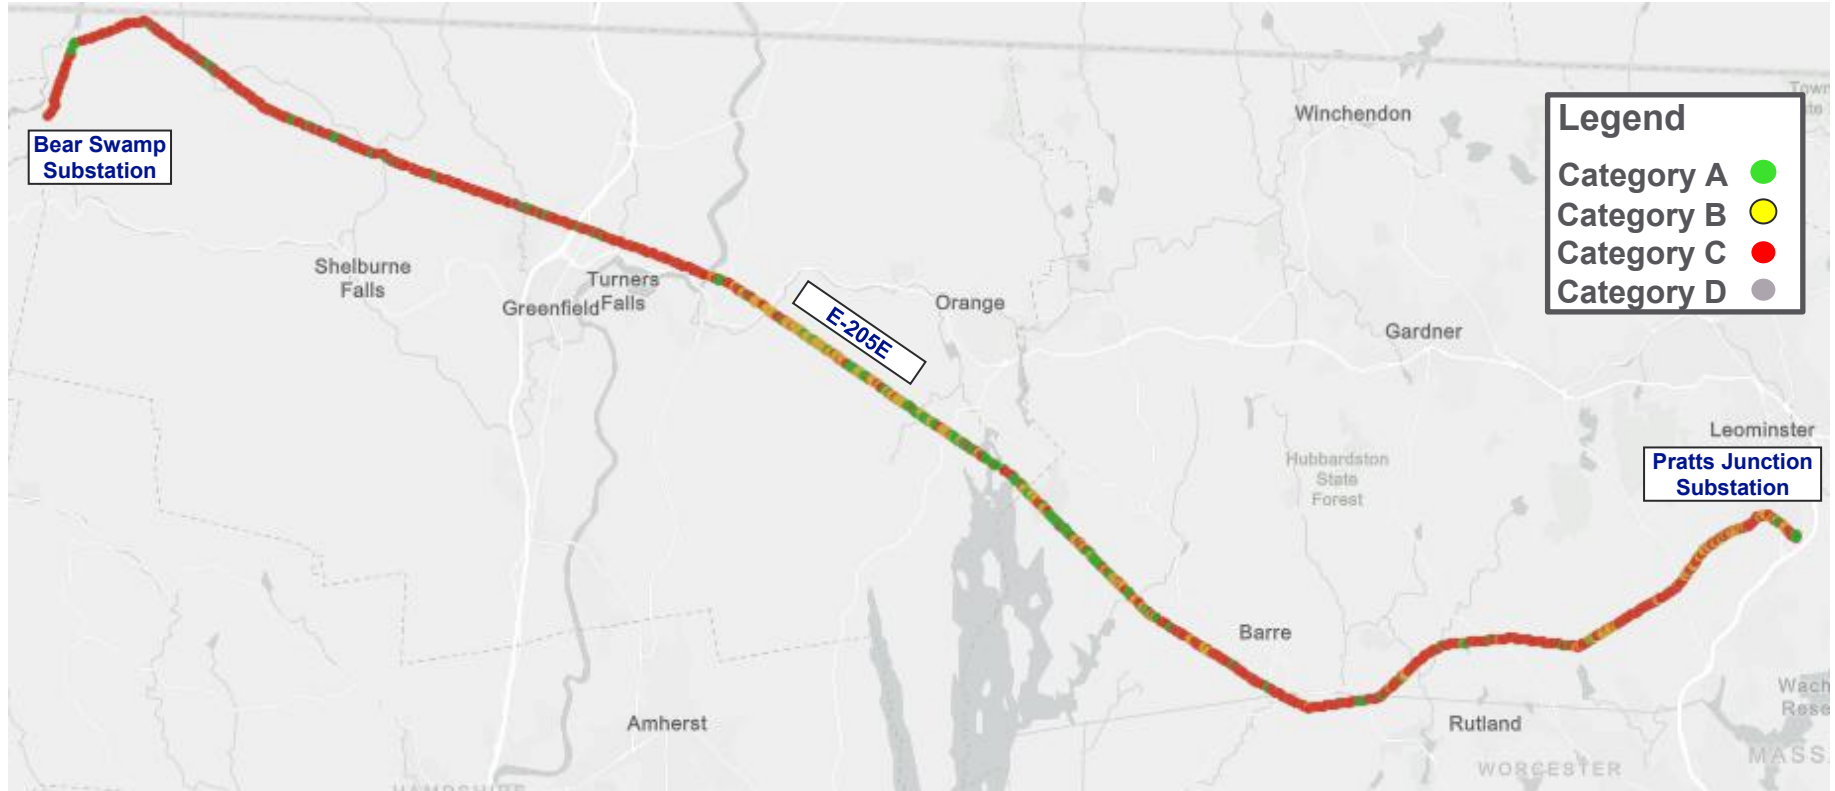
# Project Needs and Drivers - Structure Grades Map (E-205E)

- Six hundred twenty (620) wood structures on the line are grade C due to poor condition.
- One hundred thirty (130) wood structures on the line are grade B. These are considered opportunity structures due to limited access and due to location in a woodpecker infested habitat
- One hundred thirty (130) structures are grade A.
- Six (6) structures are rated grade D due to degraded condition and will be replaced in advance of this project with wood structures. The wood replacement structures will get replaced with steel 345kV structures as part of the preferred alternative proposed in this project.

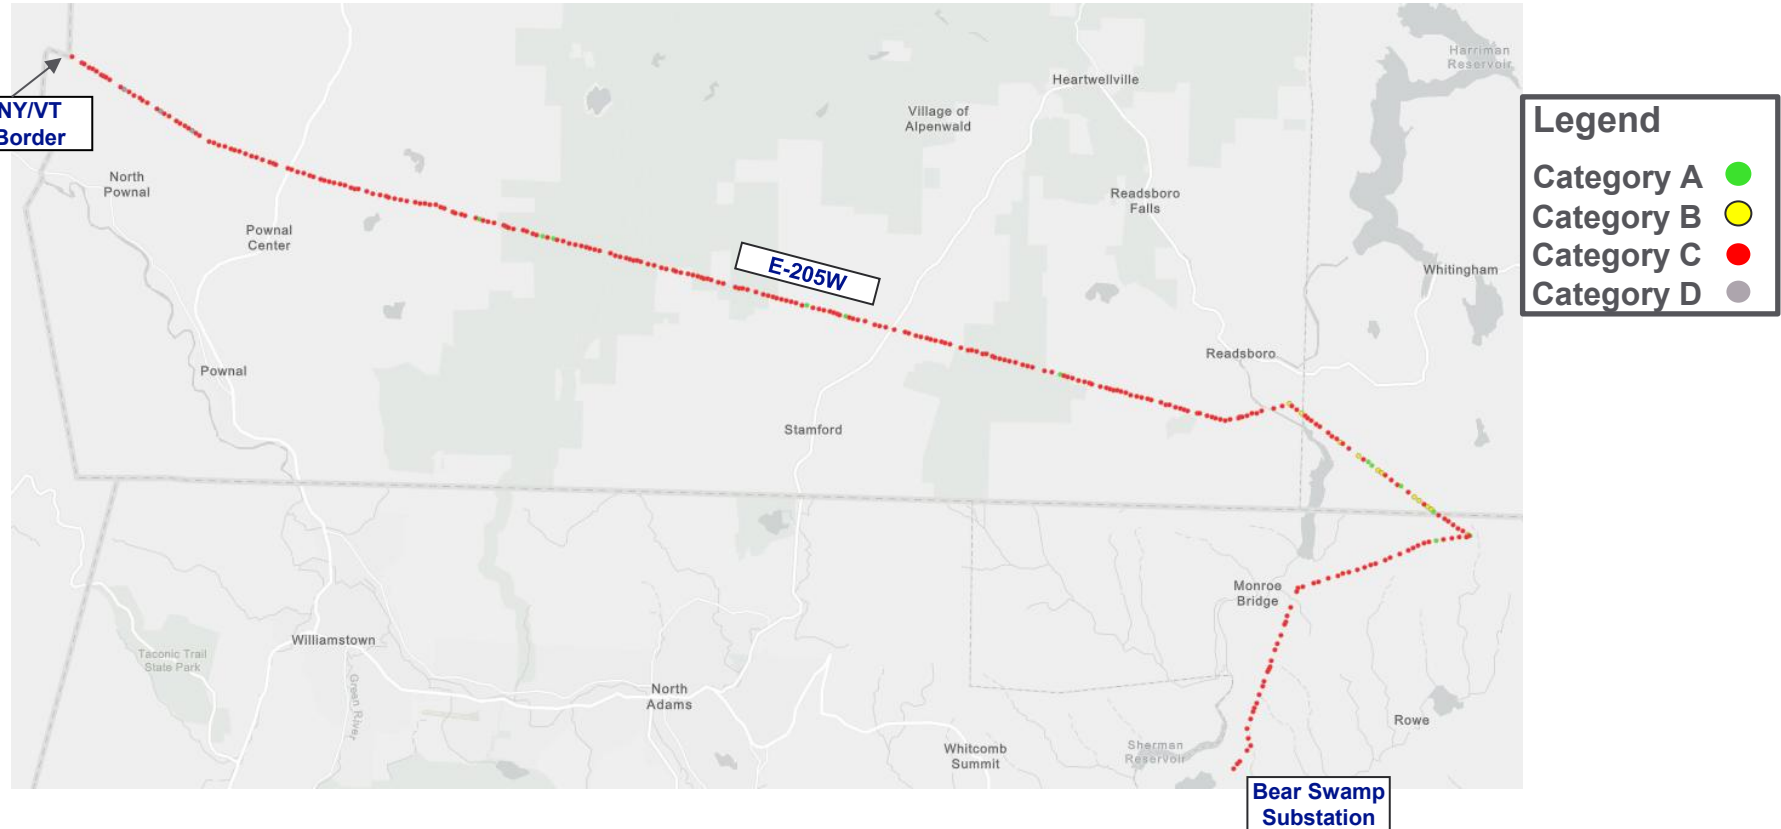
# Project Needs and Drivers - Structure Grades Map (E-205W)

- Two hundred ninety-three (293) wood structures on the line are grade C due to poor condition.
- Eleven (11) wood structures on the line are grade B. These are considered opportunity structures due to access and due to location in a woodpecker infested habitat
- Twelve (12) steel structures are grade A.
- Three (3) structures are rated grade D due to poor condition and will be replaced in advance of this project with new wood structures. These replacement wood structures will get rebuilt with steel 345kV structures as part of the preferred alternative.

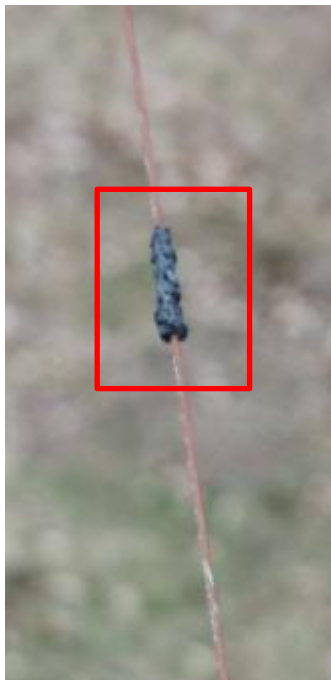
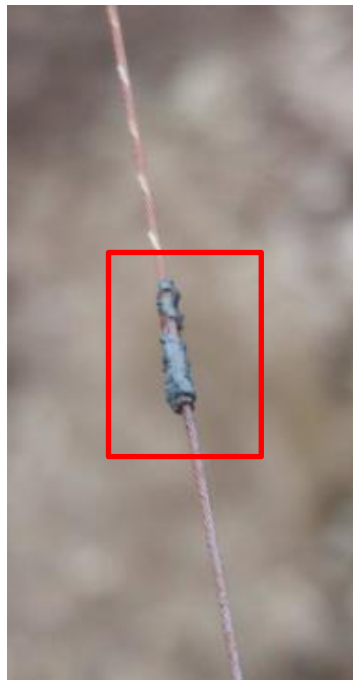
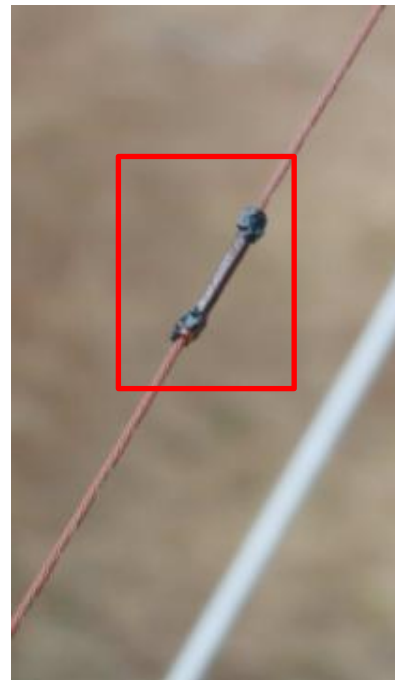
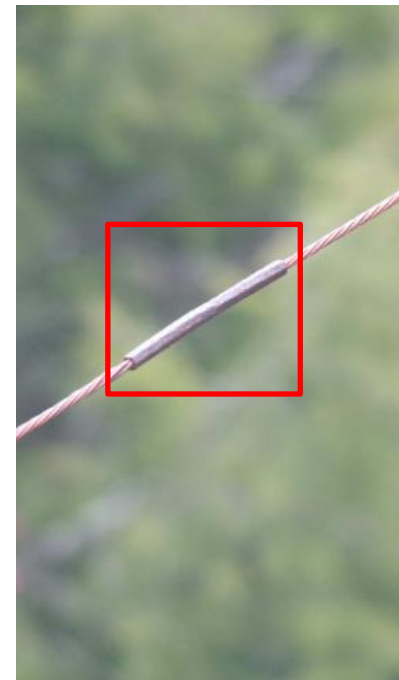
# Project Needs and Drivers – Spliced Shieldwire

- 438 splices on the E-205E phase conductors and shield wires, 83 splices on E-205W phase conductors and shield wires
- Splices pose mechanical and corrosion risks, increasing the chances of failure

**Frequent splices in shieldwire across entire circuit**

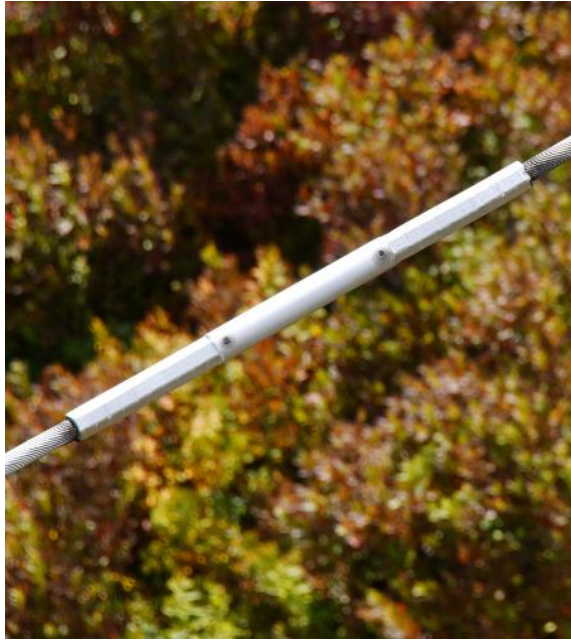
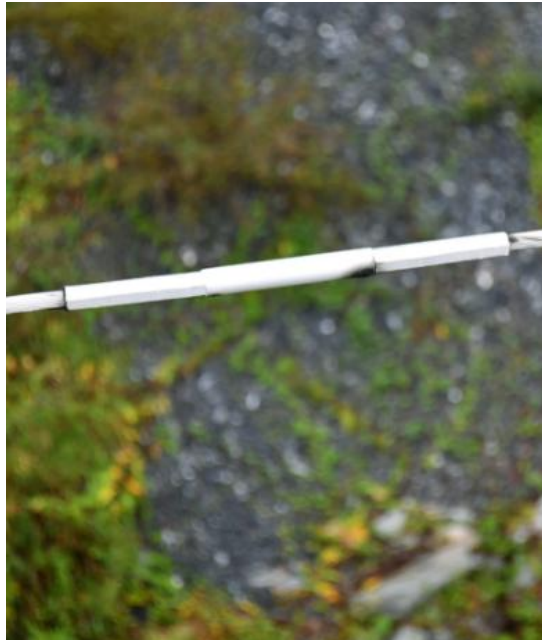
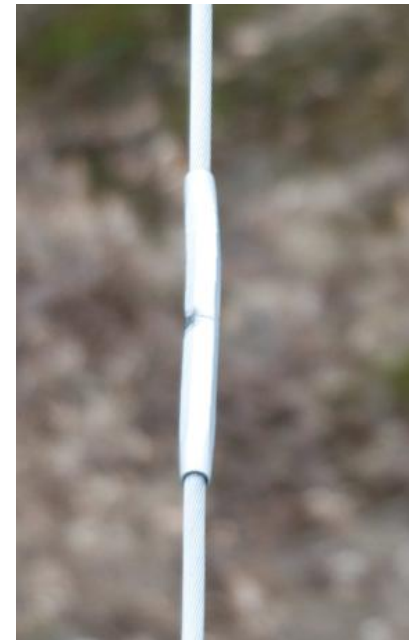
# Project Needs and Drivers – Spliced Conductor

**Frequent splices in all phases of the conductor across entire circuit**
