July 25, 2023

UI's 115kV Derby Junction to Ansonia Line Rebuild Project:

PAC Update

Presentation to:
ISO-NE PAC

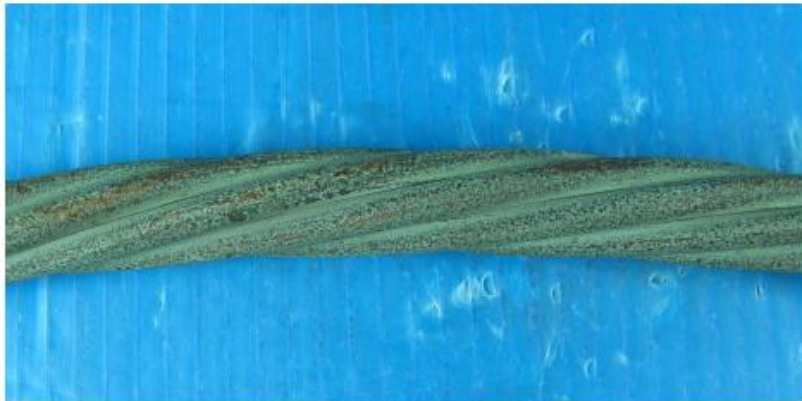
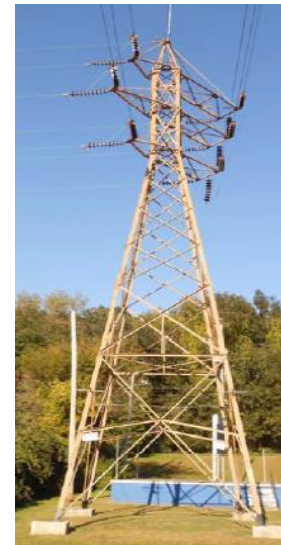
Structures & Foundations

- Climbing & visual inspections
- Mechanical loading & conductor sway simulations in PLS CADD / TOWER
