### 1191 115-kV Line Copper Conductor Replacement and Wood Pole Asset Condition Project

Planning Advisory Committee Meeting August 27<sup>th</sup>, 2020

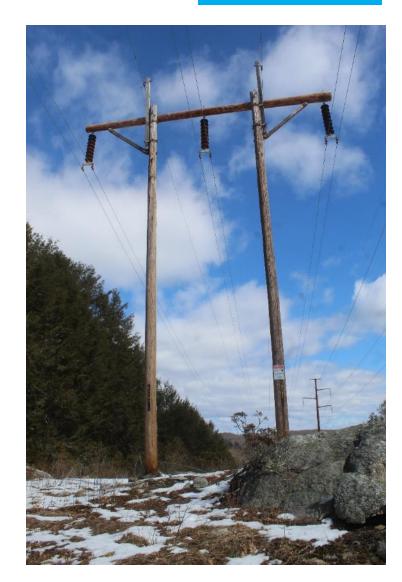
#### **Project Background**

- The 1191 115-kV line is 10.3 miles long and runs between the Campville 14R (Harwinton, CT) and Frost Bridge 8R (Watertown, CT)
- Originally constructed in 1933 as two parallel lines operated at 27.6 kV
- The lines were bundled and reconfigured to a single 115-kV transmission line in 1957

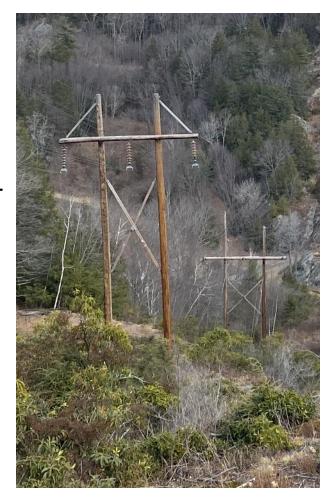
## Project Needs – Asset Condition – Copper Conductor

- Existing 2/0 copper conductor and 3/8" copperweld shield wires are obsolete and susceptible to failure due to thermal rating degradation and degradation due to environmental factors
- 2/0 copper conductor used is no longer used for transmission purposes
- Hardware for 2/0 copper conductor is not readily available, and non-traditional repair methods have to be employed

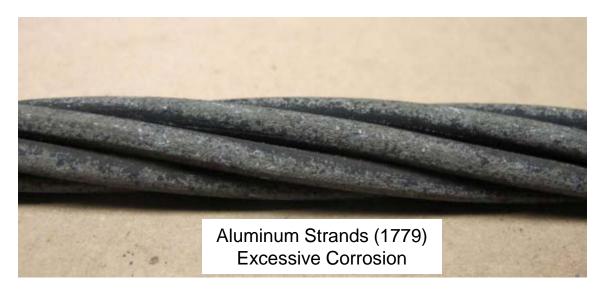
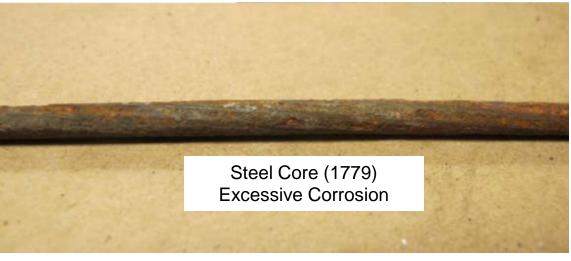
# Project Needs – Asset Condition – Copper Conductor

- National Electric Energy Testing, Research and Applications Center (NEETRAC) Report on Similar 1779 115-kV Line (~96 years old)
- Test Results Indicate:
  - Aluminum strands exhibit significant oxidation
  - Steel core exhibits significant corrosion
  - Average aluminum strand tensile strength has deteriorated to 81% of ASTM required value
  - Average steel core tensile strength has deteriorated to 89% of American Society for Testing and Materials (ASTM) required value
  - Conductor resistance has increased by 6.5%, failing to meet
    ASTM required value
