Line N133 Structure Replacement Project

Planning Advisory Committee Meeting June 20, 2024

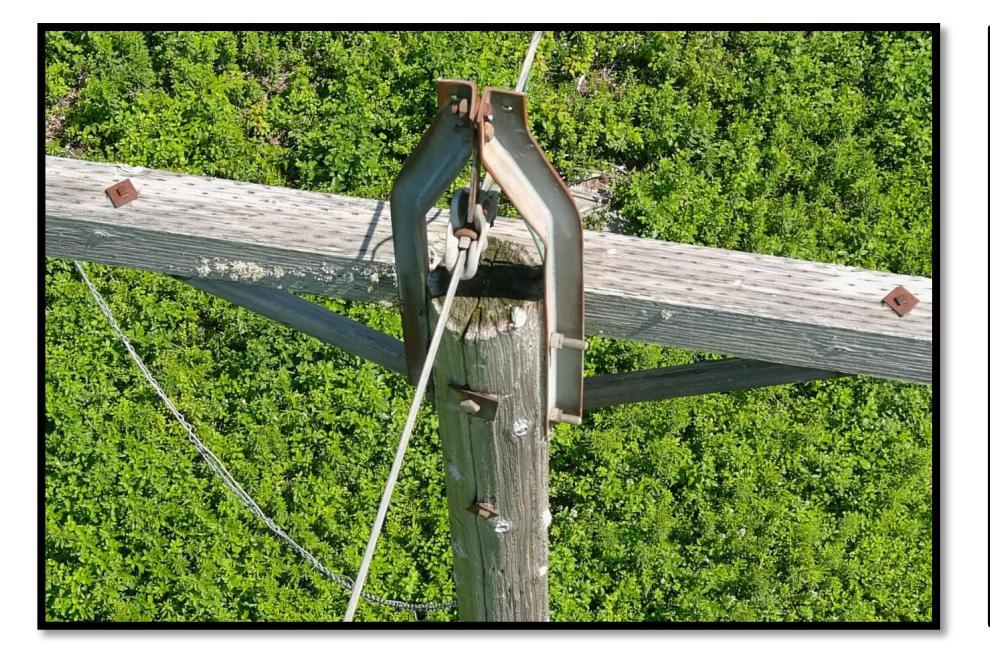
- A: Nominal Defect No action required
- B: Minimal Defect Monitor degradation
- C: Moderate Defect Rehabilitation recommended as scheduled maintenance
- D: Severe Defect Repair, reinforce, or replace as soon as possible
- Grade C round wood structures showed one or more of the following age-related degradations, leading to decreased load carrying capability
 - Cracking, splitting
 - Weathered pole tops, rust on hardware and insulators
- Additional B grade structures were identified and prioritized for replacement based on Engineering requirements to meet current uplift standards as well as efficiencies in required permitting approvals for replacing Grade C structures, and minimizing environmental impacts
 - If not addressed, these issues jeopardize the long-term integrity of the transmission system and its continued reliability

Structure 32 – Weathered top, splits, rust on hardware

Structure 47 – Pole splits

- Alternative 2 (Preferred): Replace priority C rated structures, uplift and nearby priority B rated structures
 - Addresses the long-term integrity and the continued reliability of the N133 line
